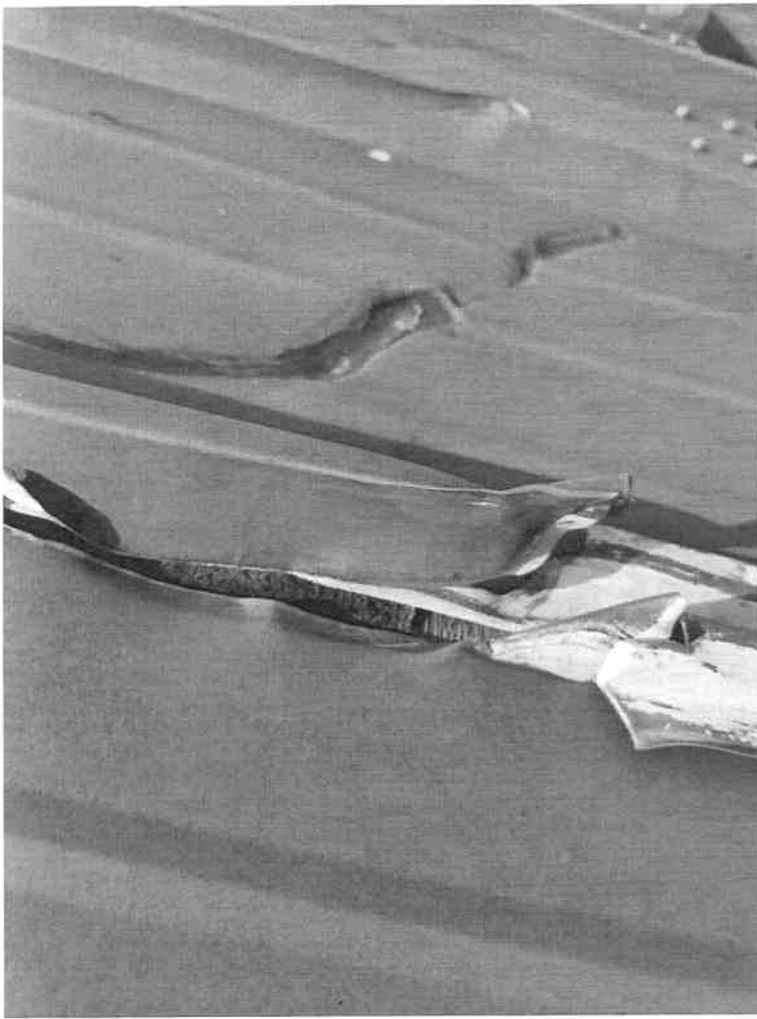
PHOTO-2025-10-12-20-07-24.jpg

Photo Description: North slope close-up ribbed portion torn and dented panel about 8-10 inches long, with approximately 18 inch jagged scrape, signs of rust and erosion. Plywood compromised.

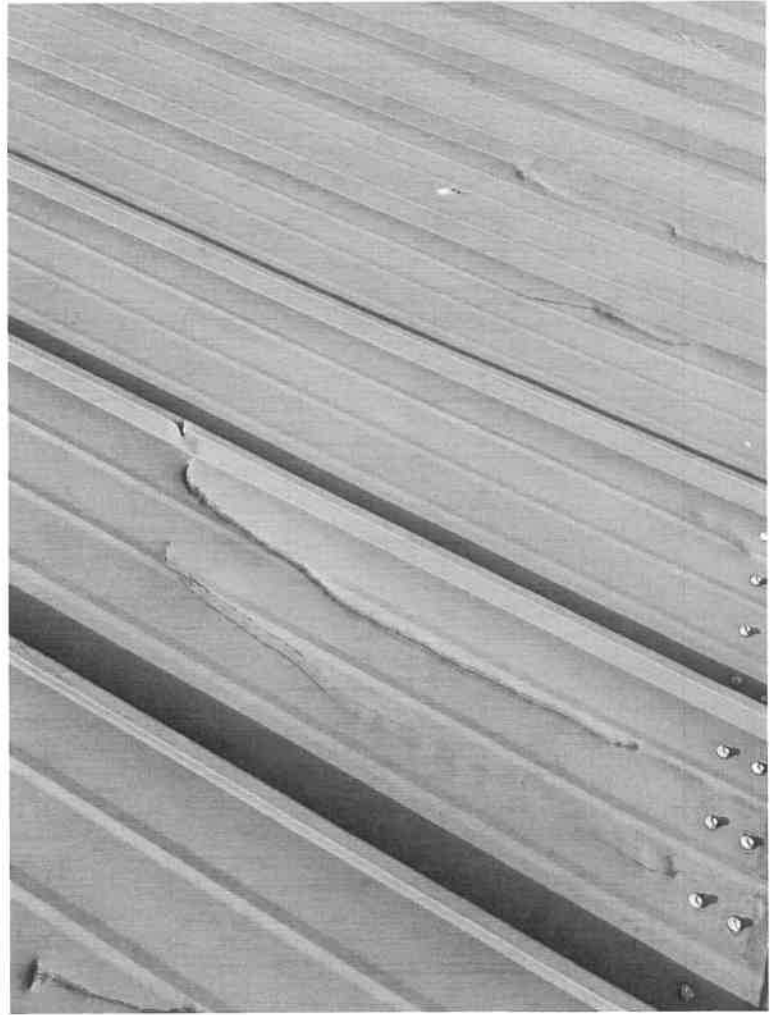
PHOTO-2025-10-12-20-07-24_1.jpg

Photo Description: North slope of roof with mutiple long, jagged scrapes on a number of panels, 2 to 3 feet in length. Rust and erosion evident.

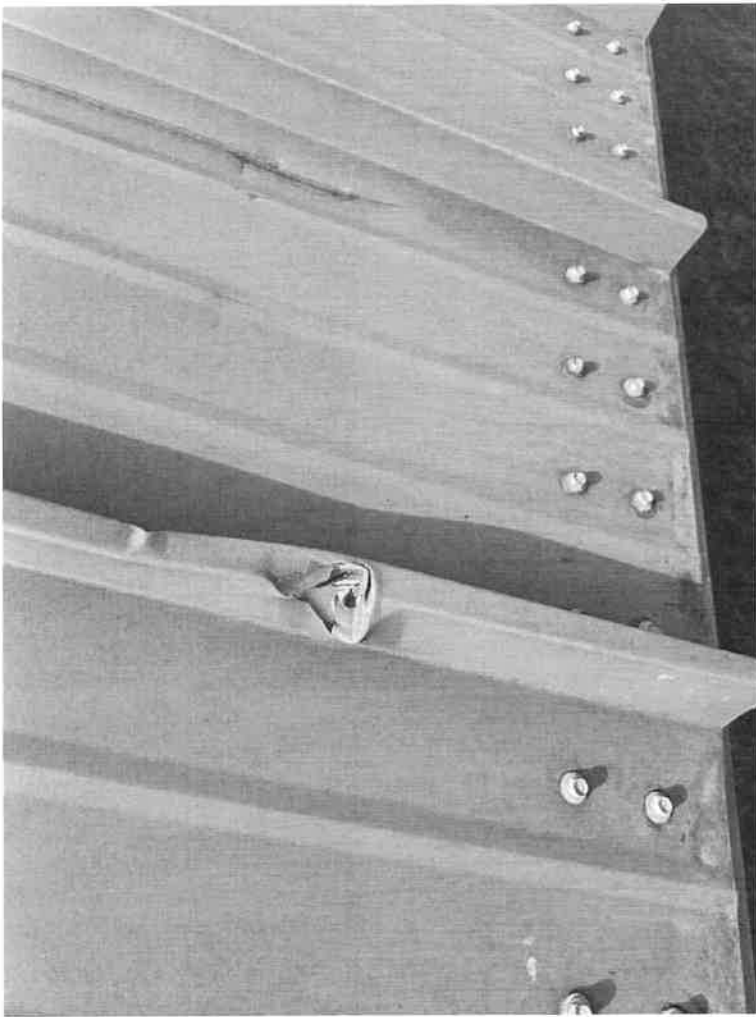
PHOTO-2025-10-12-20-07-26.jpg

Photo Description: North slope dented and torn ribbed portion of the panel located on the north slope of building. The affected area is about the size of a golf ball.

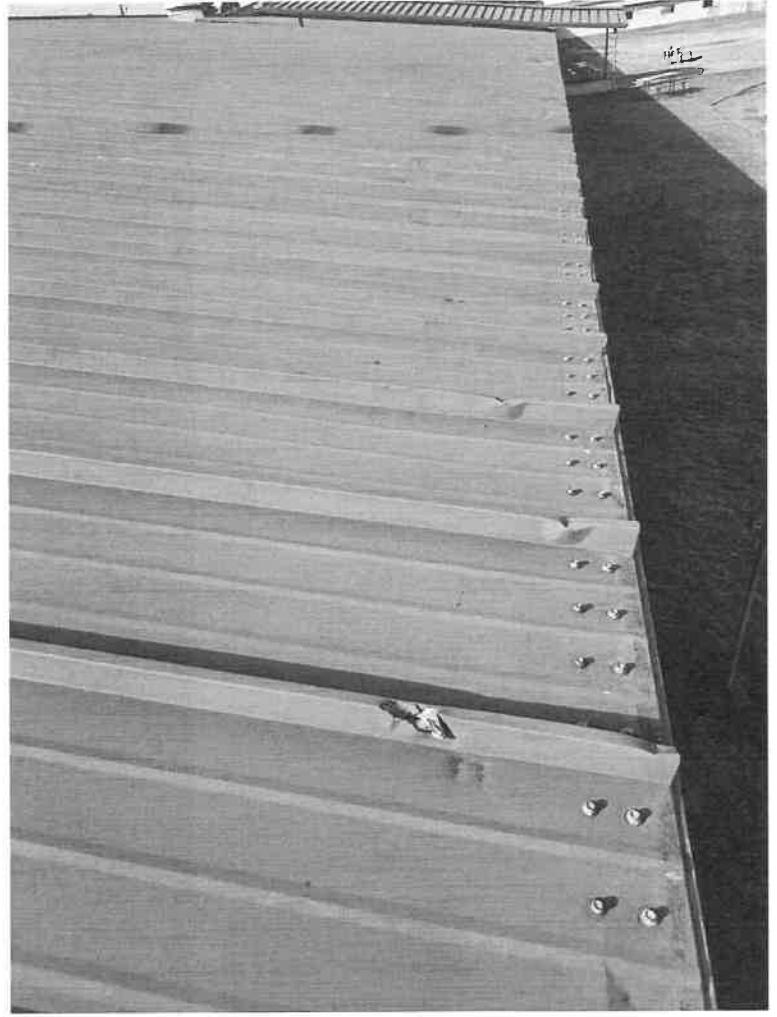
PHOTO-2025-10-12-20-07-25.jpg

Photo Description: North Slope multiple dented and torn ribbed portion of the affected metal panels. Affected areas range in size from 2 to 6 inches.

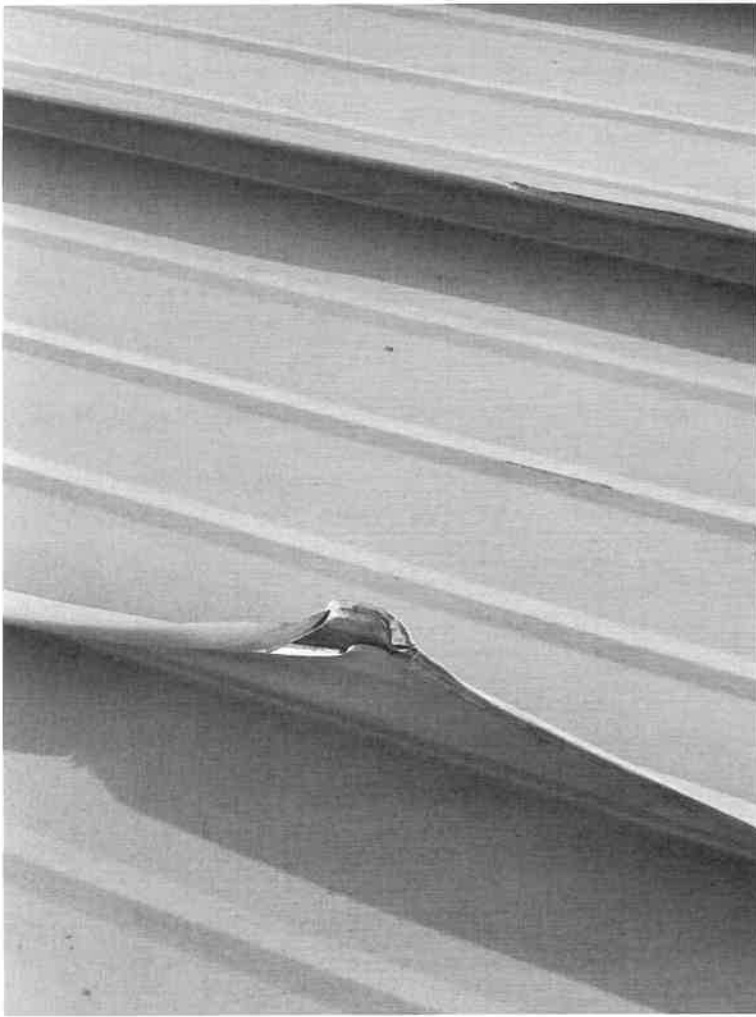
PHOTO-2025-10-12-20-07-21_1.jpg

Photo Description: North slope close-up metal panel with seam ripped open about 2 inches wide and actual damage to the panel that is approximately 10 inches wide.

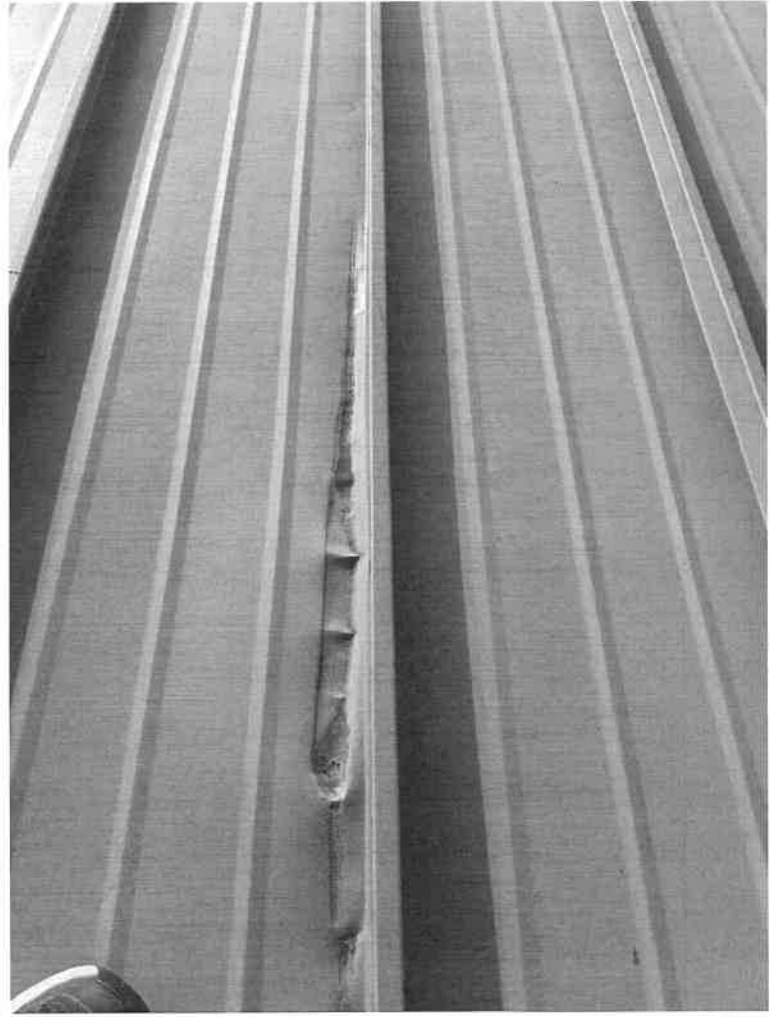
PHOTO-2025-10-12-20-07-22.jpg

Photo Description: North Slope dented metal panel about 3 feet long showing signs of rust and erosion with pin holes starting to form.

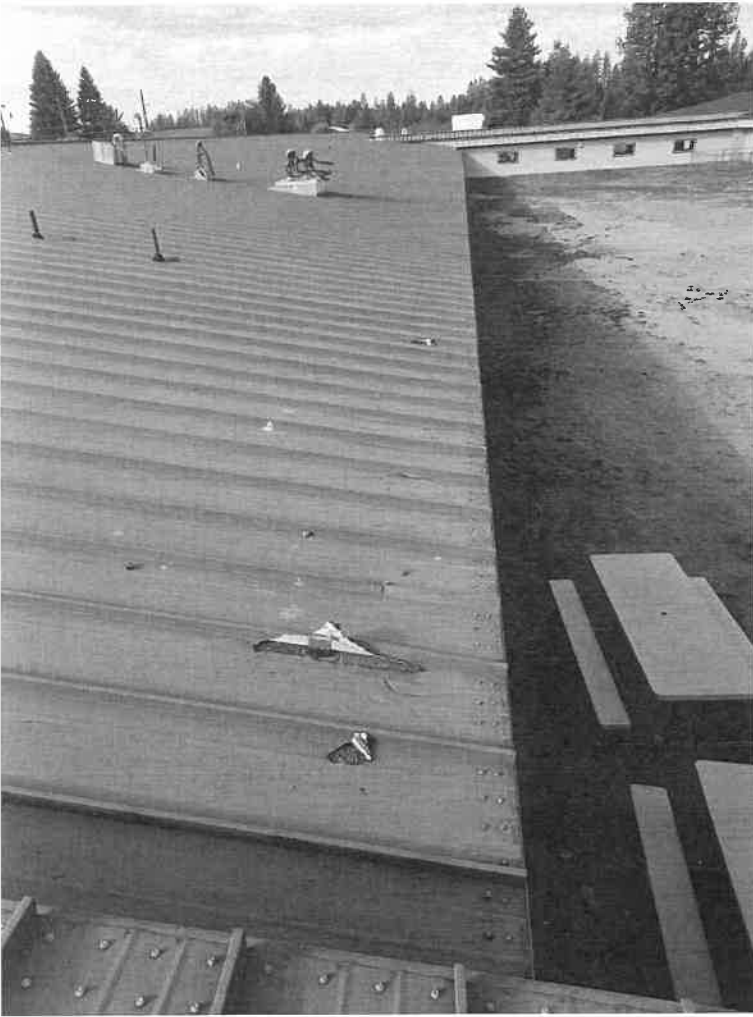
PHOTO-2025-10-12-20-07-20.jpg

Photo Description: North slope overview multiple panels with scrapes, dents and tears. Panels show gaping hole about 3-4 inches is diameter and other is approximately 18 inches in length also open 1-2 inches. Note underlying plywood has been compromised, evident of water intrusion.

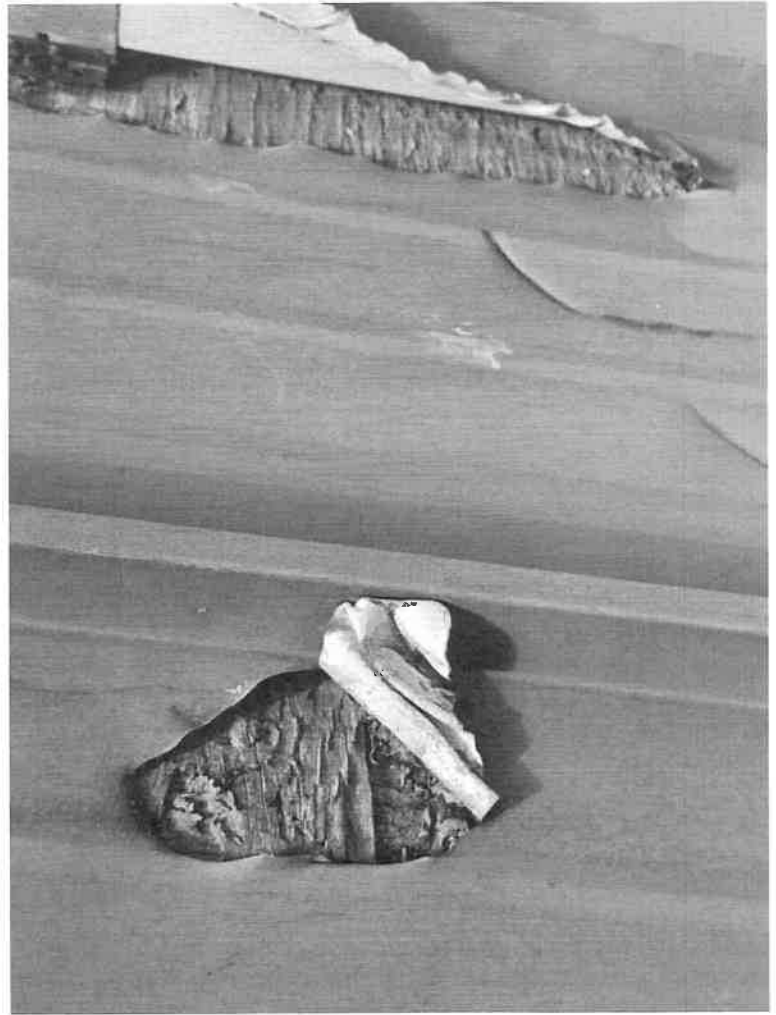
PHOTO-2025-10-12-20-07-17.jpg

Photo Description: North slope close-up, note underlying plywood is compromised, evident of water intrusion.

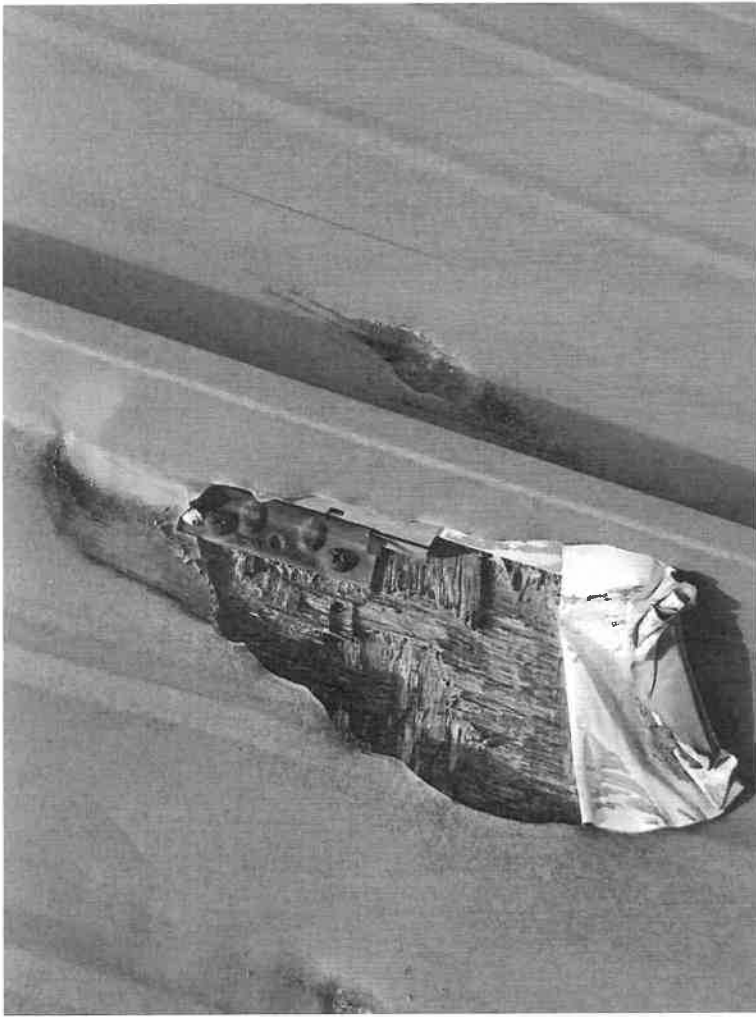
PHOTO-2025-10-12-20-07-08_3.jpg

Photo Description: North slope close-up, note underlying plywood is compromised, evident of water intrusion. Different panel shows gaping, jagged hole.

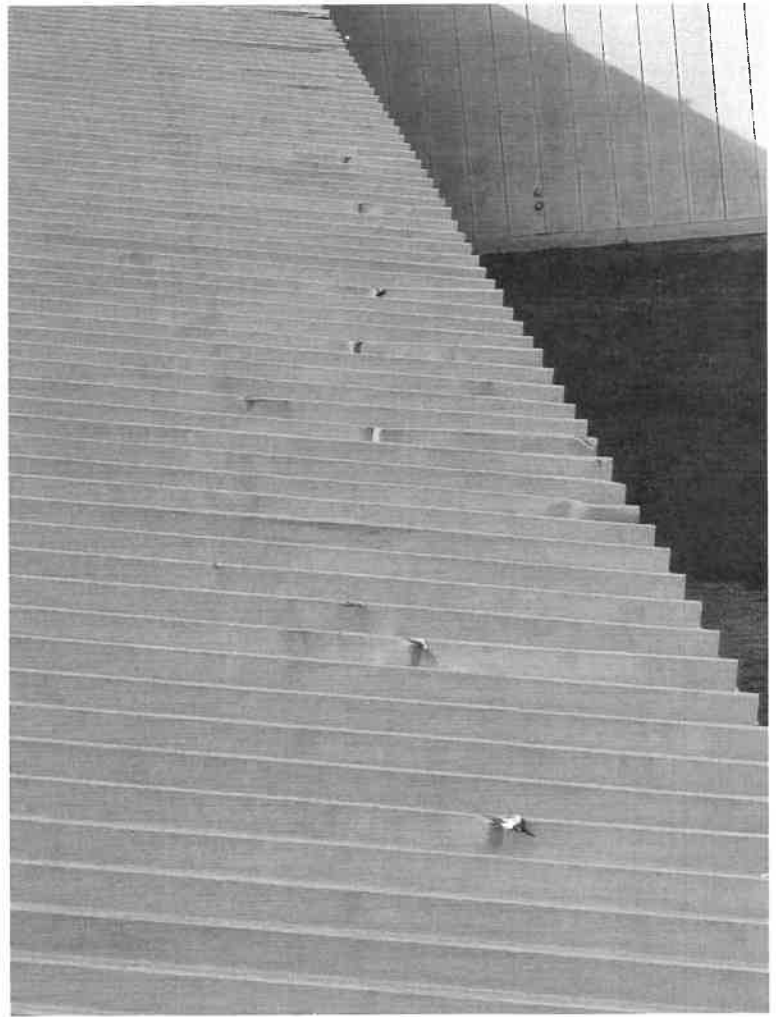
PHOTO-2025-10-12-20-07-08_2.jpg

Photo Description: North Slope overview photo showing affected panels are throughout the entire elevation.

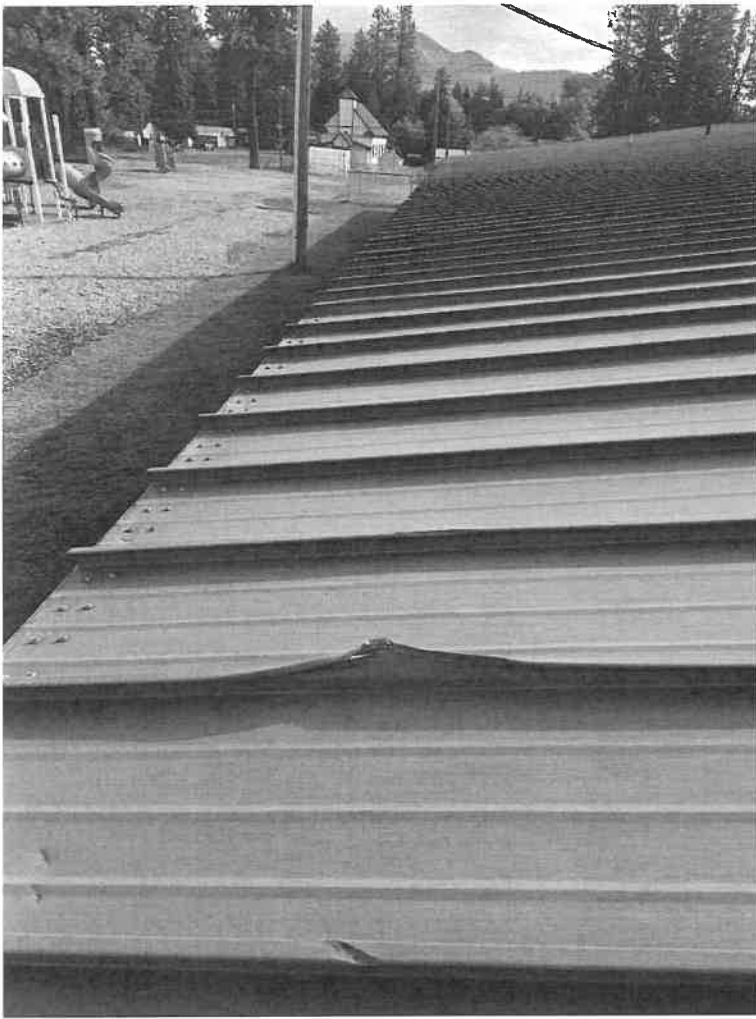
PHOTO-2025-10-12-20-07-21.jpg

Photo Description: North Slope overview (previously listed) also shown, 1 inch dented panel not pictured in other photo.

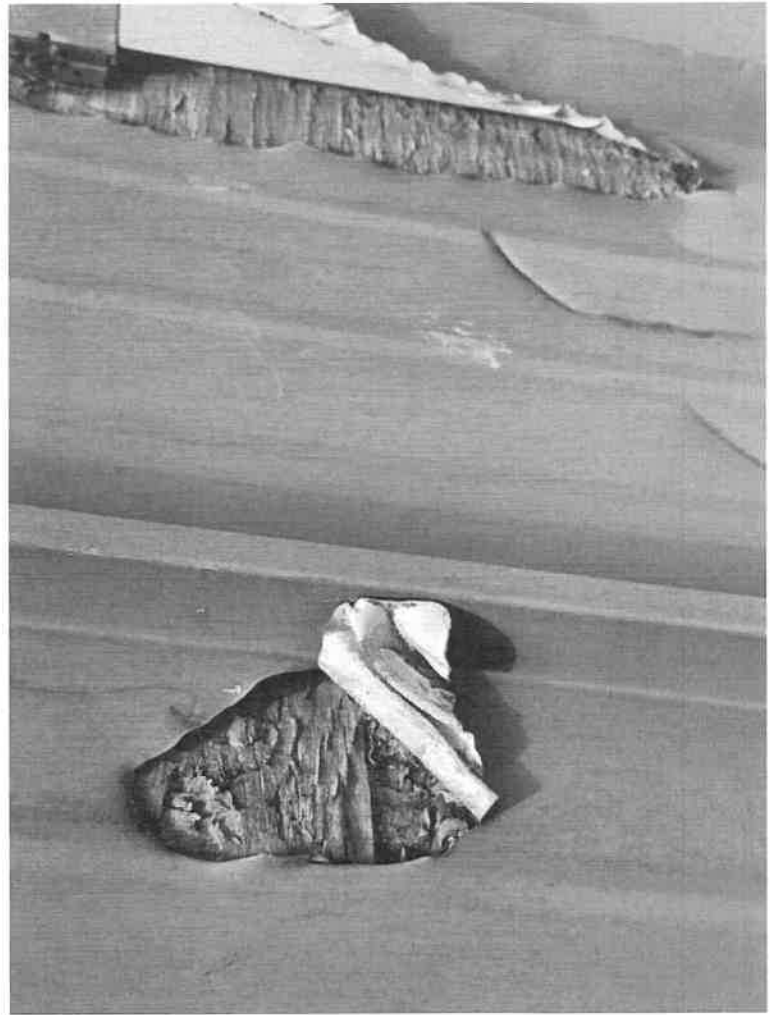
PHOTO-2025-10-12-20-07-17.jpg

Photo Description: North slope (previously pictured) close up showing evidence of water intrusion and deteriorating plywood underneath,
