Board Report

Priest Lake Gymnasium Roof Replacement

May 20, 2026

Commercial Roof Report

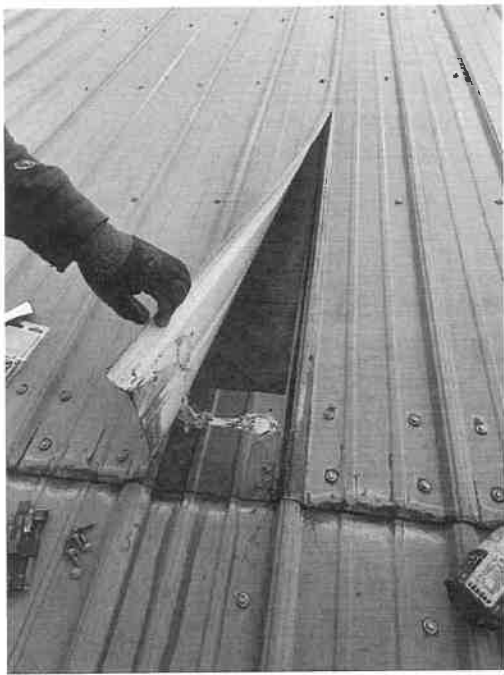
Photo Description: Overview loose metal panel pulled away from roof, not secure, no screws

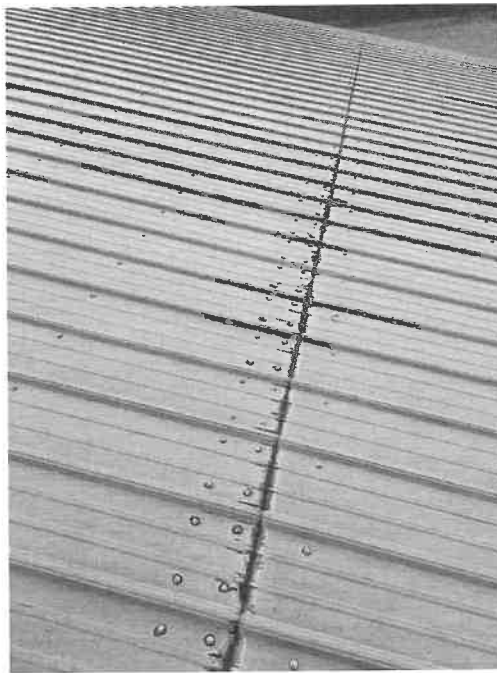
This failure has created pathways for water intrusion. Supporting this finding, video documentation captured during the inspection clearly shows evidence of water infiltration occurring beneath the metal panels. This confirms that the roofing system is actively allowing moisture penetration, creating the potential for additional structural and interior damage, and ongoing maintenance concerns if not addressed promptly.

Photo Description: Overview metal seam no longer water sealed - water intrusion under metal panel. See video

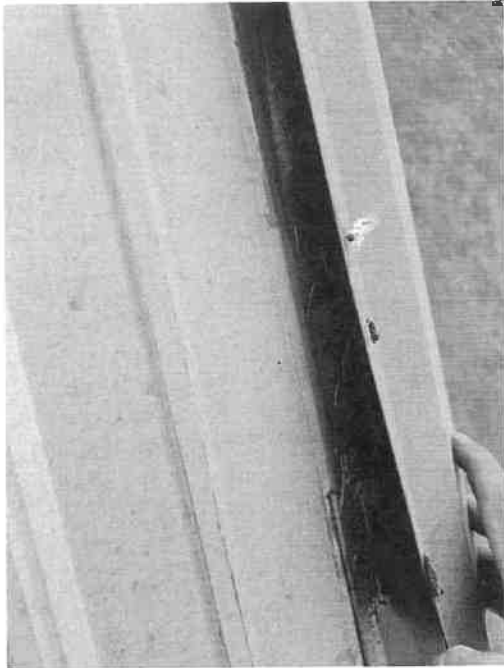
Photo Description: Screws missing in several areas of the roof - metal panels are loose and failing

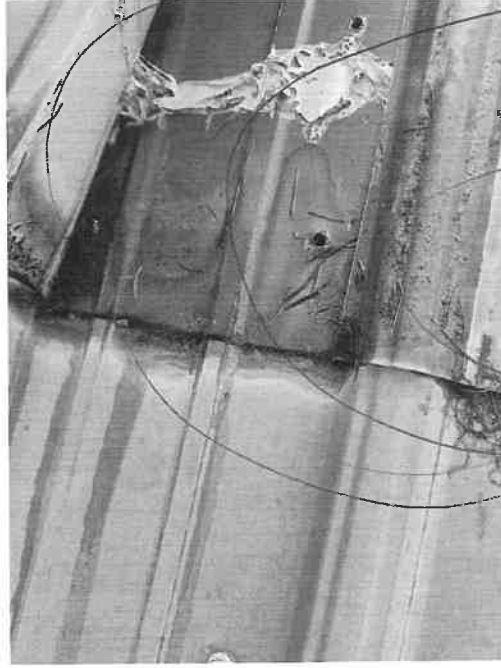
Photo Description: Close-up metal panel not secure screws no longer in place

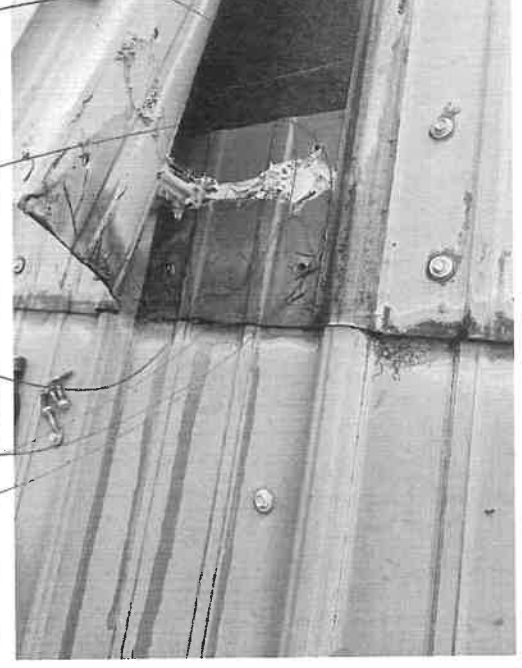
Photo Description: Metal panel torn away from roof no screws in place to secure panel
