## ROOF PROGRESS REPORT THROUGH 07-13-2026

| <b>Contractor:</b> | Black Hawk Roof Company |

### Areas of Work: Roof Area 6 & 7

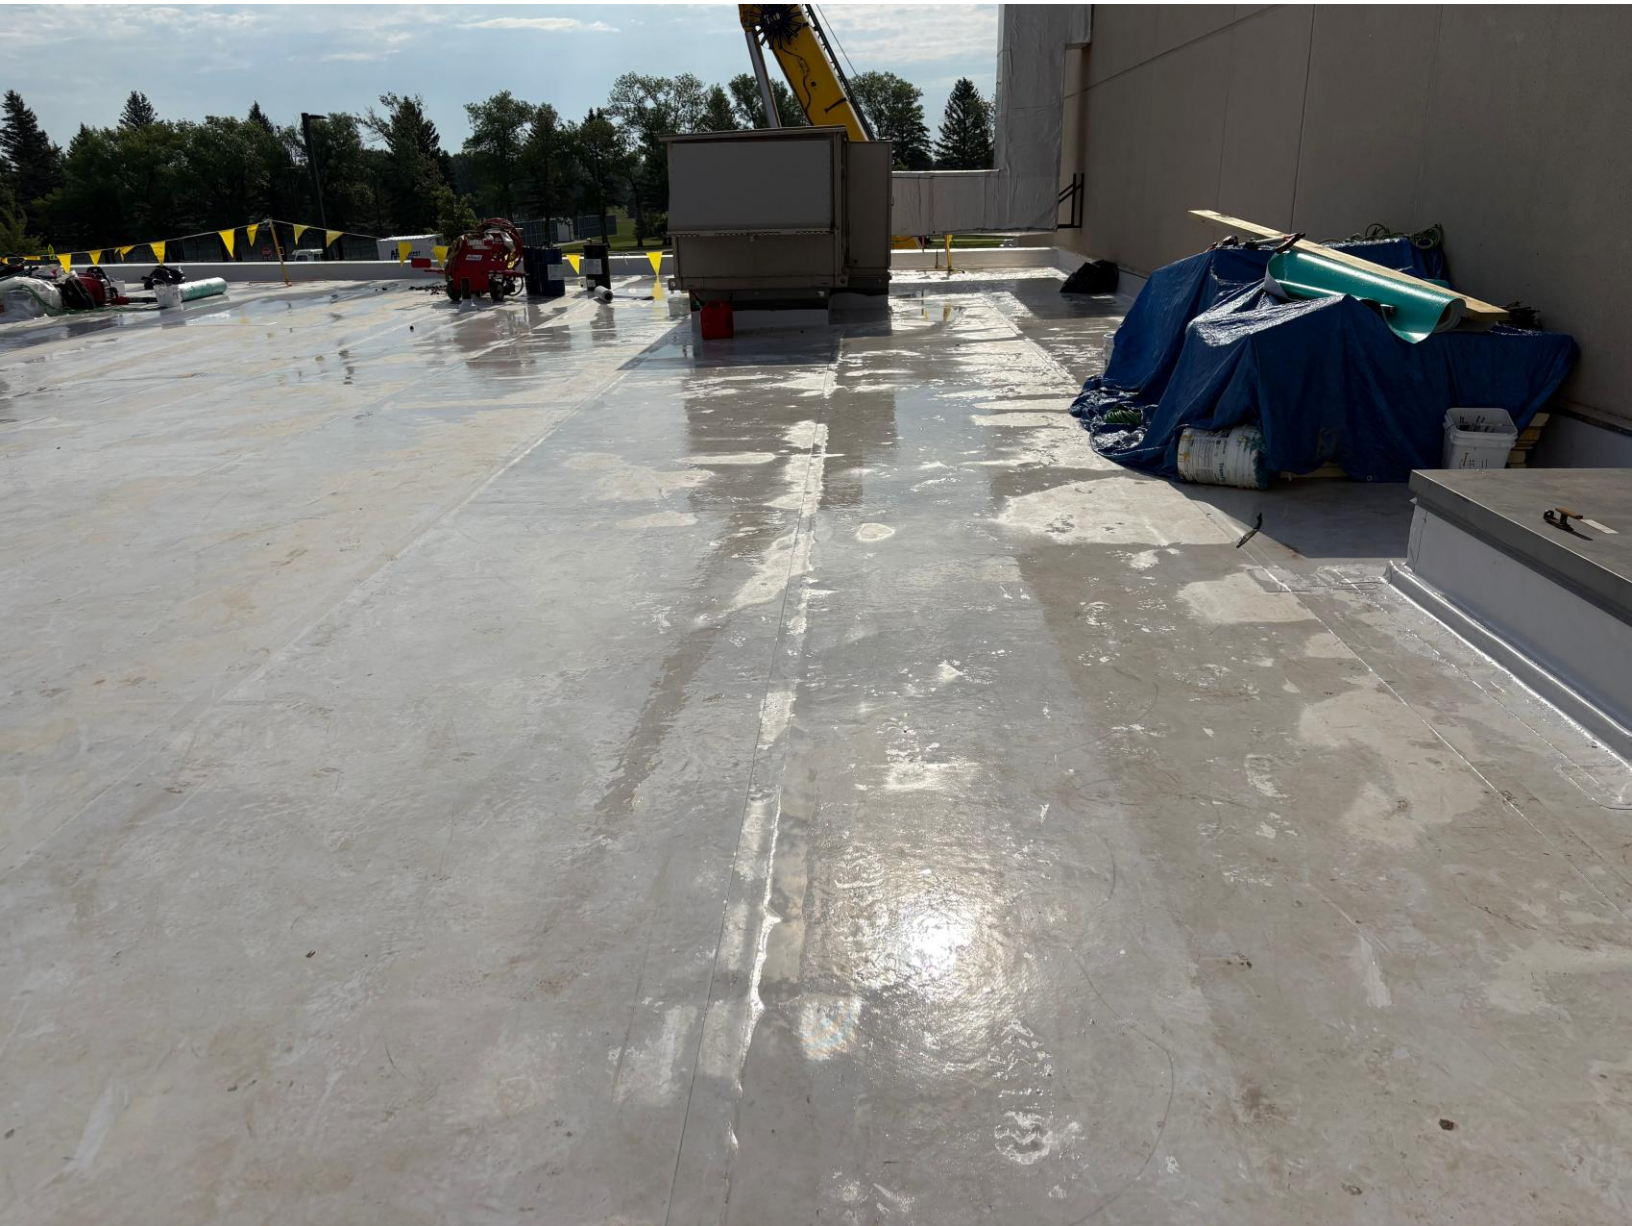
60 Mil KEE fleece-backed membrane adhered  
in membrane adhesive on Roof Area #6

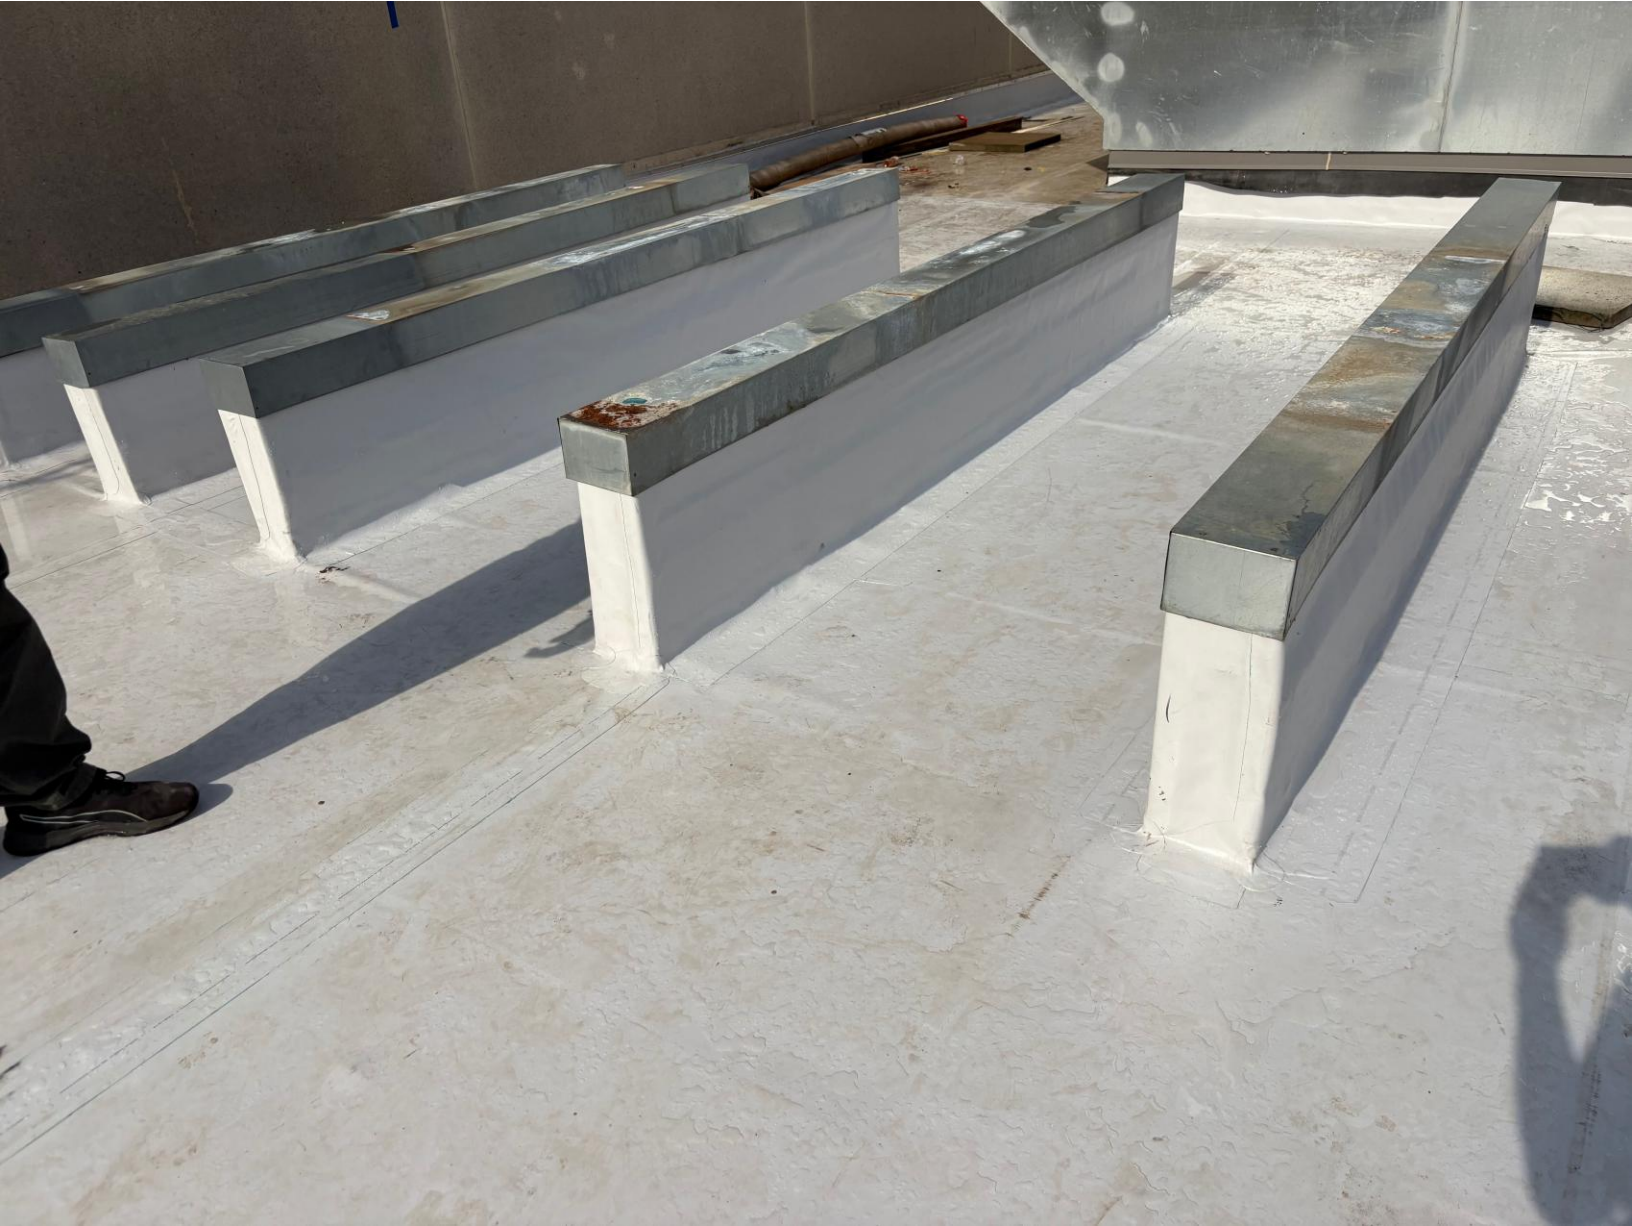
Membrane insulation at roof area #5 has been completed around roof curbs, mechanically fastened with cap nails.

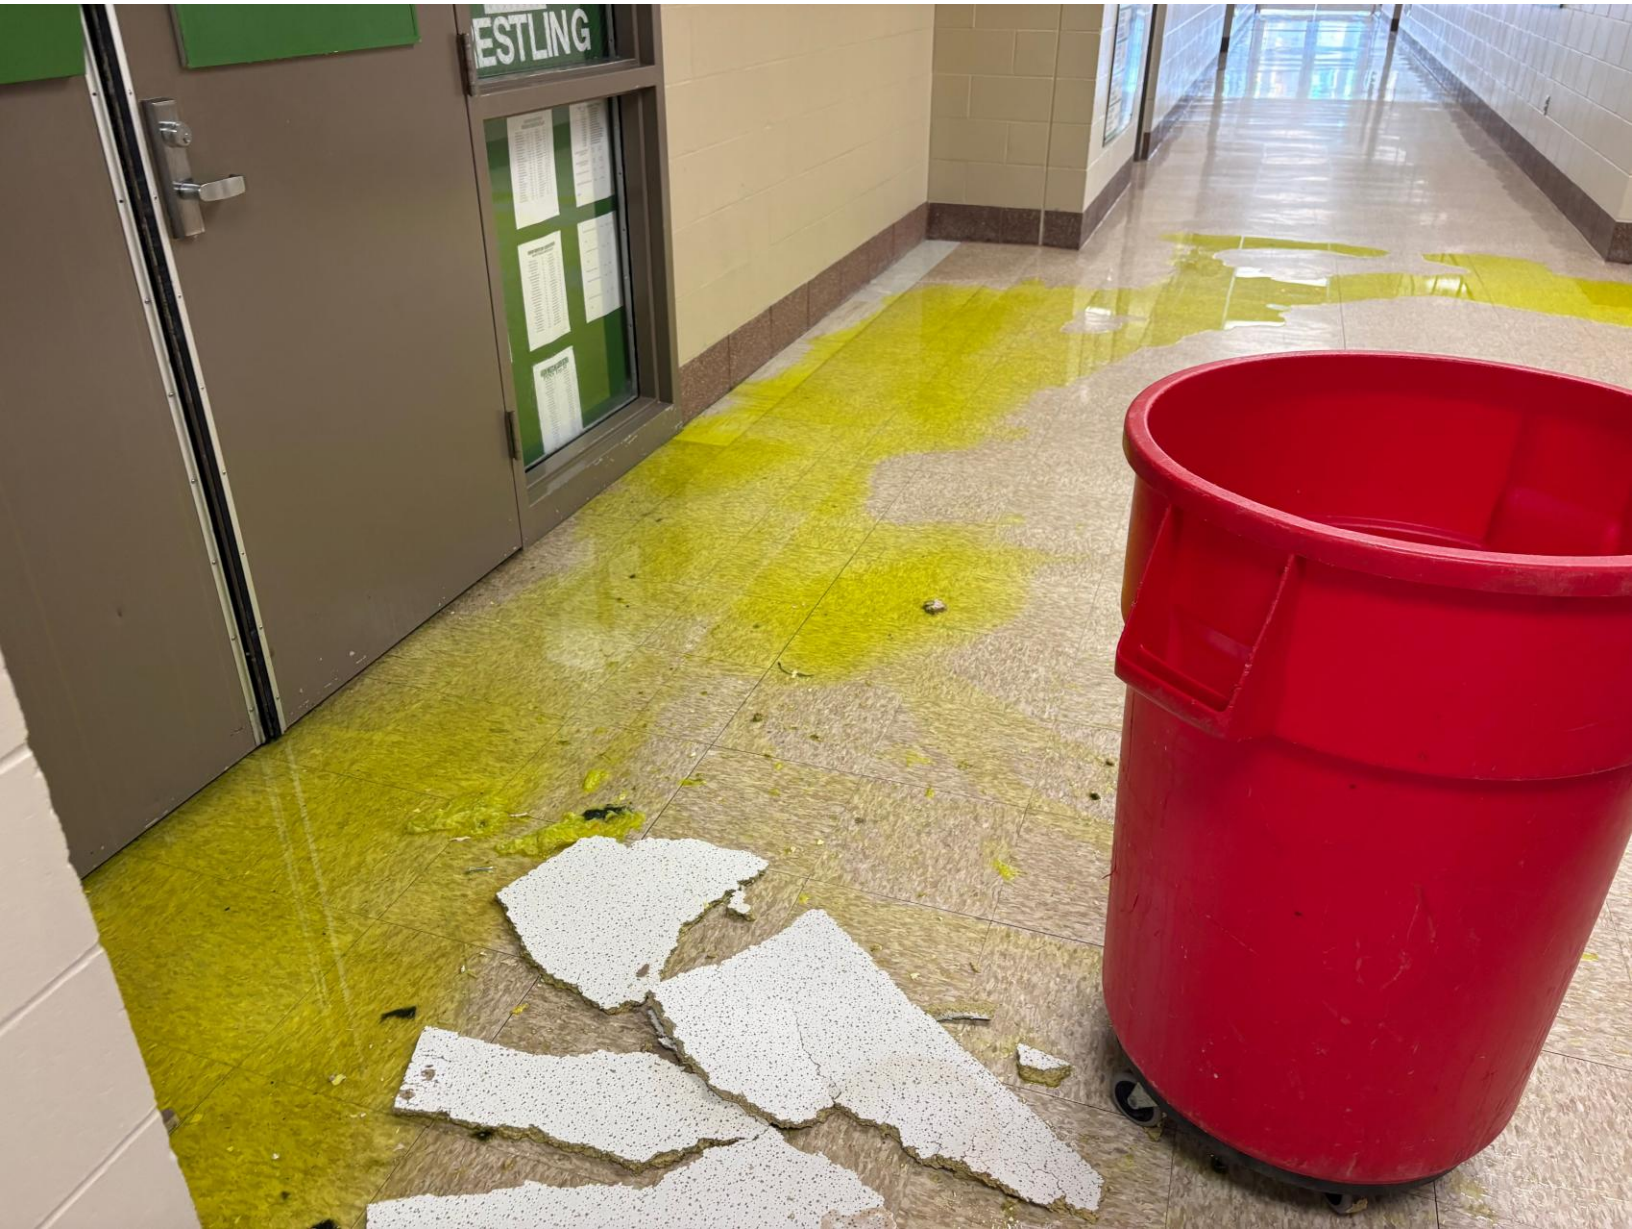
- Identified and replaced 124 square feet of wet insulation (Roof Area 5, 6, & 7)
- Roof area #5 unit removal caused leakage around wrestling room ceiling.
- Stone mason to fix leak found on the wall of roof area 12

Roof area #5 unit removal caused  
leakage around wrestling room ceiling.

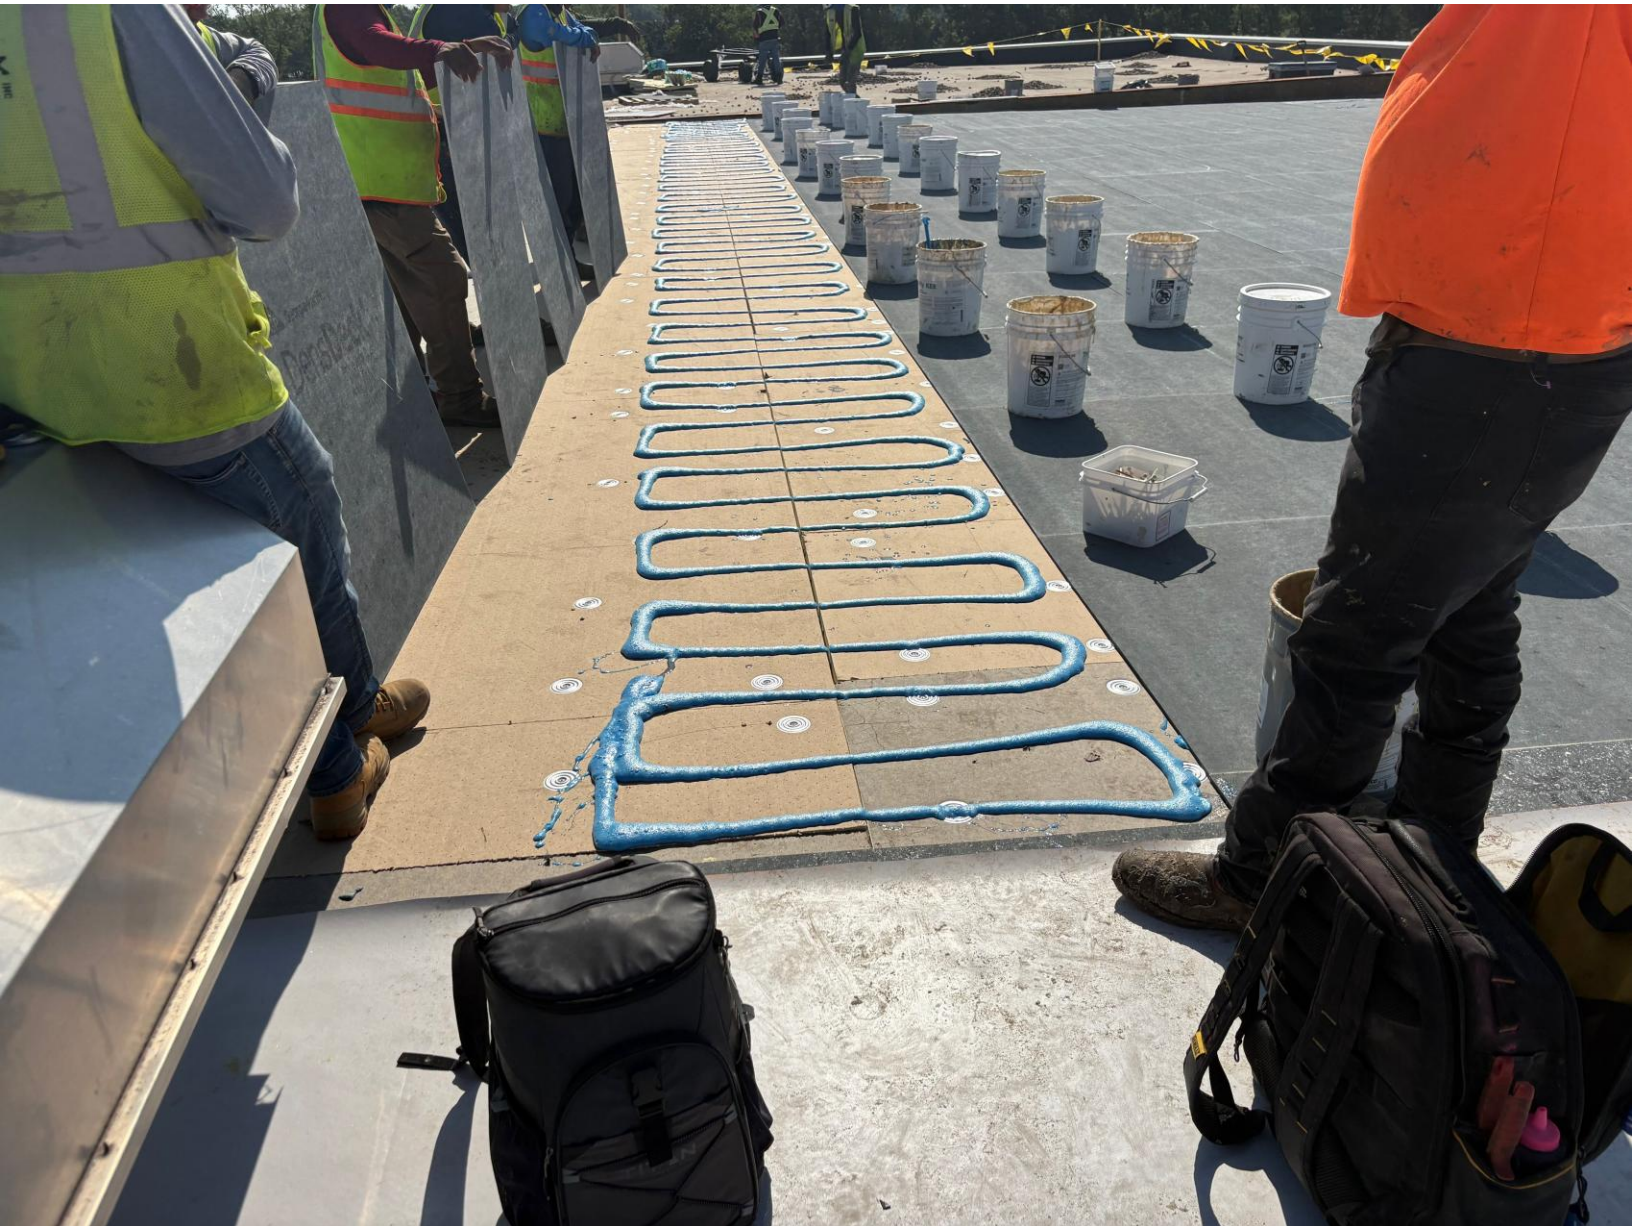
Low-rising adhesive applied prior to dens  
prime board setting on roof area #6

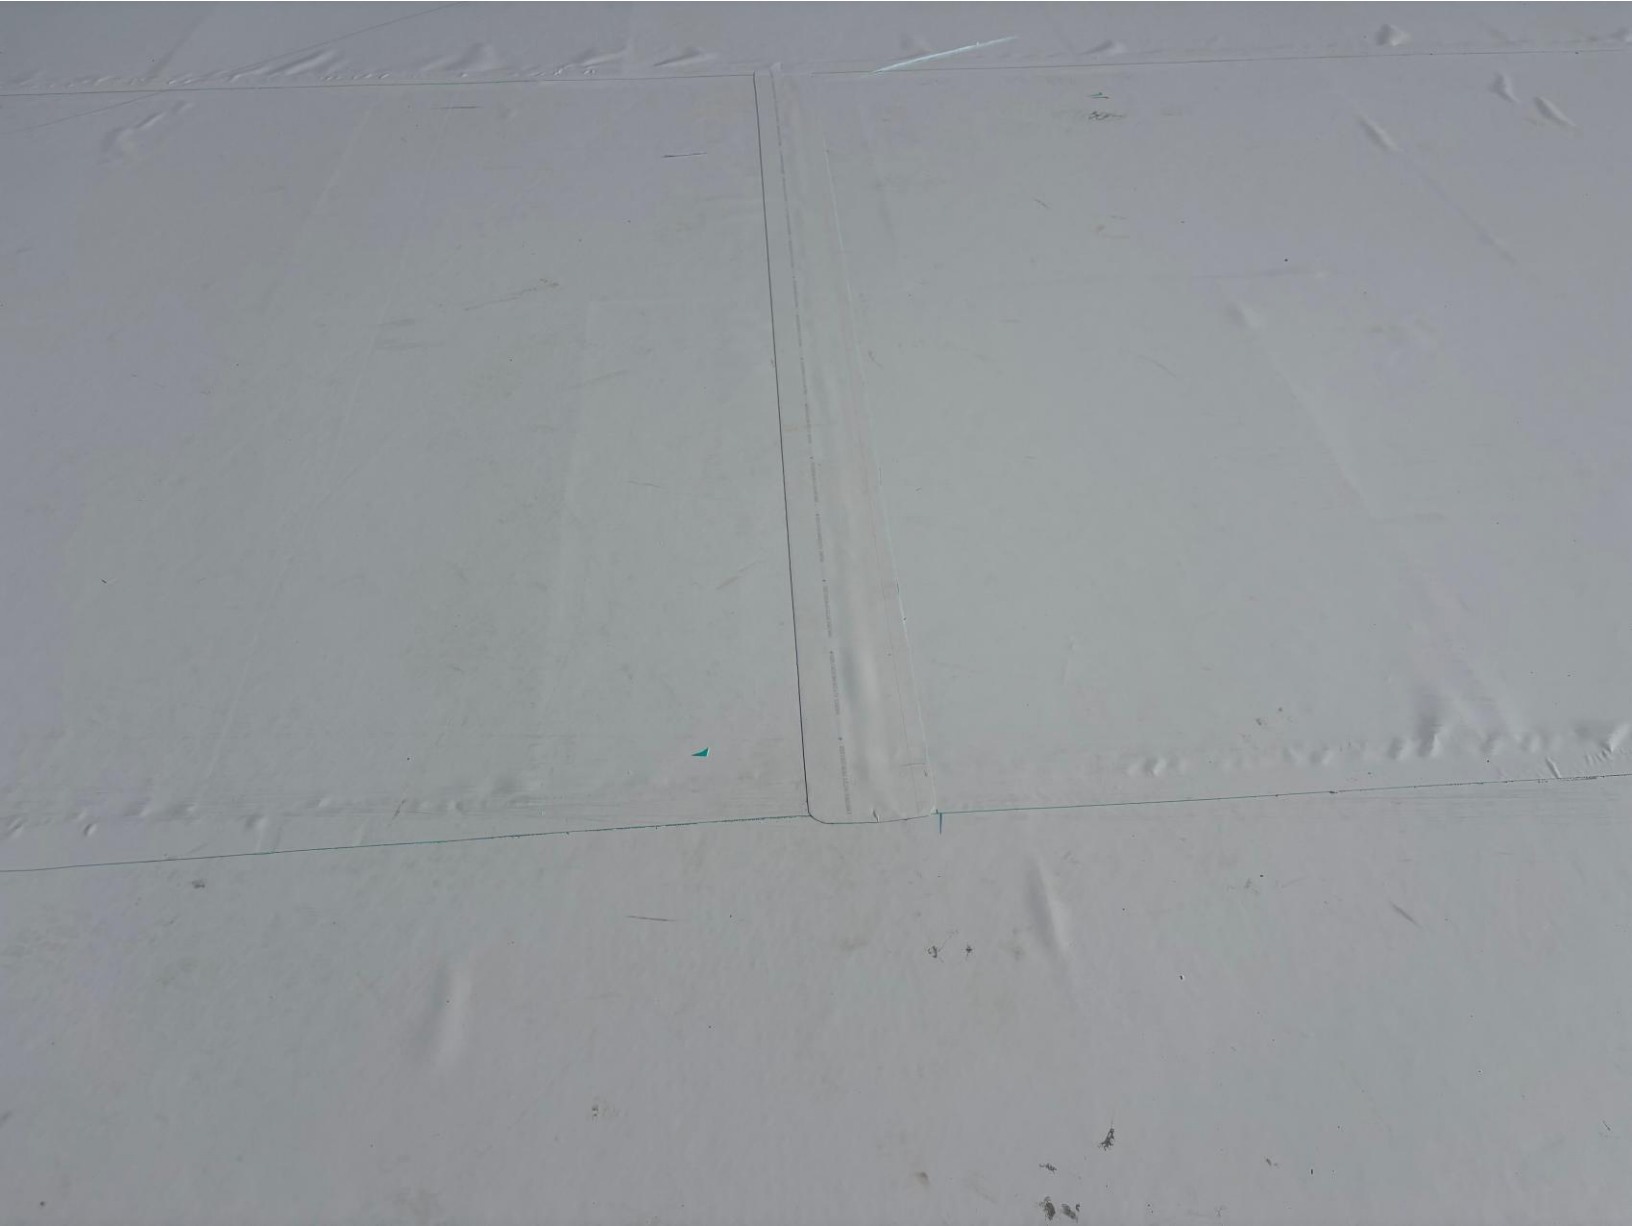
45 Mil KEE fleece-backed membrane  
seams water-tight on Roof Area #6

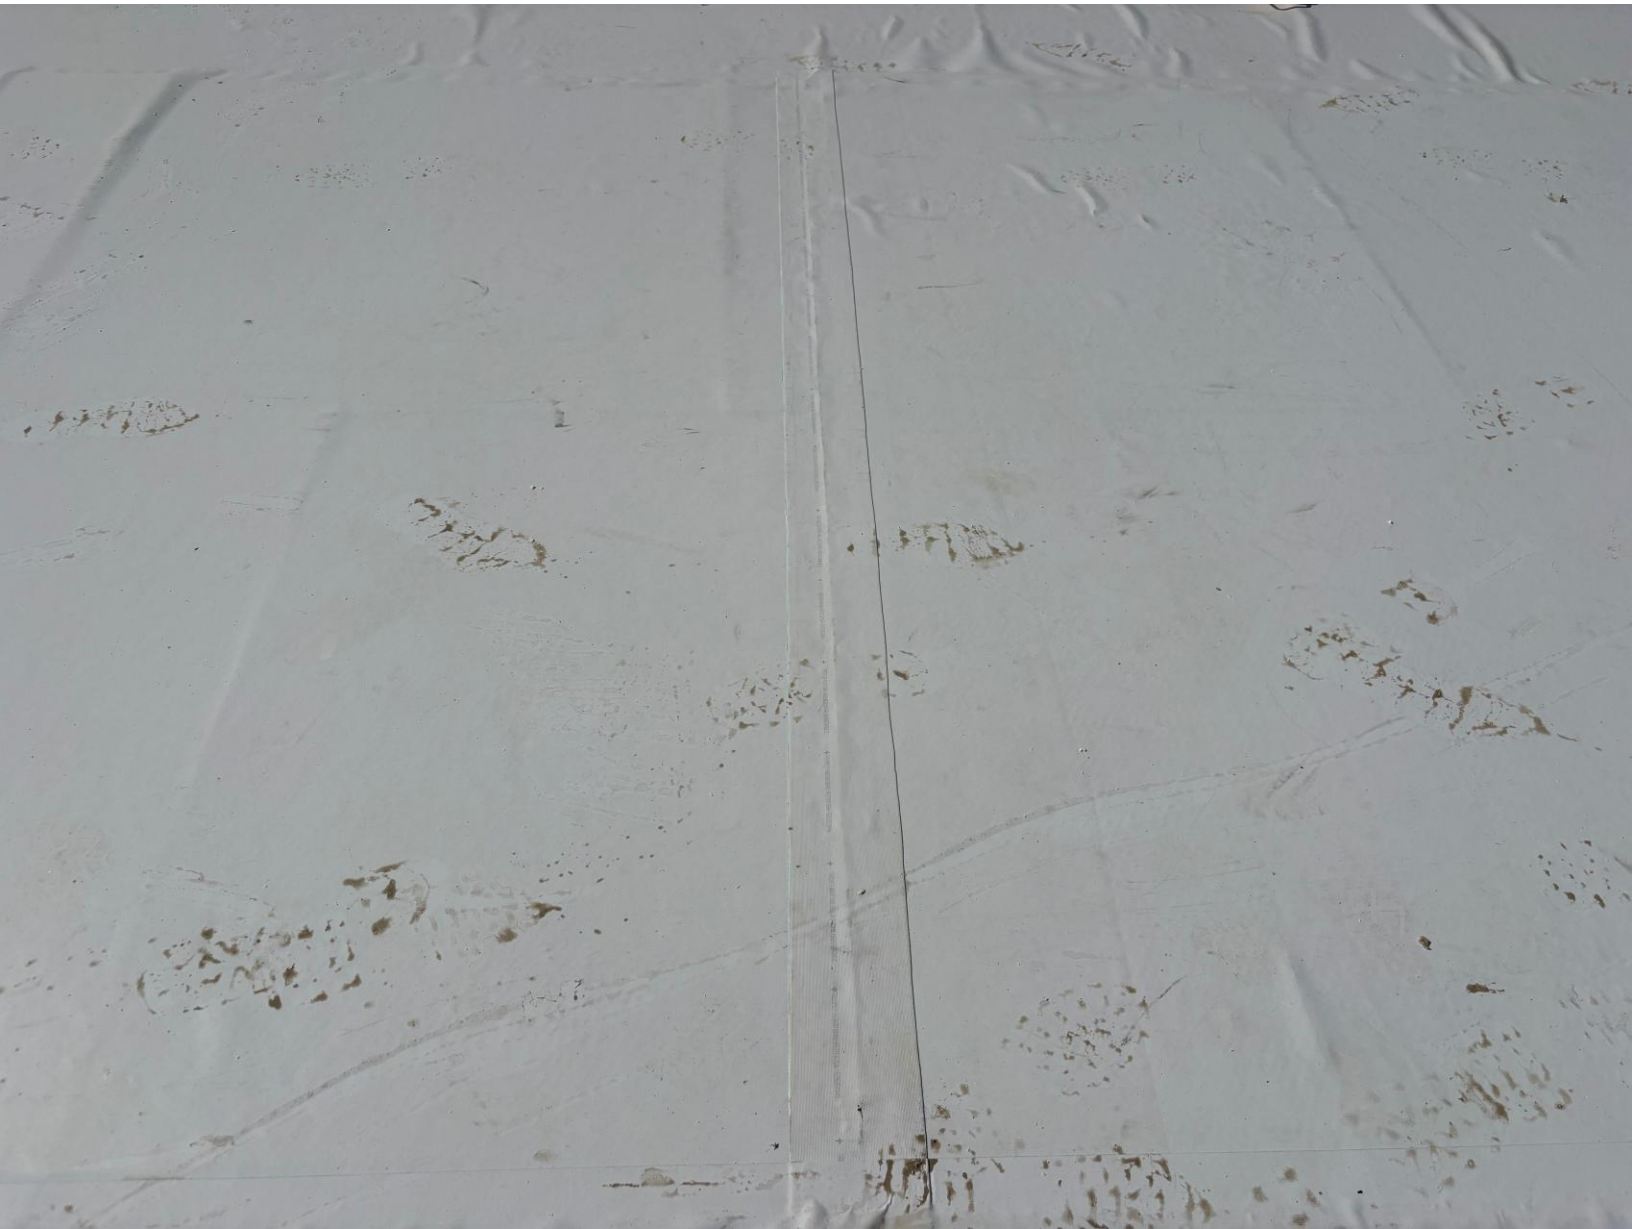
45 Mil KEE fleece-backed membrane  
seams water-tight on Roof Area #7

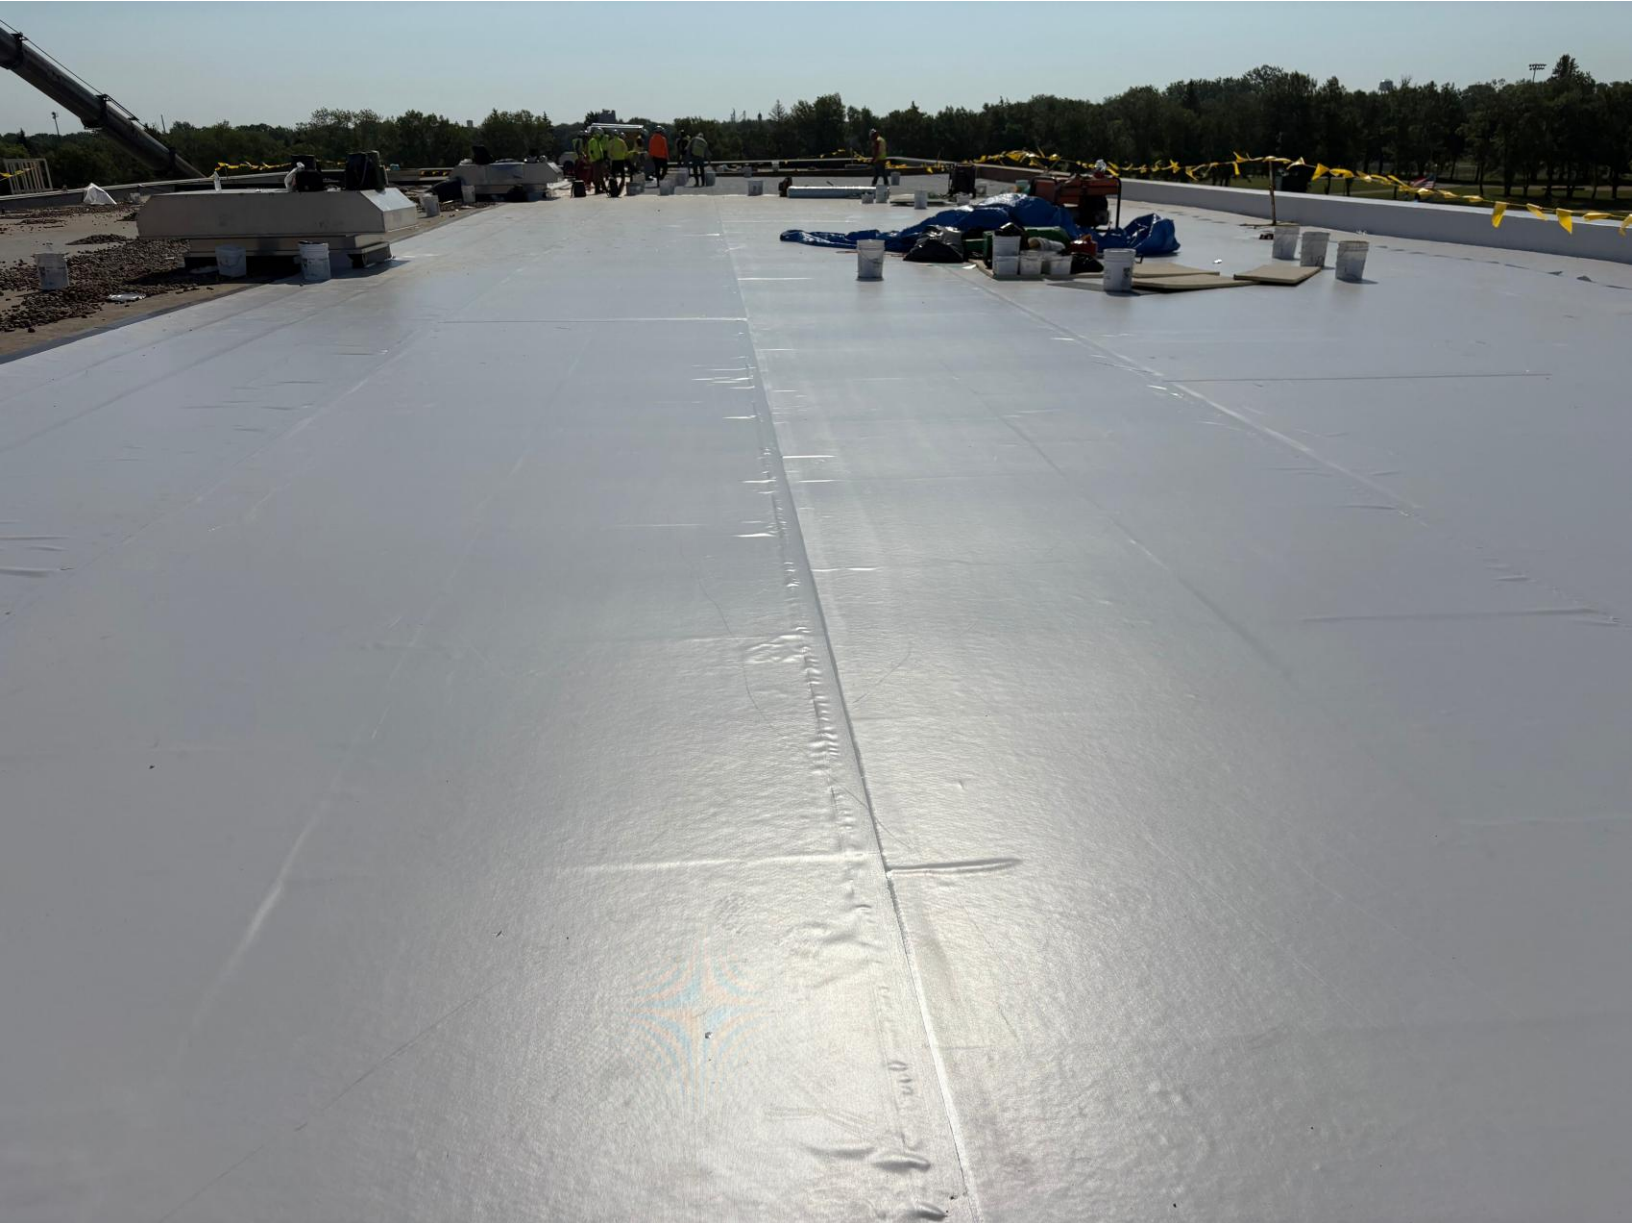
45 Mil KEE fleece-backed membrane adhered in  
membrane adhesive on Roof Area #6

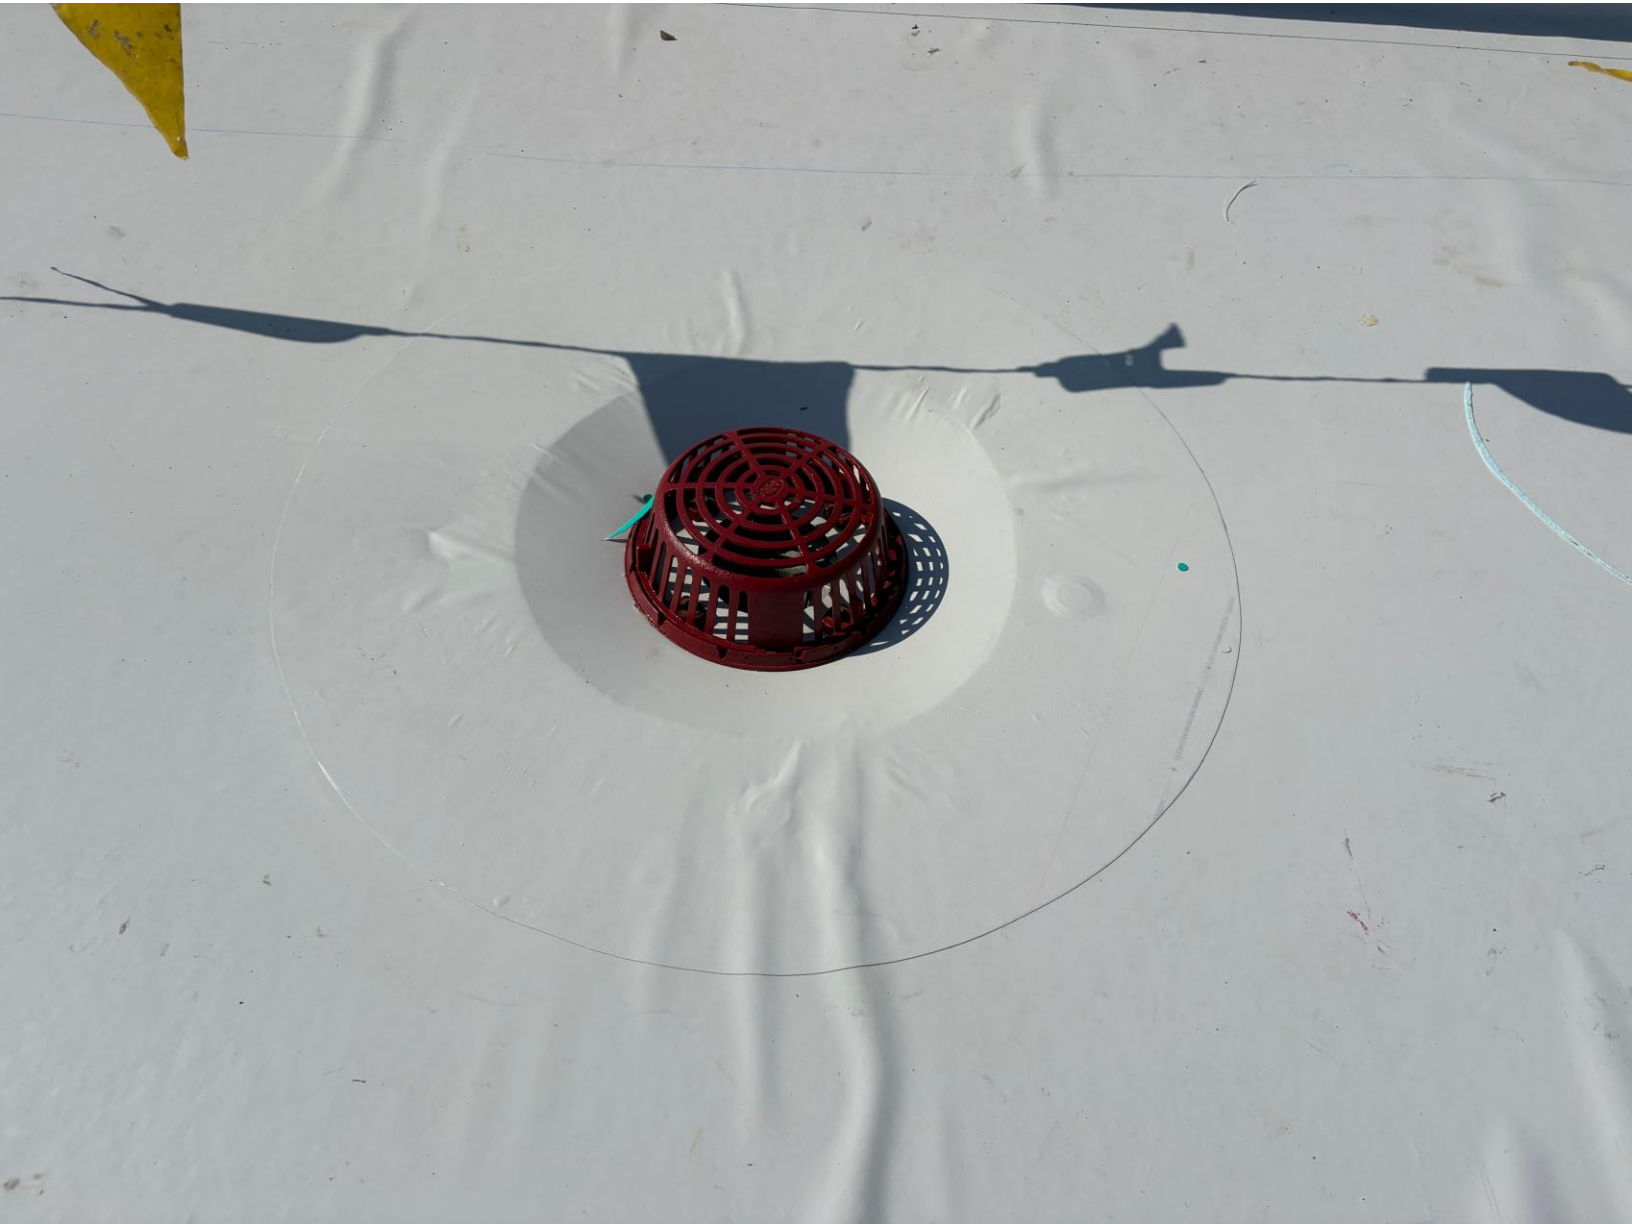
Drain and Sump Detail: KEE membrane is sealed to ensure watertight connection around drain on Roof Area #6

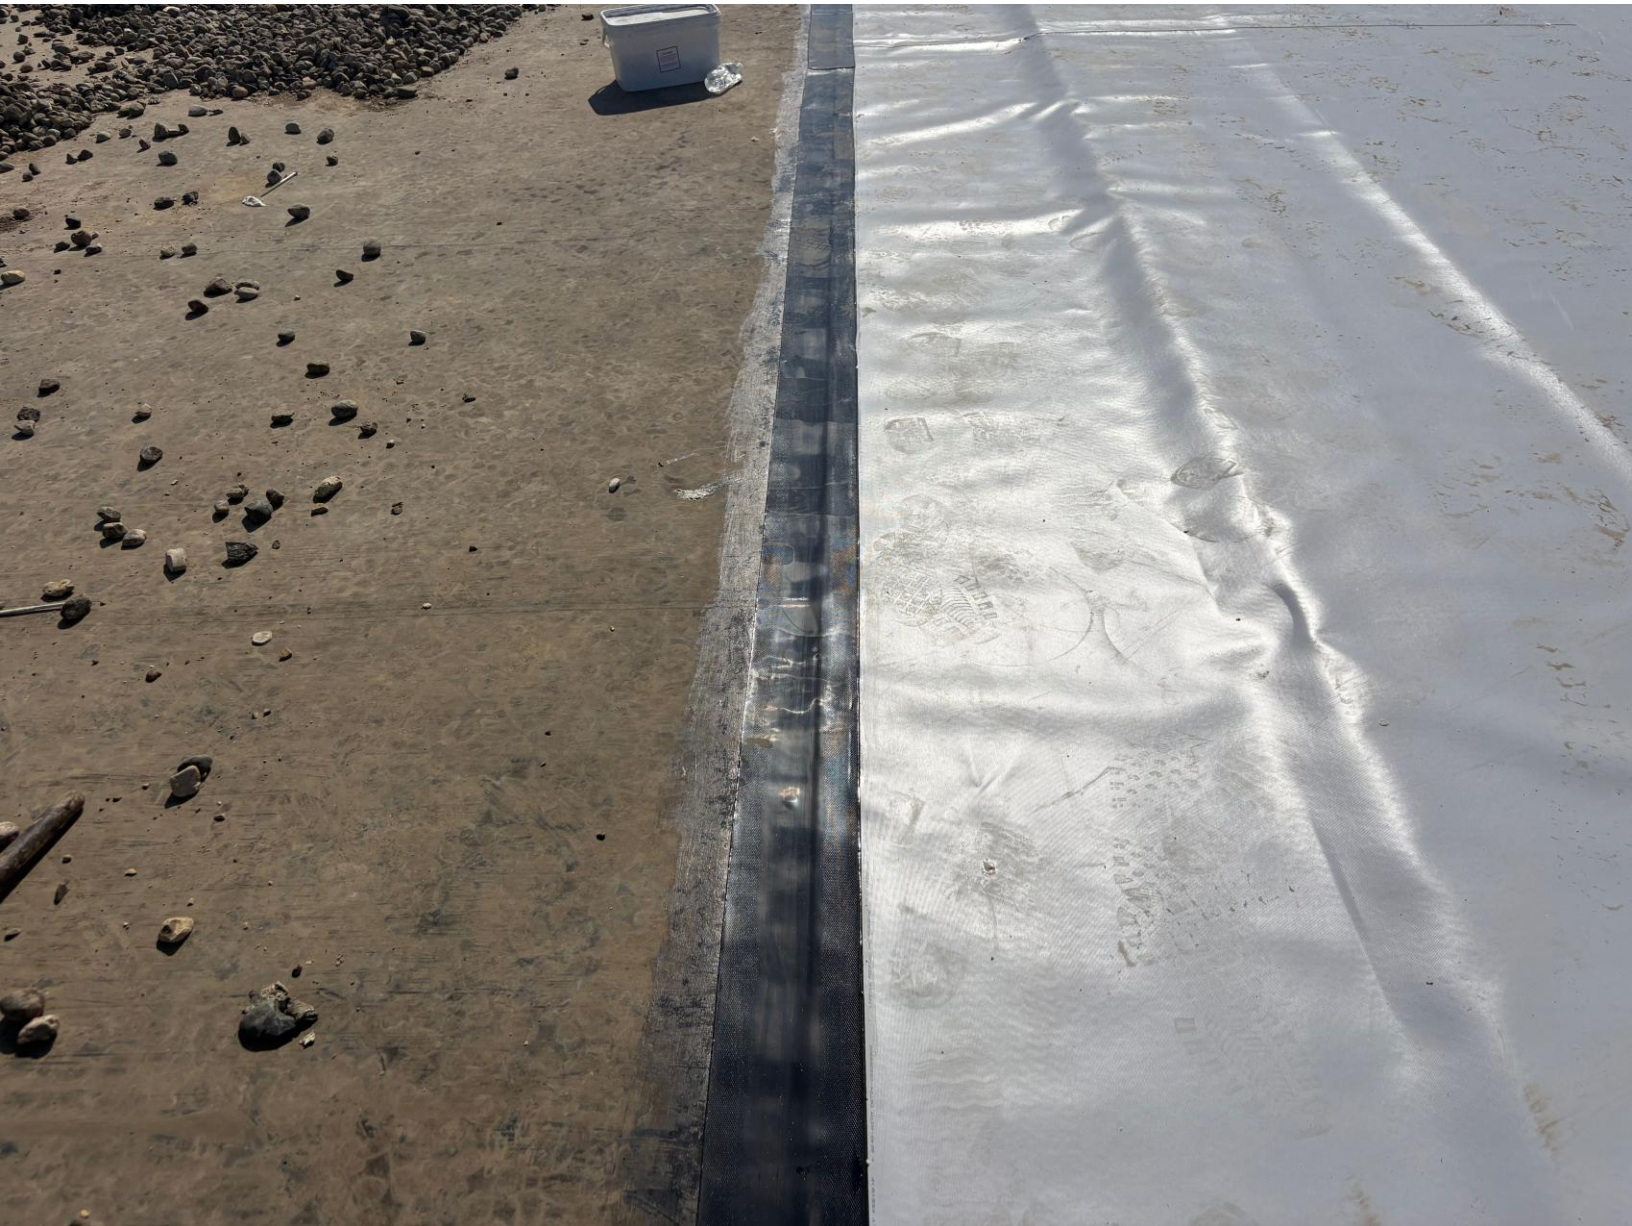
Tied off 45 Mil KEE fleece-backed membrane adhered in membrane adhesive to existing roof membrane on Roof Area #6

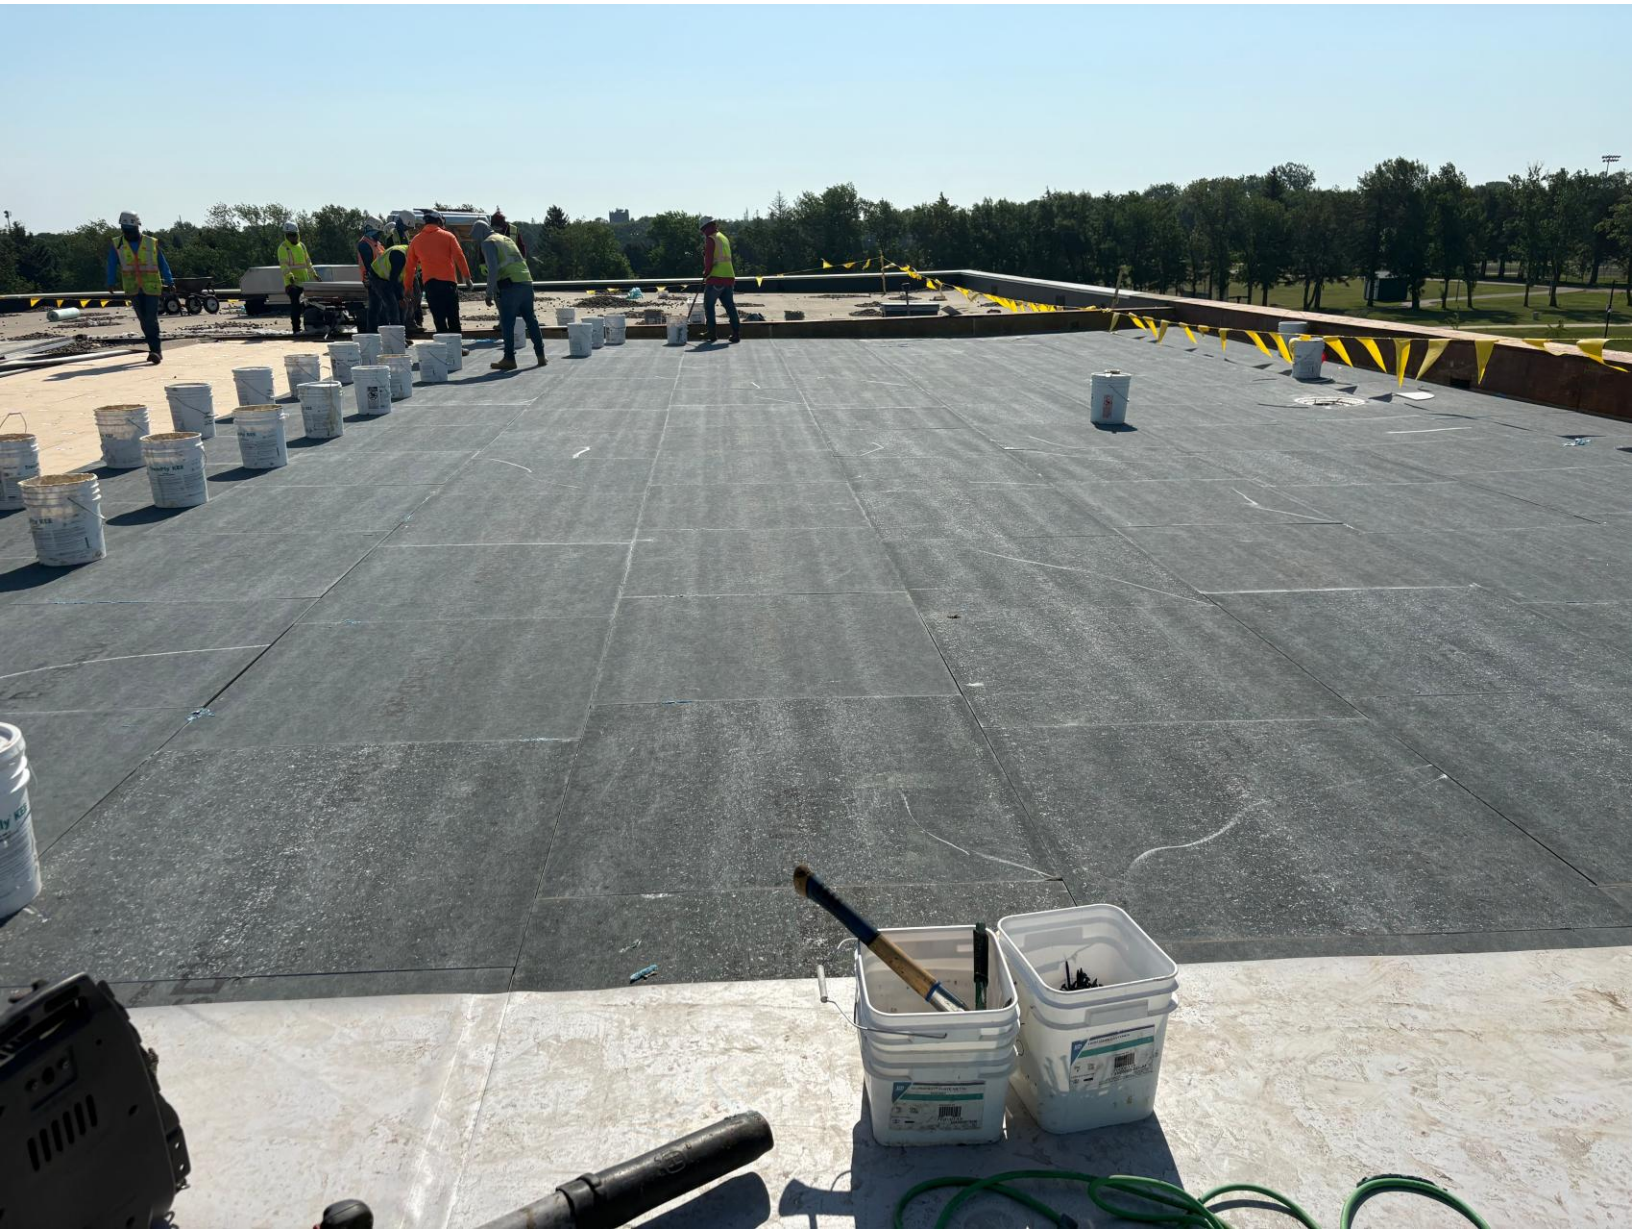
$\frac{1}{4}$ " prime coverboard adhered in low-rise adhesive  
over insulation coverboard on Roof Area #6

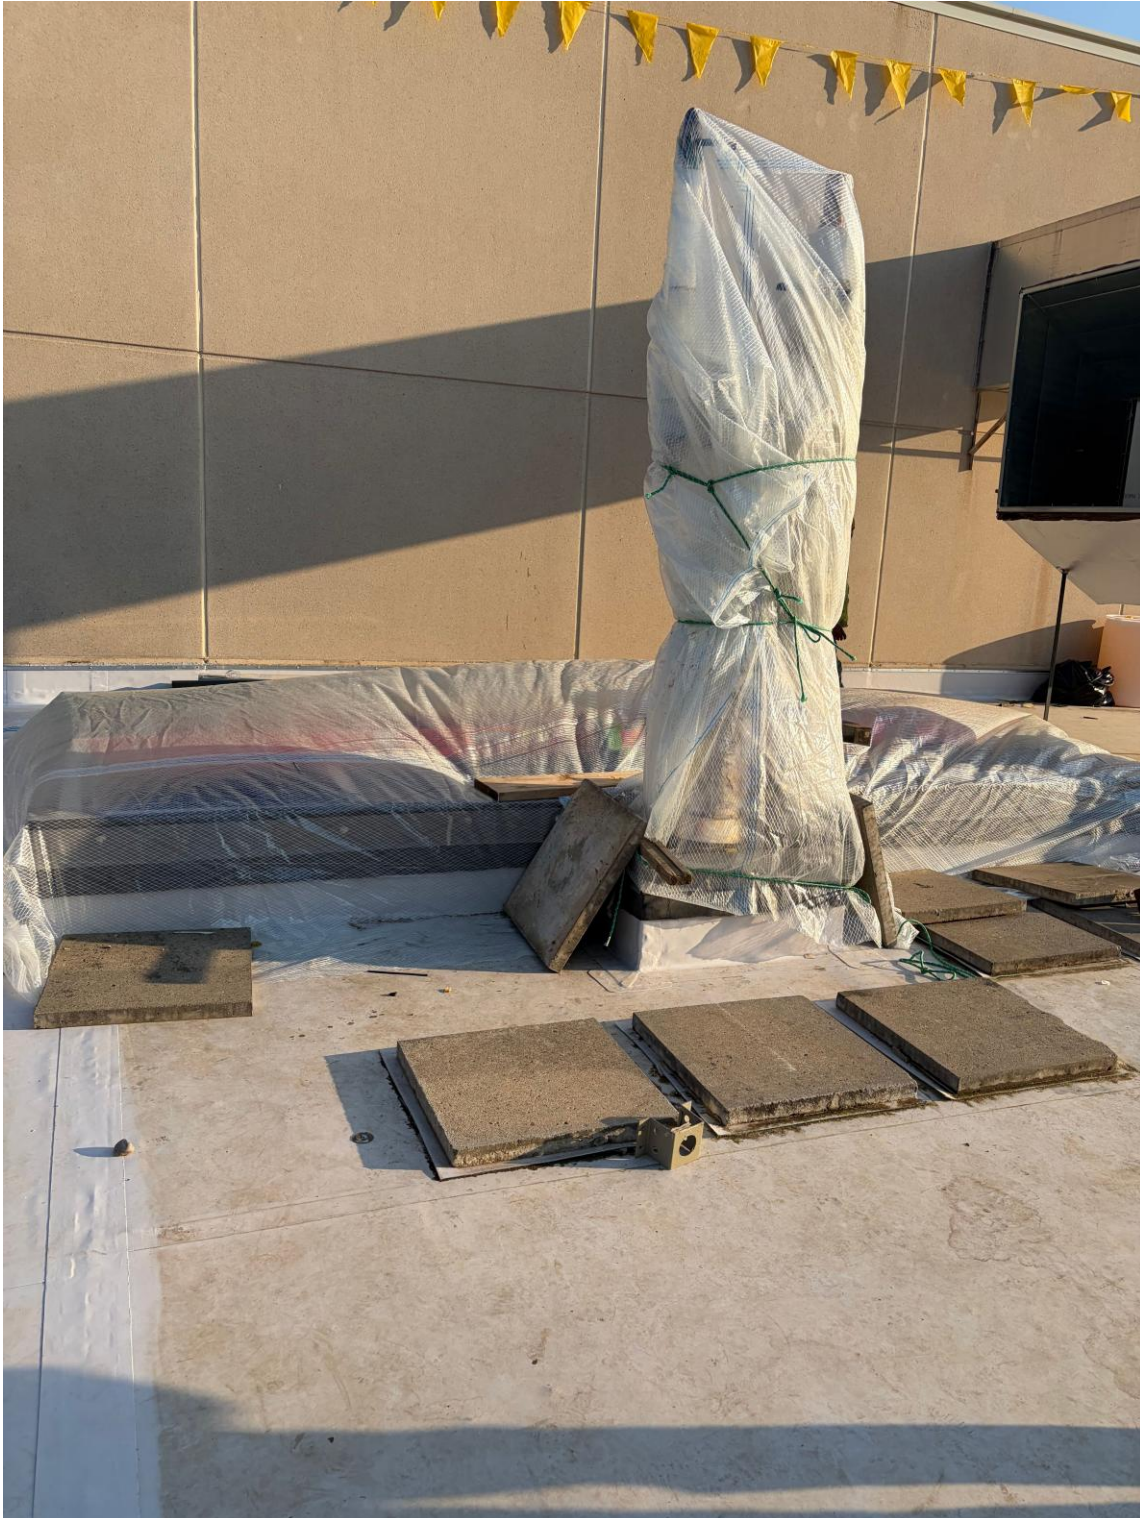
Unit removal: Tied off open roof area  
prior to storm on roof area #5
