## ROOF PROGRESS REPORT THROUGH 07-13-2026

| <b>Contractor:</b> | Black Hawk Roof Company |

### Areas of Work: Roof Area 6 & 7

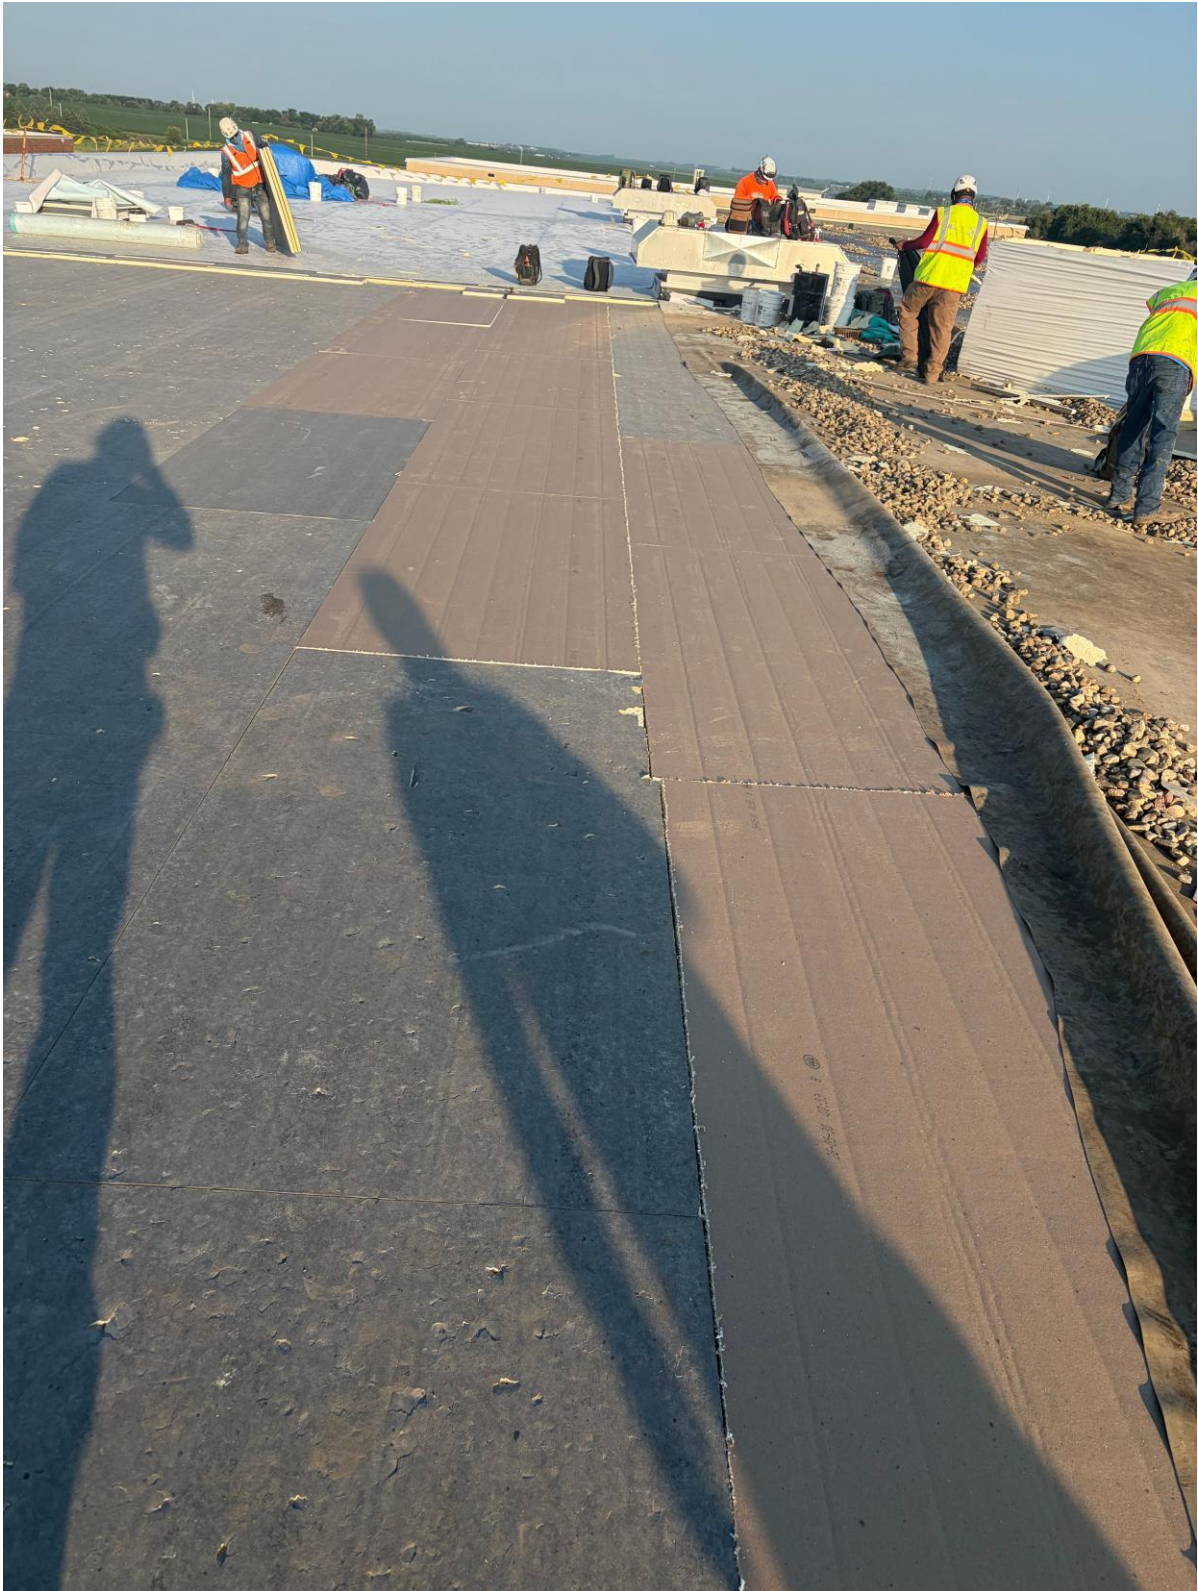
1-1/2" Isocyanurate insulation board mechanically attached  
over existing insulation with fast adhesive for ISO  
coverboard on Roof Area #6

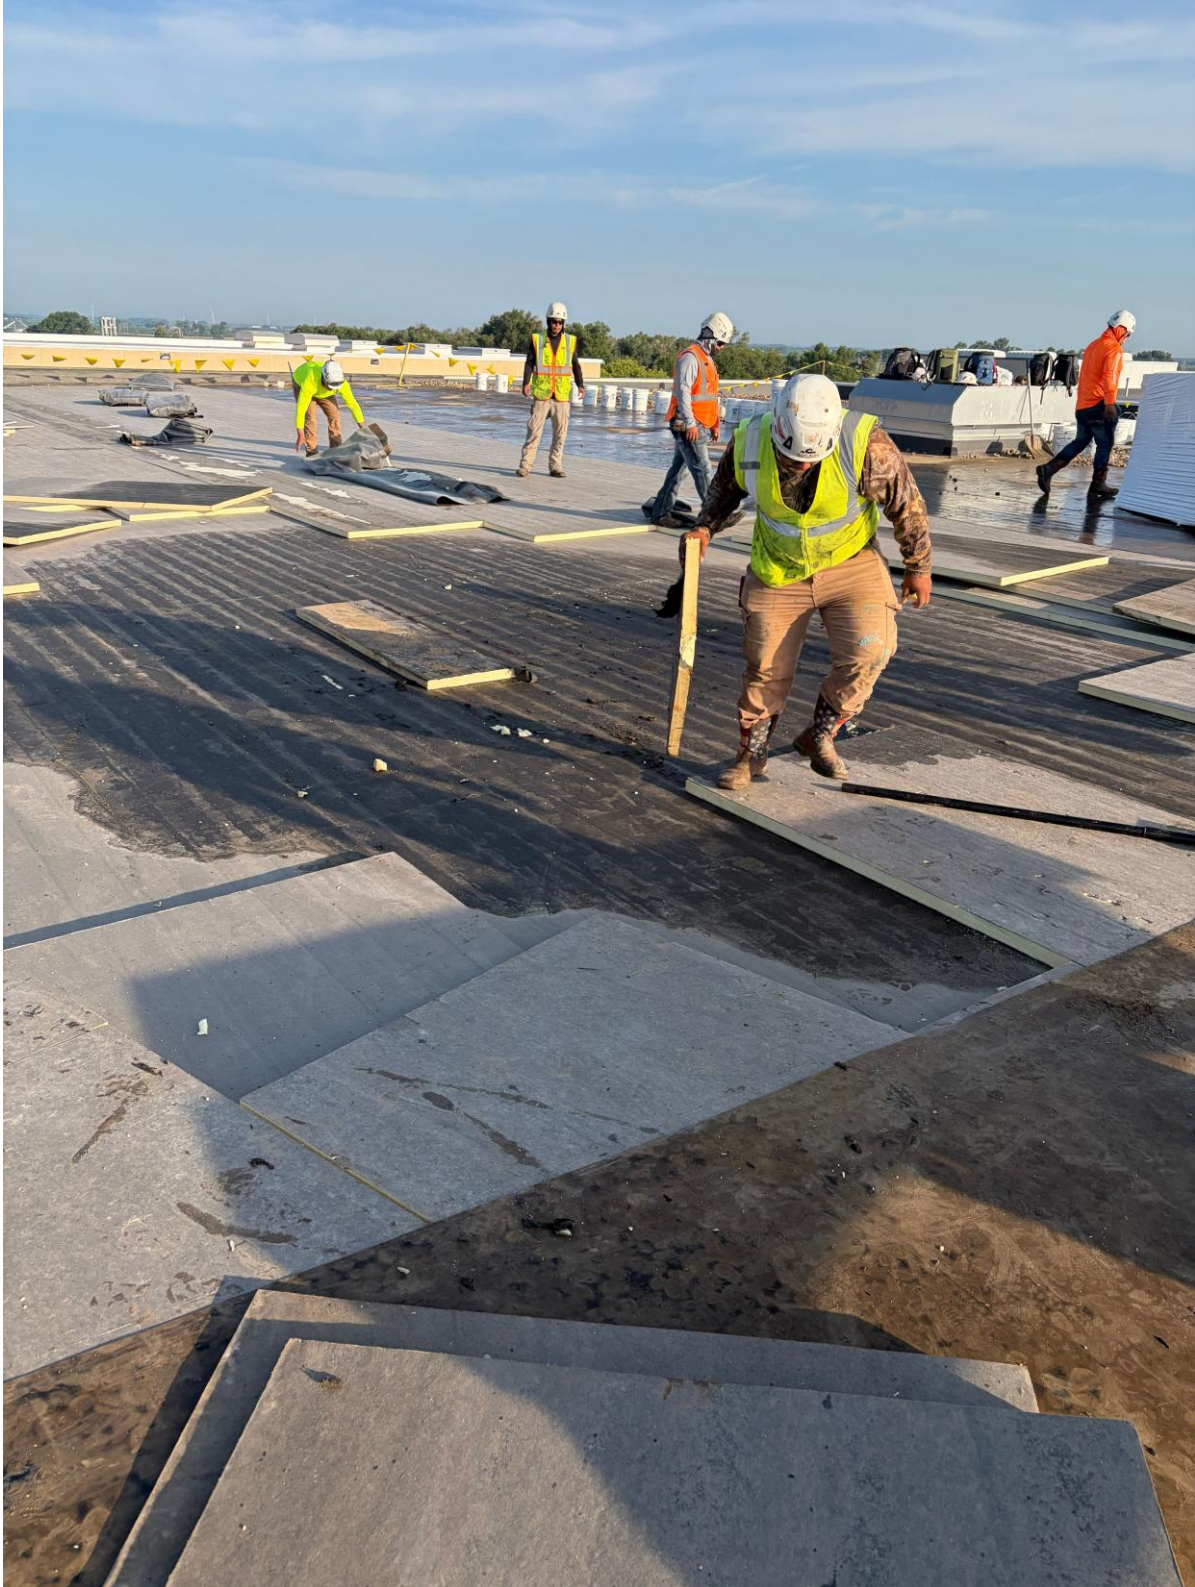
26 square feet of wet insulation found  
on Roof Area # 6

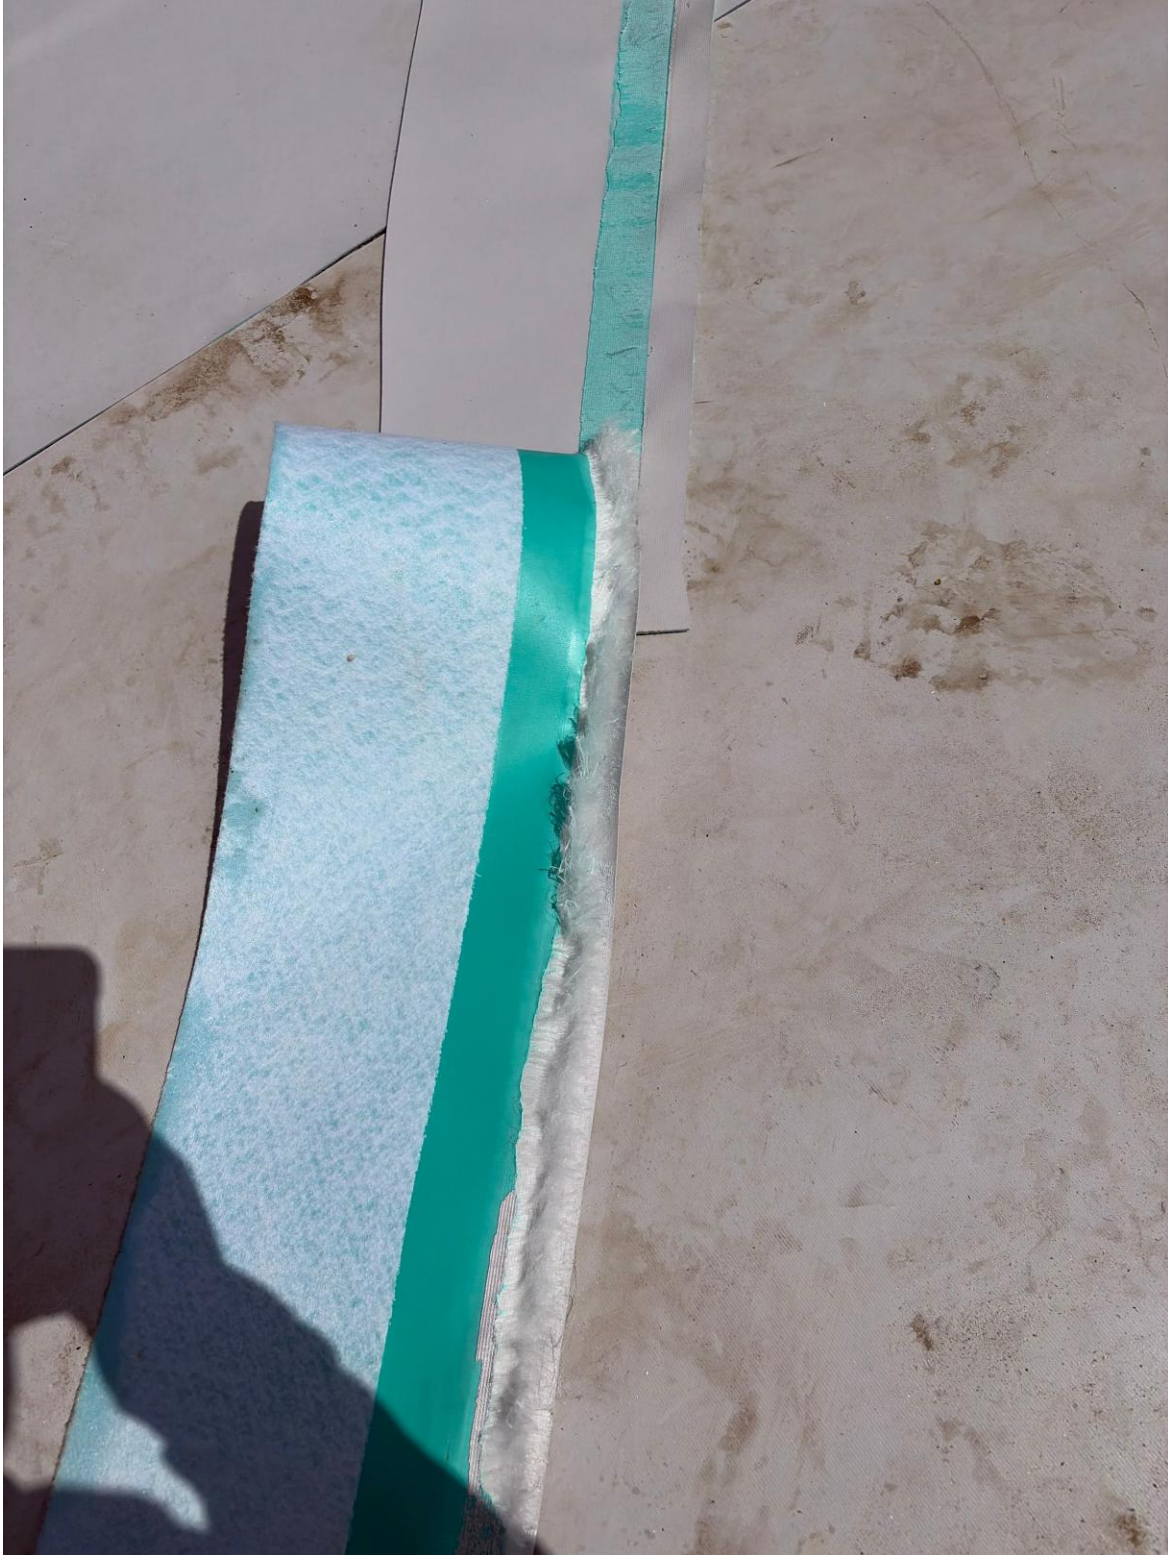
Daily weld test

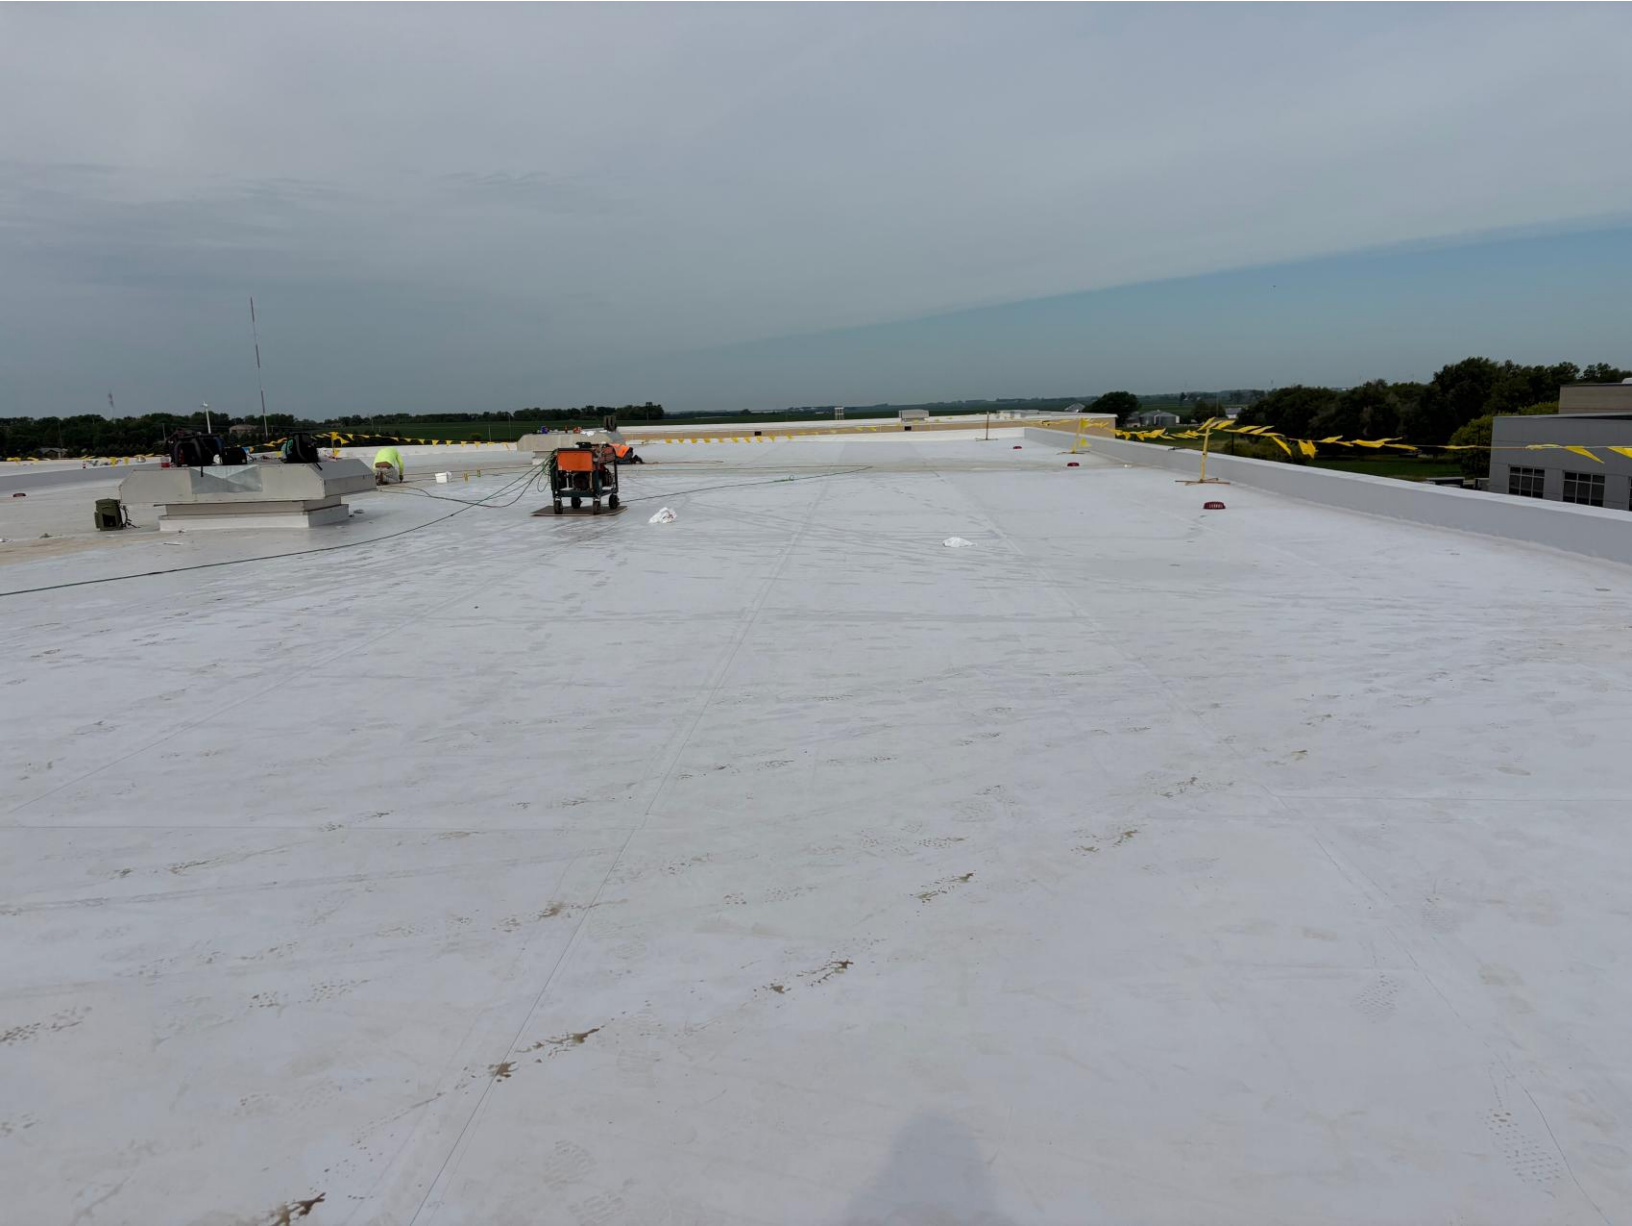
45 Mil KEE fleece-backed membrane adhered in  
membrane adhesive on Roof Area #6

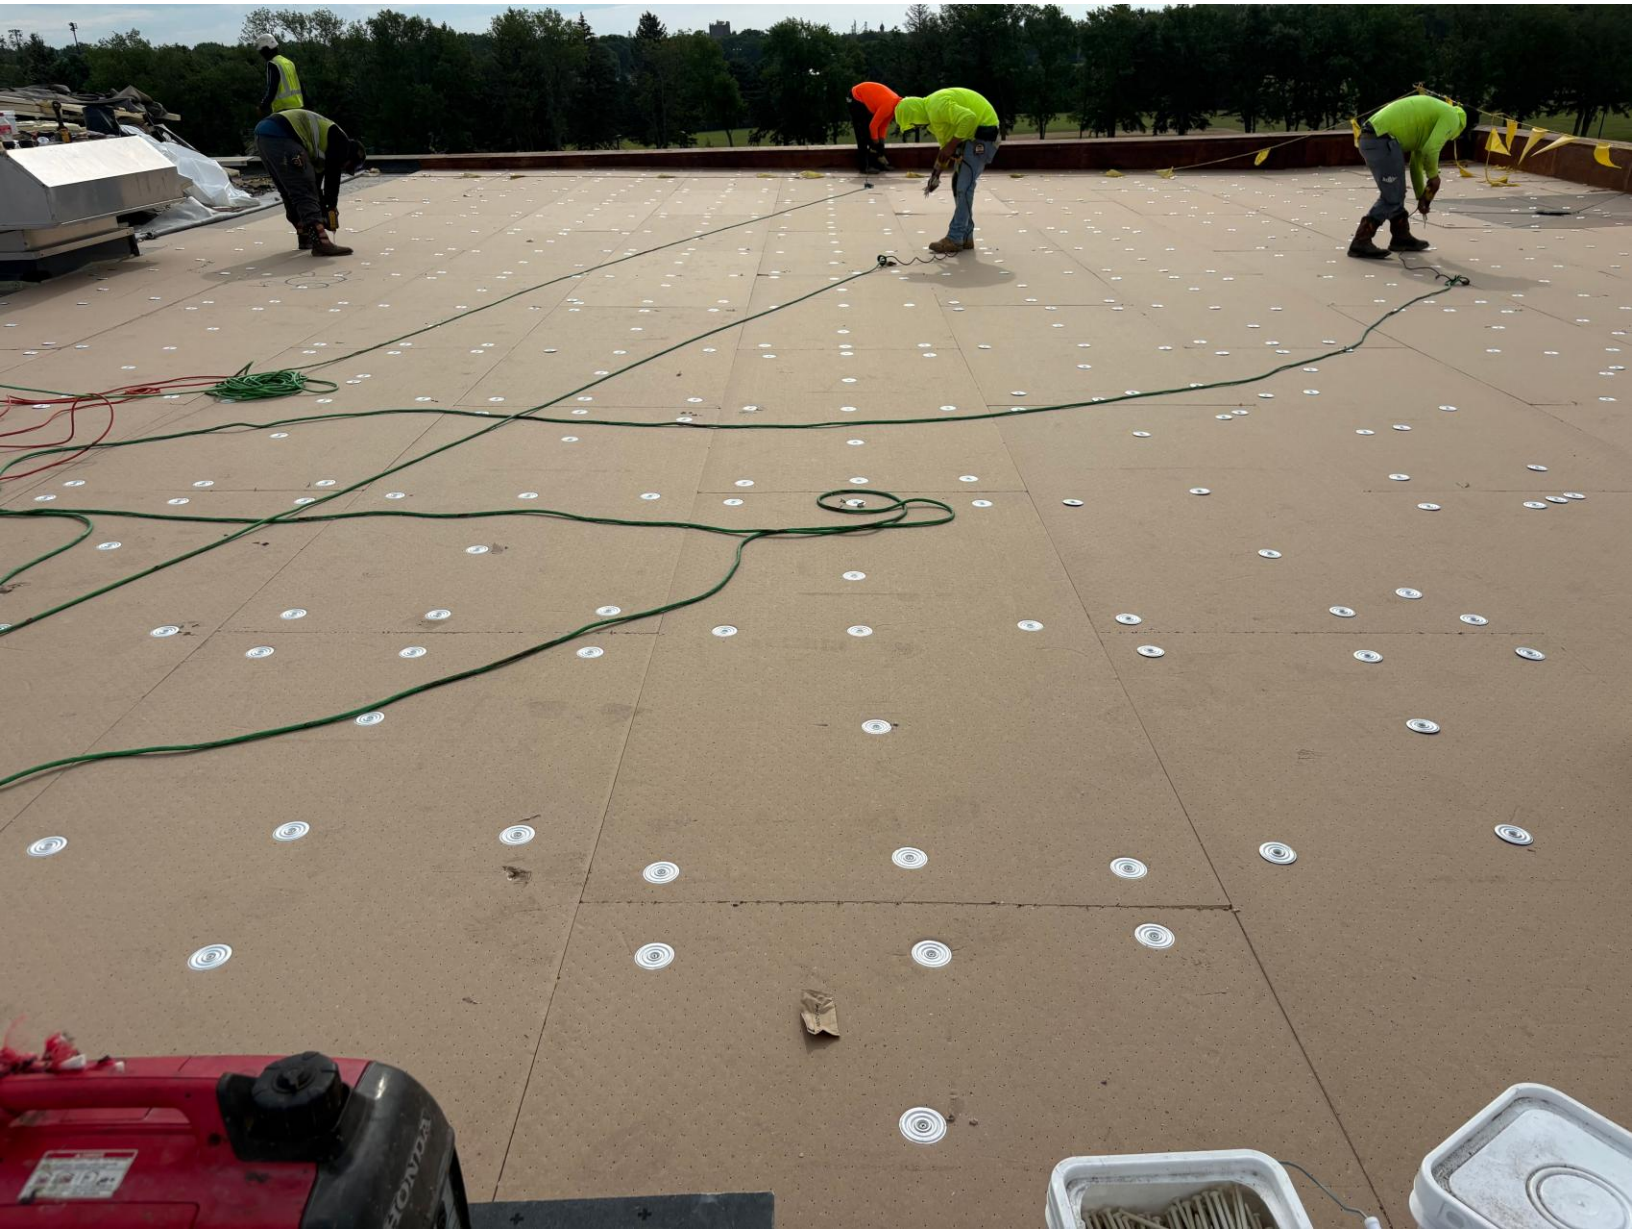
1-1/2" Isocyanurate insulation board mechanically  
attached over existing insulation with fast adhesive for  
ISO coverboard on Roof Area #7

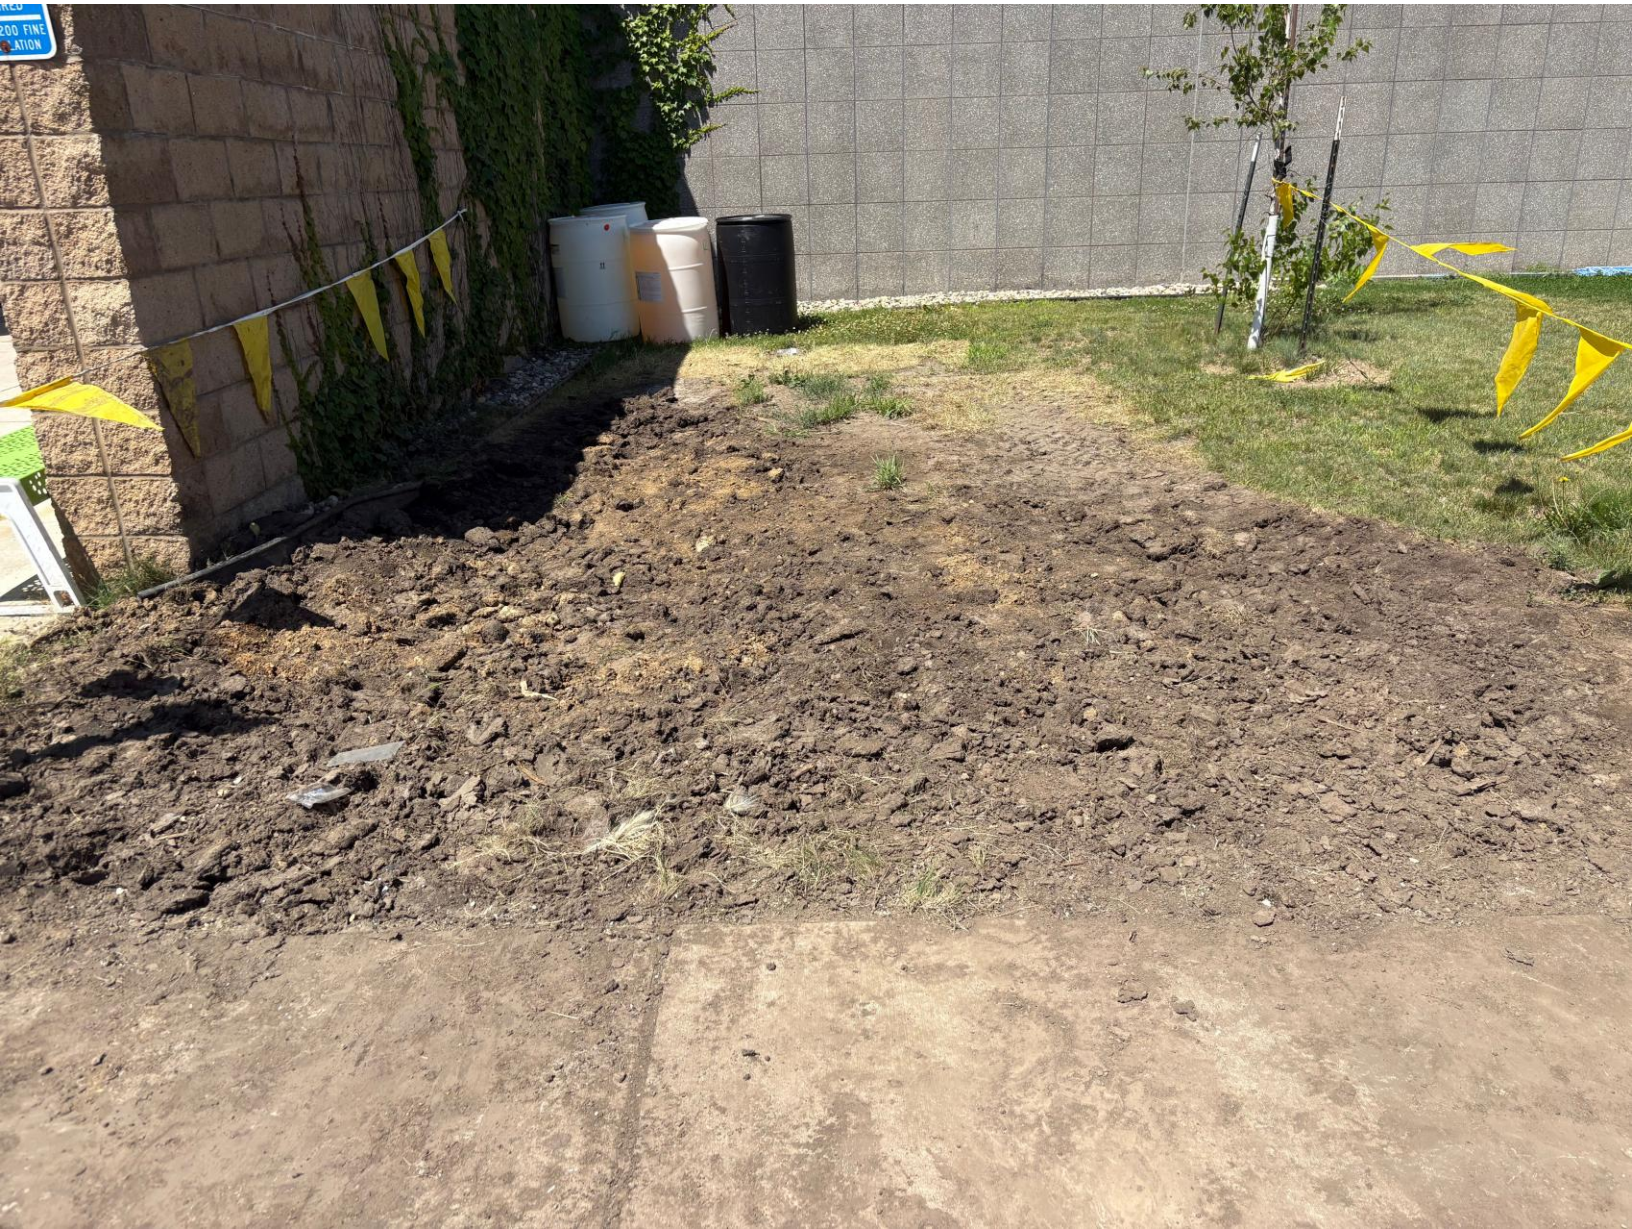
Lawn temporarily raked. Sheet metal crew to utilize lawn to transport material roof

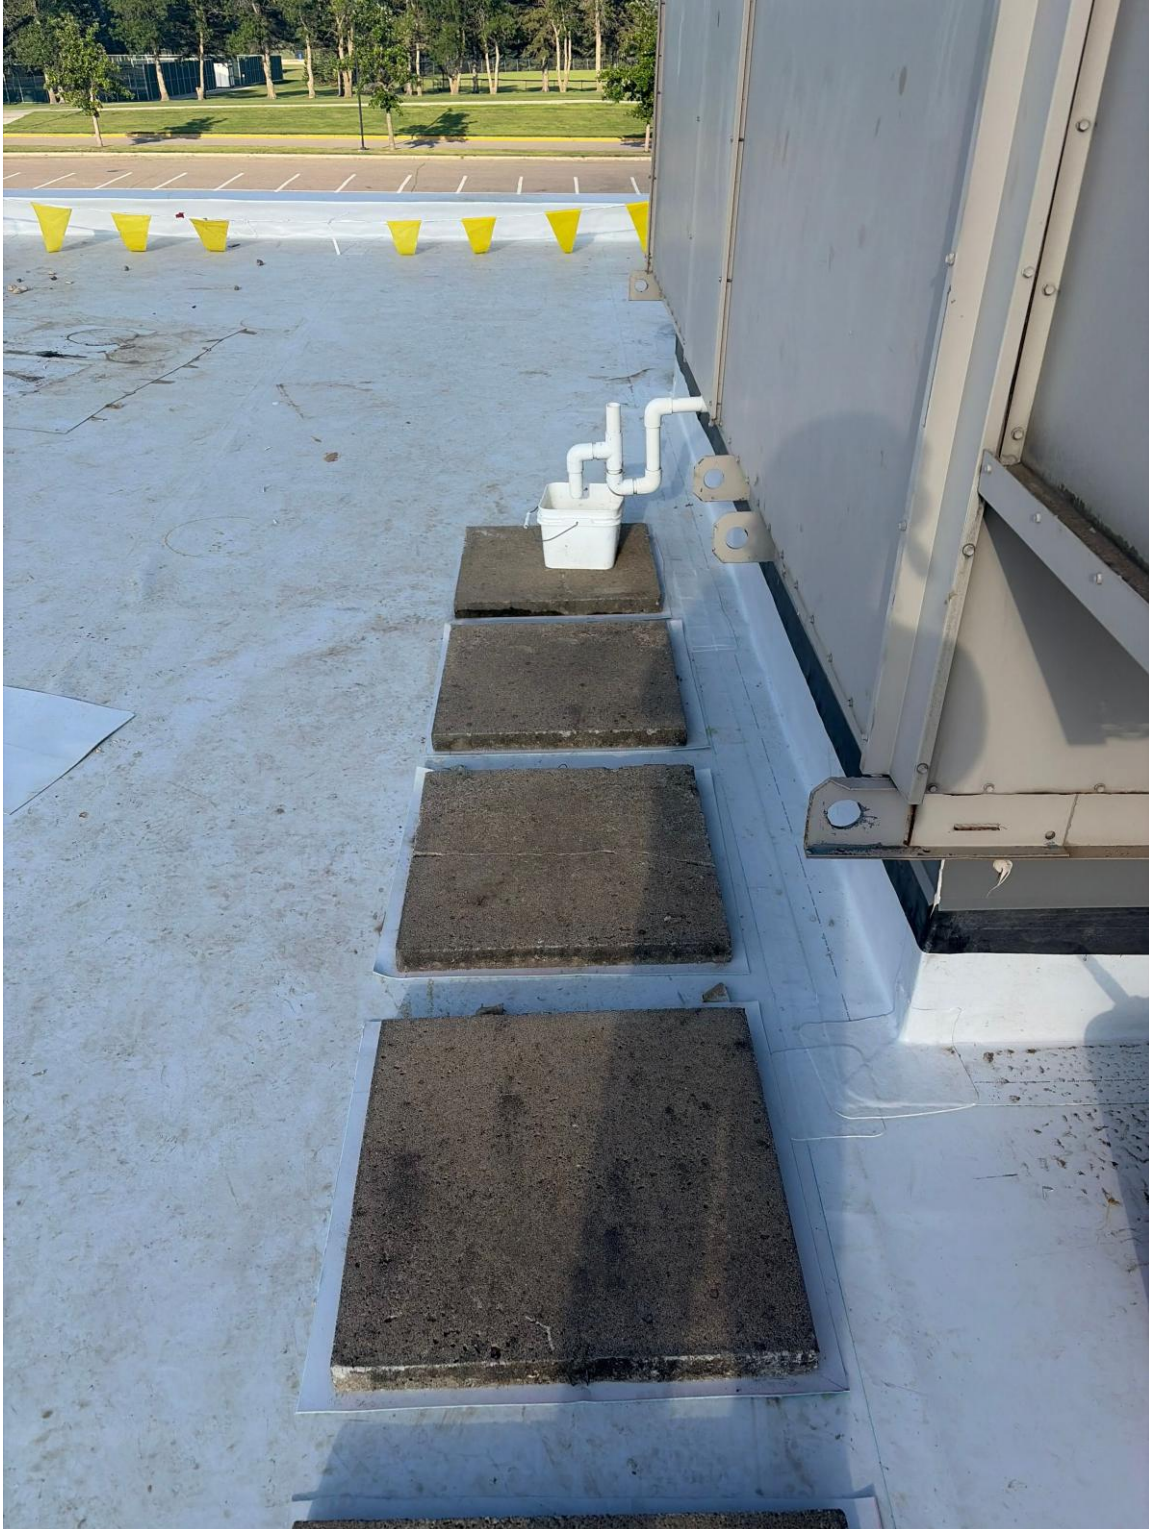
Concrete pads placed around perimeter of unit  
to capture condensate on roof area #6

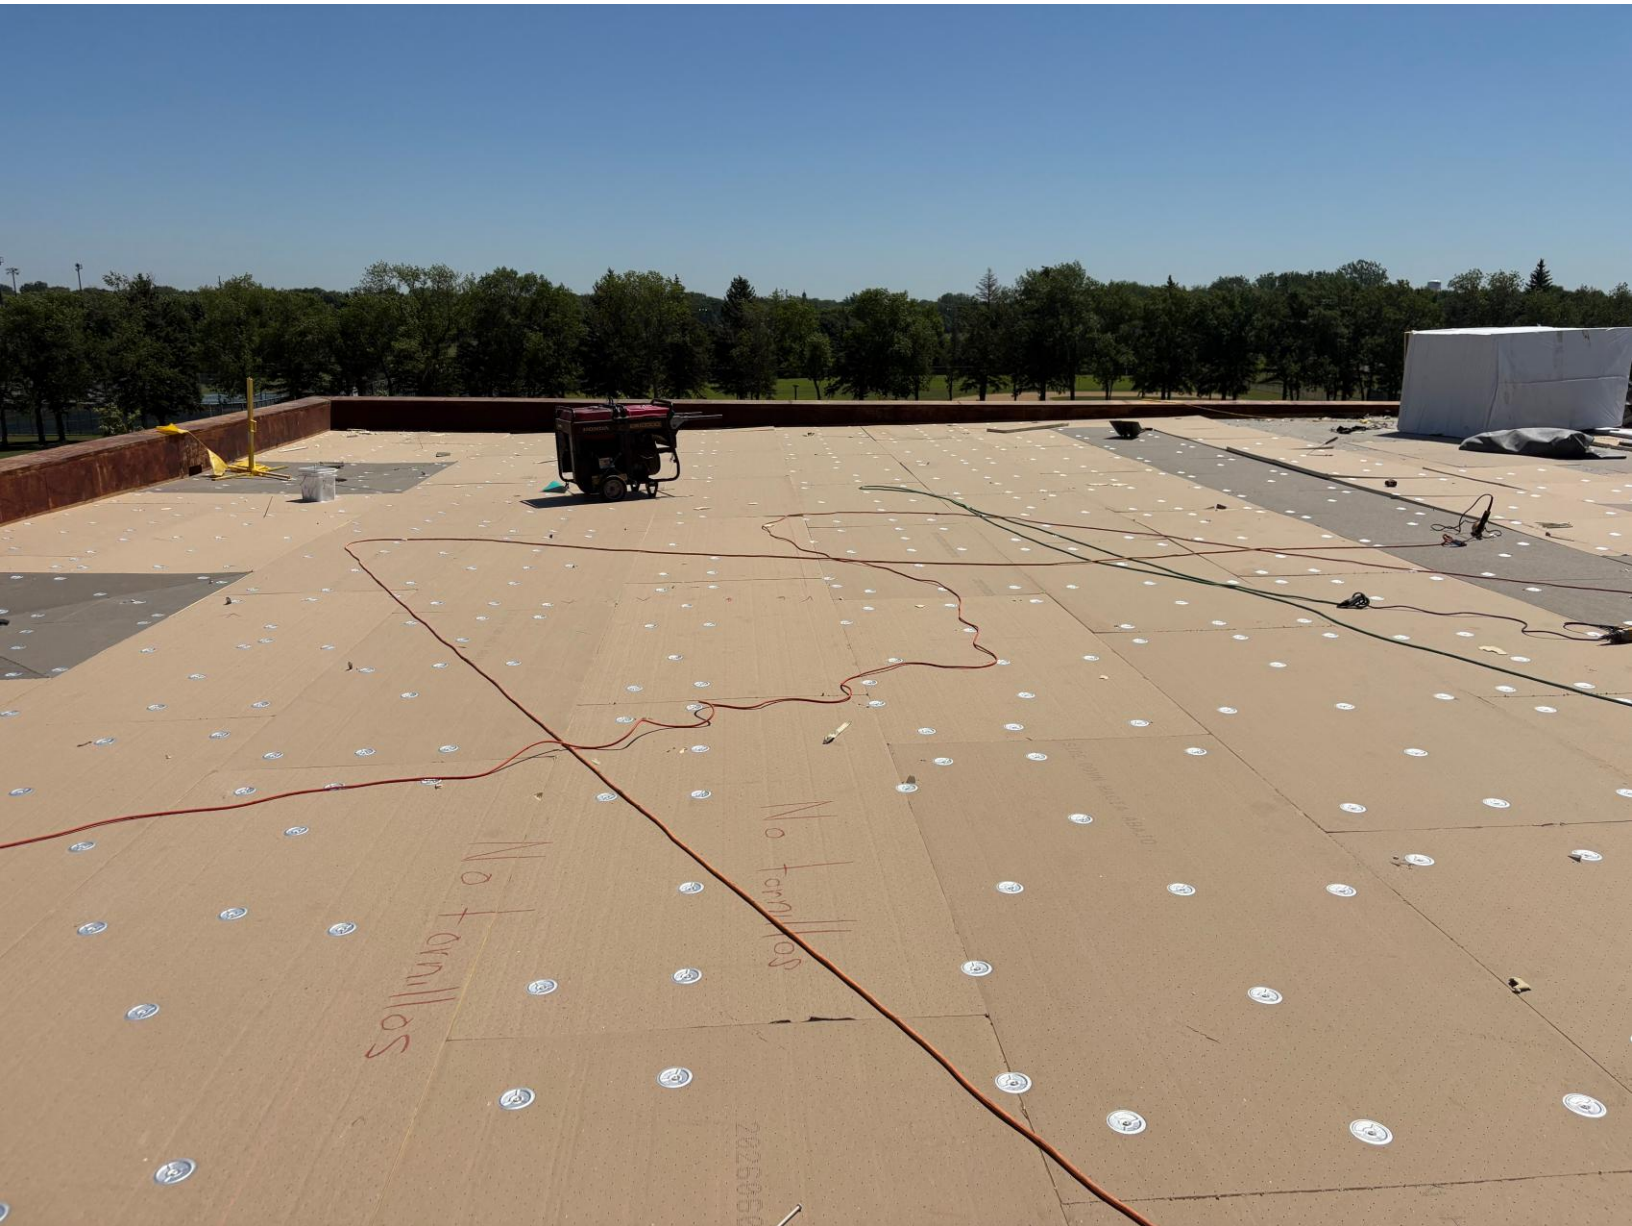
1-1/2" Isocyanurate insulation board mechanically  
attached over existing insulation with fast adhesive for  
ISO coverboard on Roof Area #7

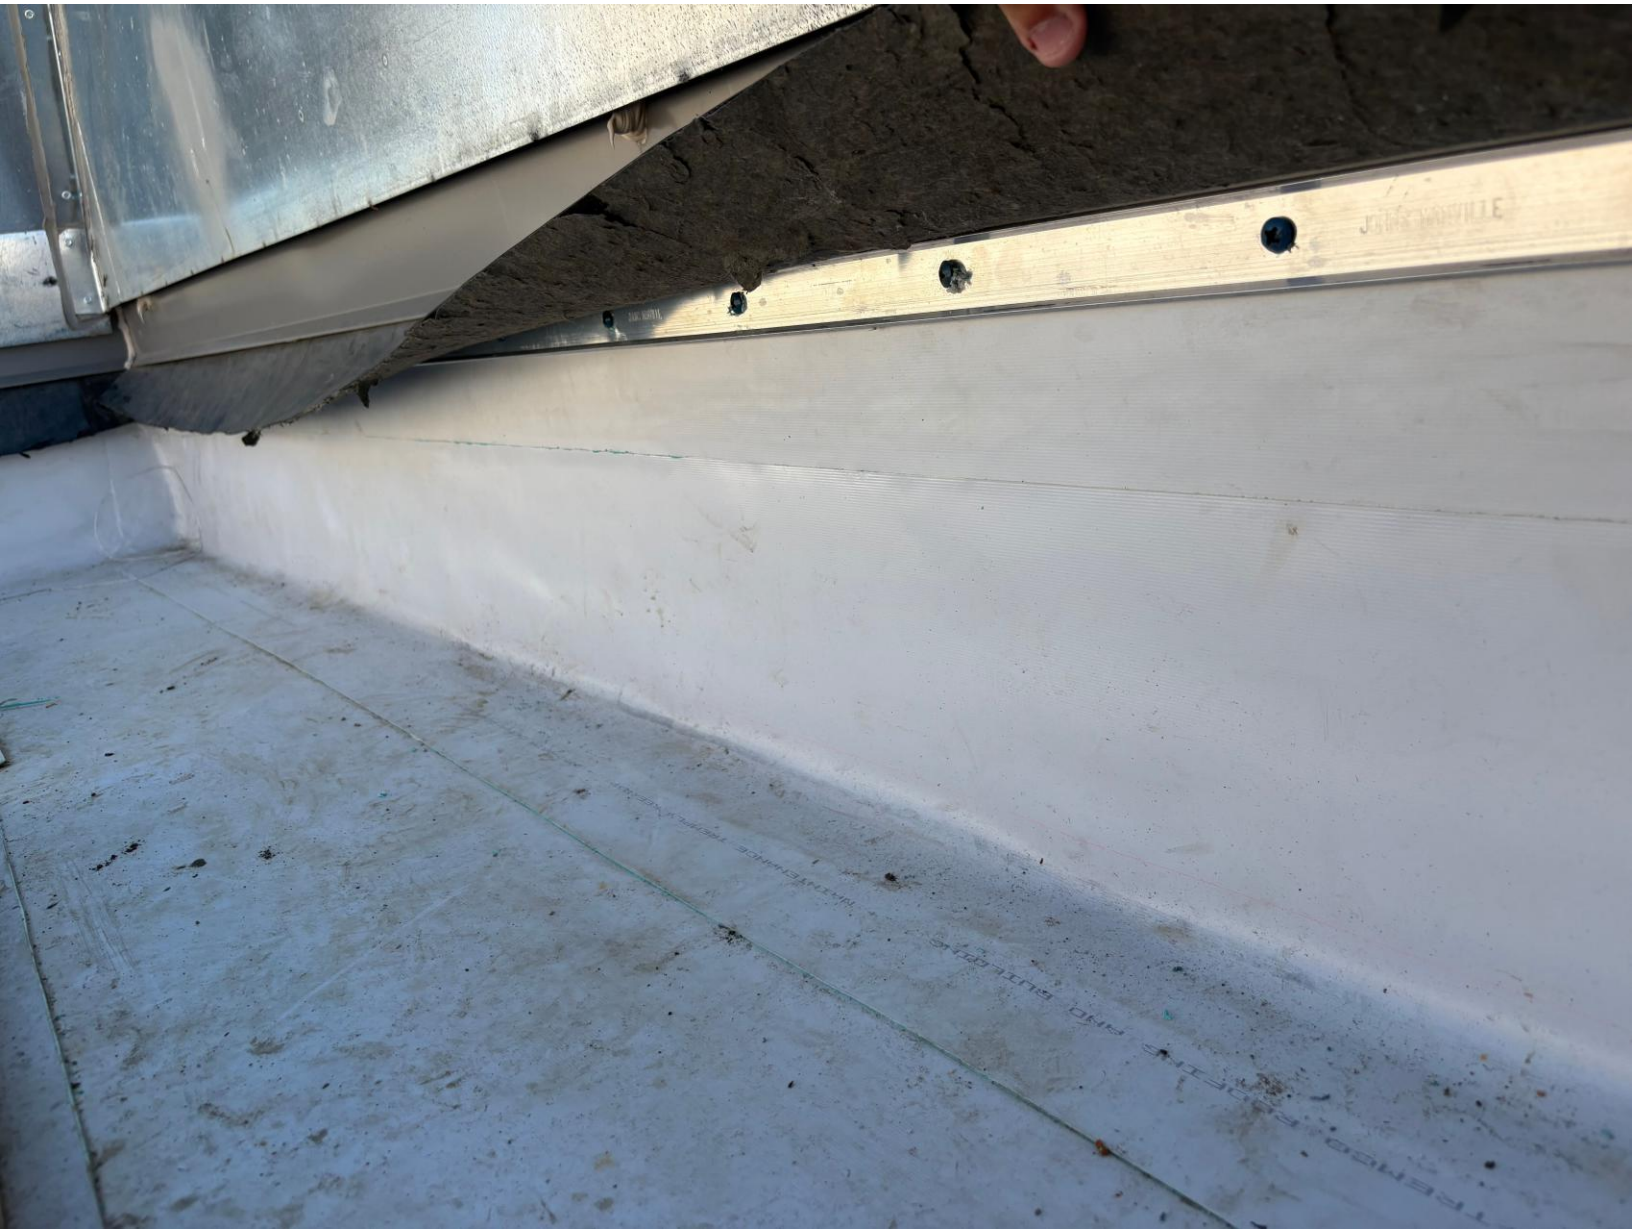
Flashing detail water-tight to curb with  
termination far fastening the membrane  
on roof area #5

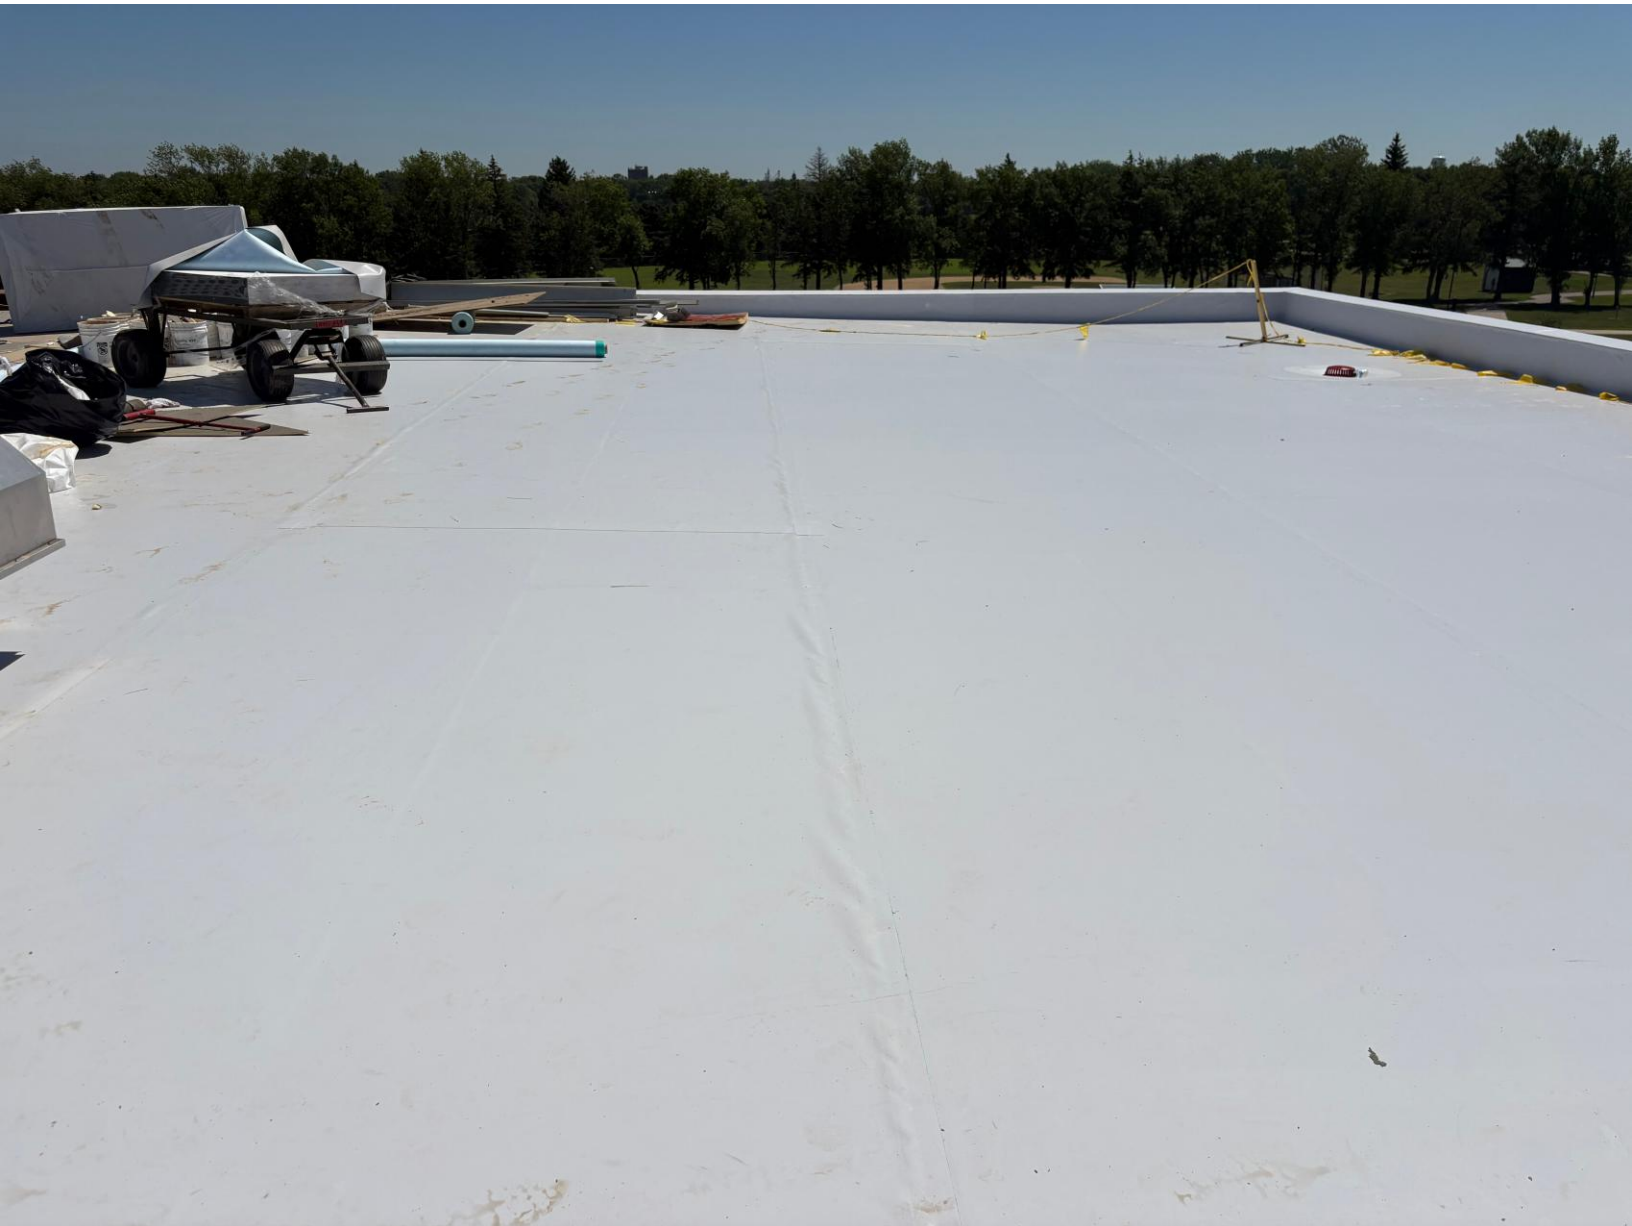
45 Mil KEE fleece-backed membrane adhered in  
membrane adhesive on Roof Area #7
