Memorandum

Re: Lincoln Hall: Floor site walk

On October 22, 2025, members from Studio GC and Lincolnwood School District 74 conducted a walkthrough at Lincoln Hall School to review the soft floor spots observed by District personnel in various classrooms. Below is a summary of our observations.

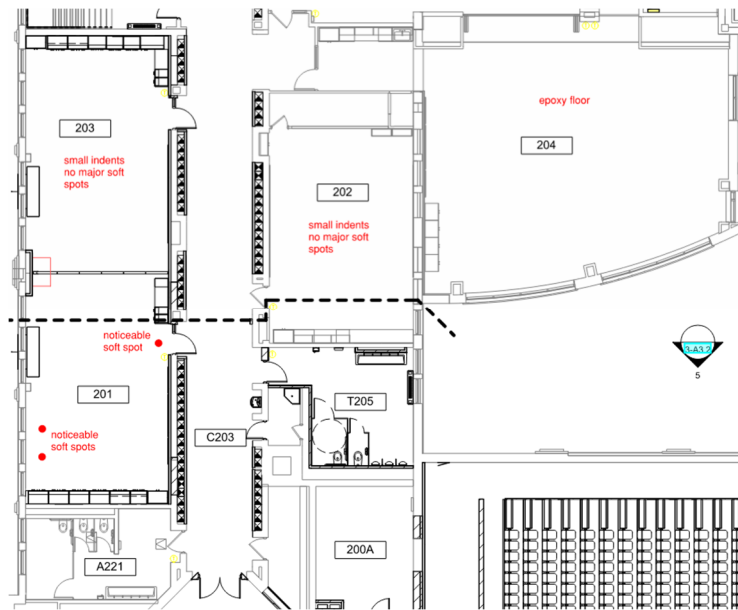
Image 1 - 2nd floor Lincoln Hall

The existing drawings from the 1940 building indicate a gypsum concrete over wood joists floor construction. While no structural concerns are evident, over time with the bending and shifting of the floor under load, the gypsum concrete is susceptible to cracking due to its inelasticity. The soft spots observed during our walkthrough were on the 2nd and 3rd floors. No spots were observed on the 1st floor.

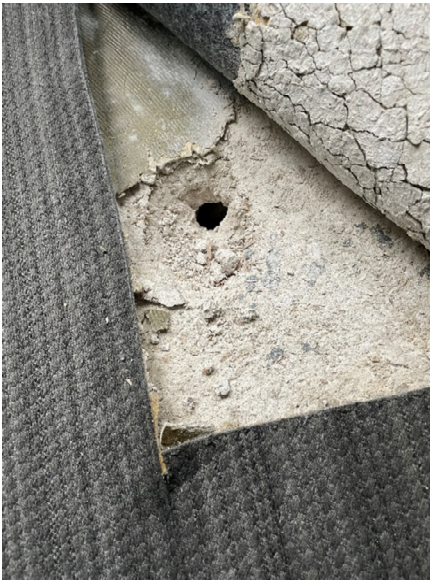
When the carpet tile floor finish was pulled back on one of the spots on the 2nd floor, in Image 3 below, this spot was noted to have telegraphed through the full depth of the floor. It is recommended to repair and improve this floor slab condition by cutting back and removing the gypsum concrete floor slab between the wood joists and as wide as the nearest non-

flaking/cracking gypsum and infilling the removed area with additional wood framing supports below, plywood and a leveler to meet the elevation of the existing floor finish.

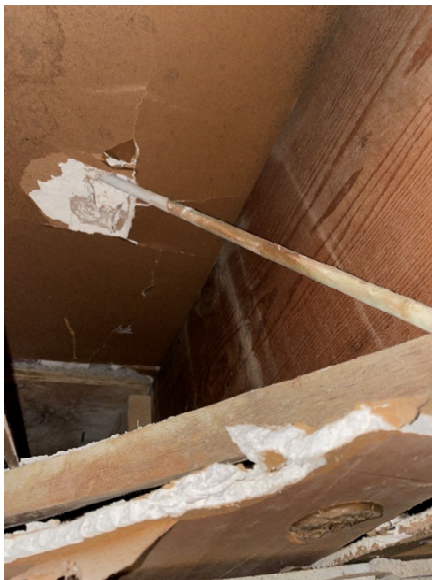
Image 4 - Image 3 from below

When observing these spots from below, Images 4 and 5, the wood joists appear to be in good condition and show no signs of cracking themselves or any moisture issues. It is recommended that below all the soft spots, additional wood framing supports be attached to the existing wood joists for additional reinforcement. This will assist with the sagging of the

gypsum concrete deck material. Alternatively, a more invasive solution would be a full-depth floor tear out and replacement with a plywood subfloor and leveler in the classrooms with any soft spots. It is recommended that this repair (either approach) be completed over a summer break in order to allow for adequate time and access.
