ROOF PROGRESS REPORT THROUGH 06-19-2026

| Contractor: | Black Hawk Roof Company |

Areas of Work: Roof Area 1, 3A, 3B

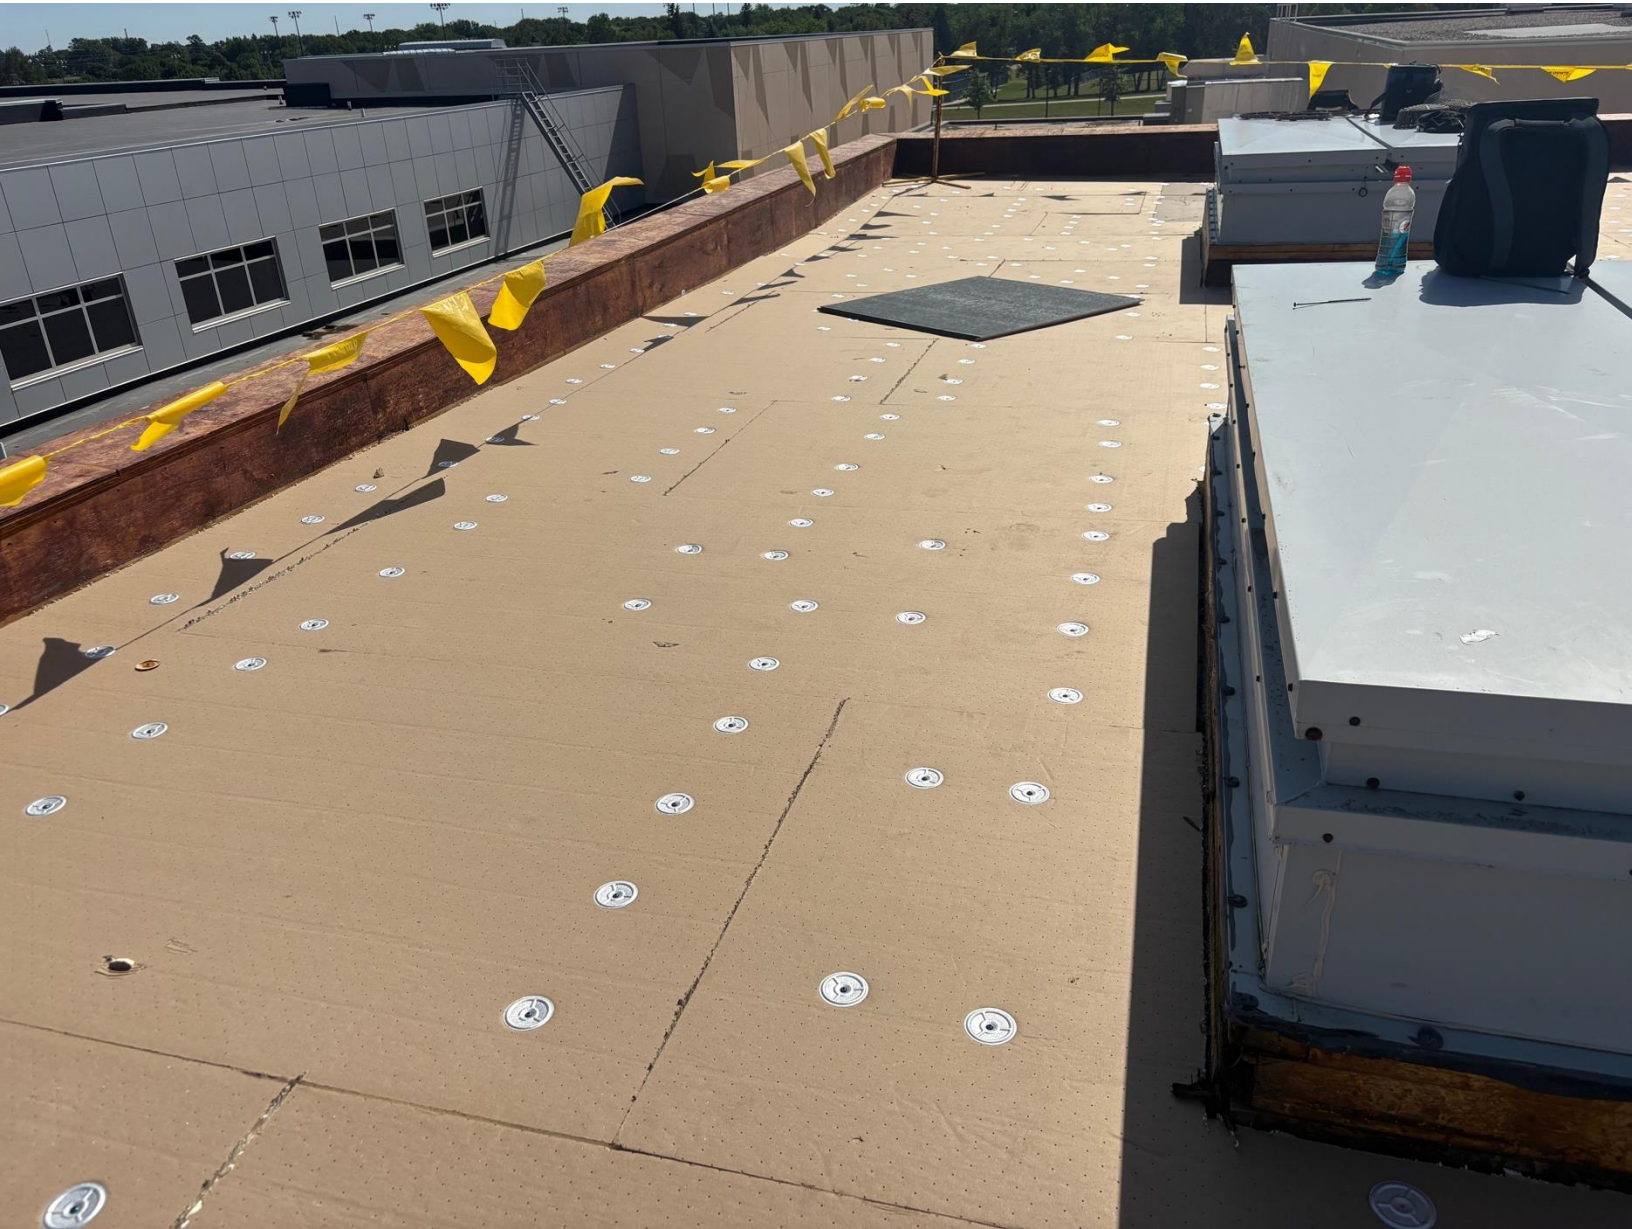
1-1/2" Isocyanurate insulation board mechanically attached over existing insulation with fast adhesive for ISO coverboard on Roof Area #3A

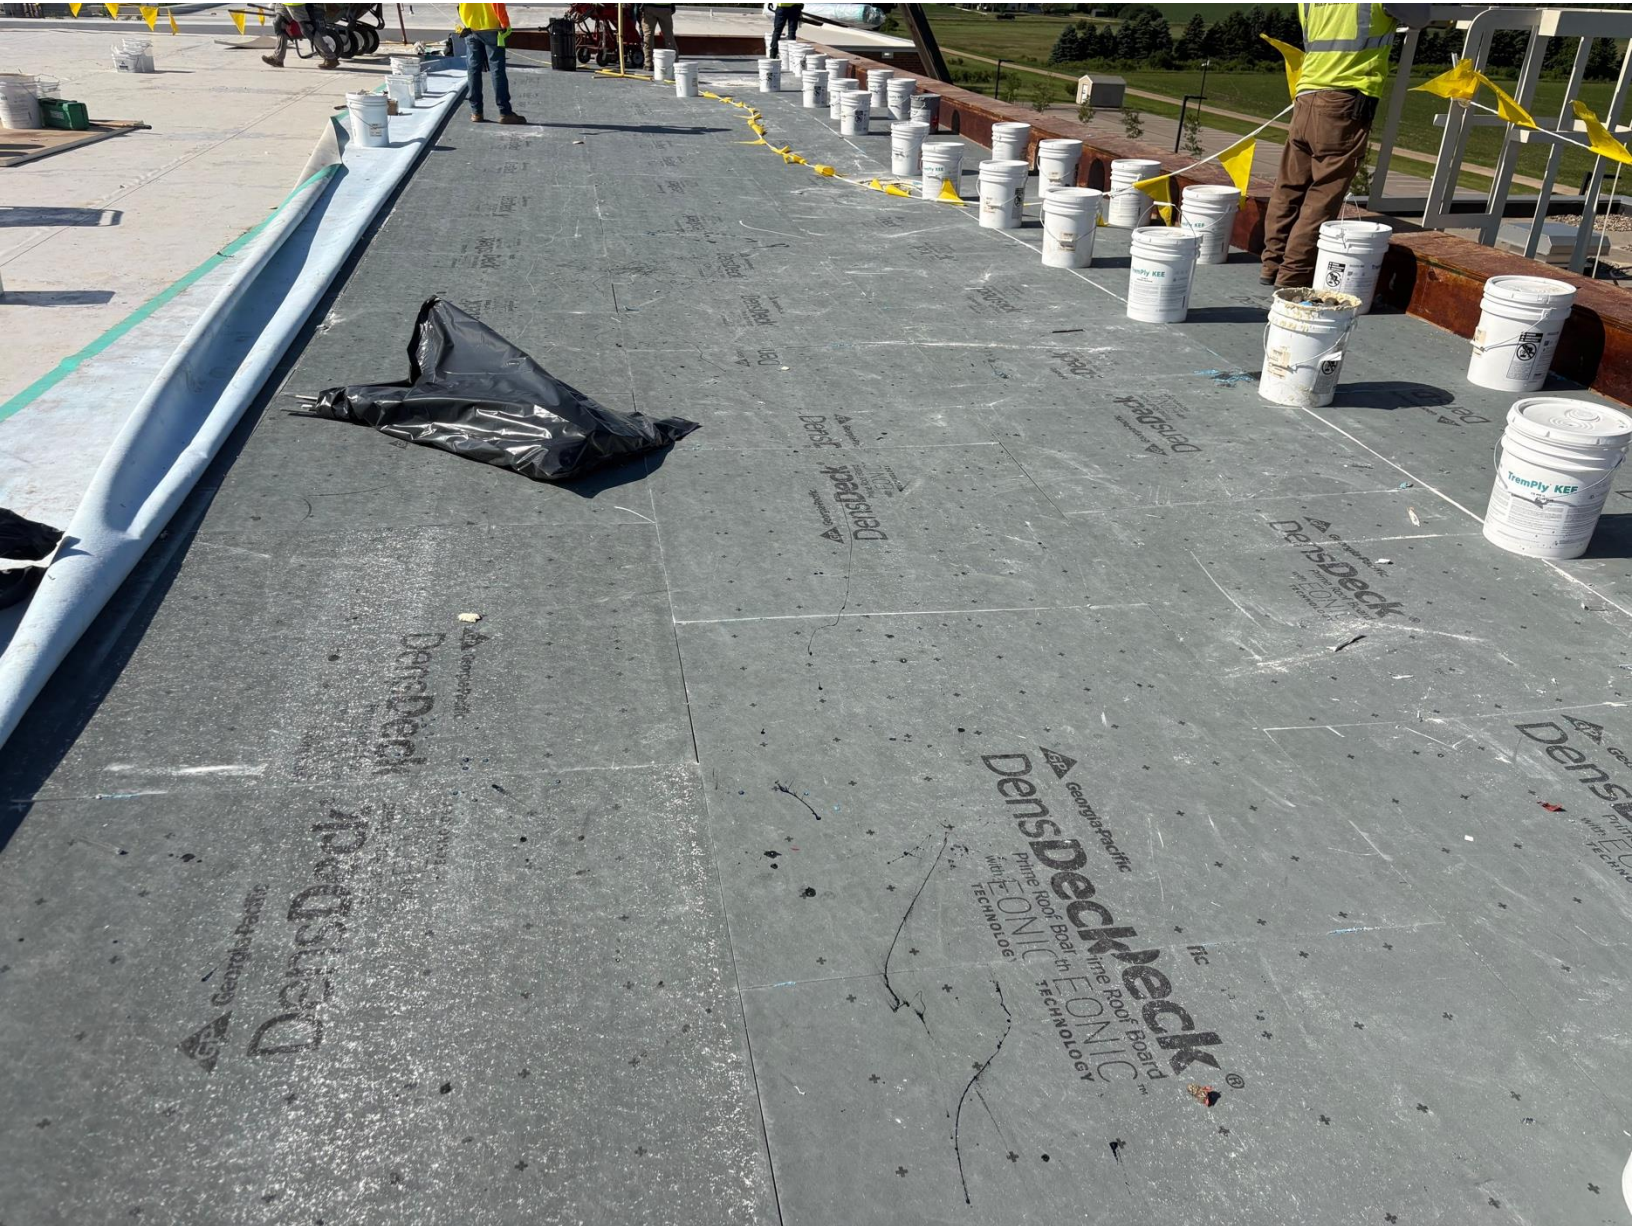
¼" prime coverboard adhered in low-rise adhesive over insulation coverboard on Roof Area #3B

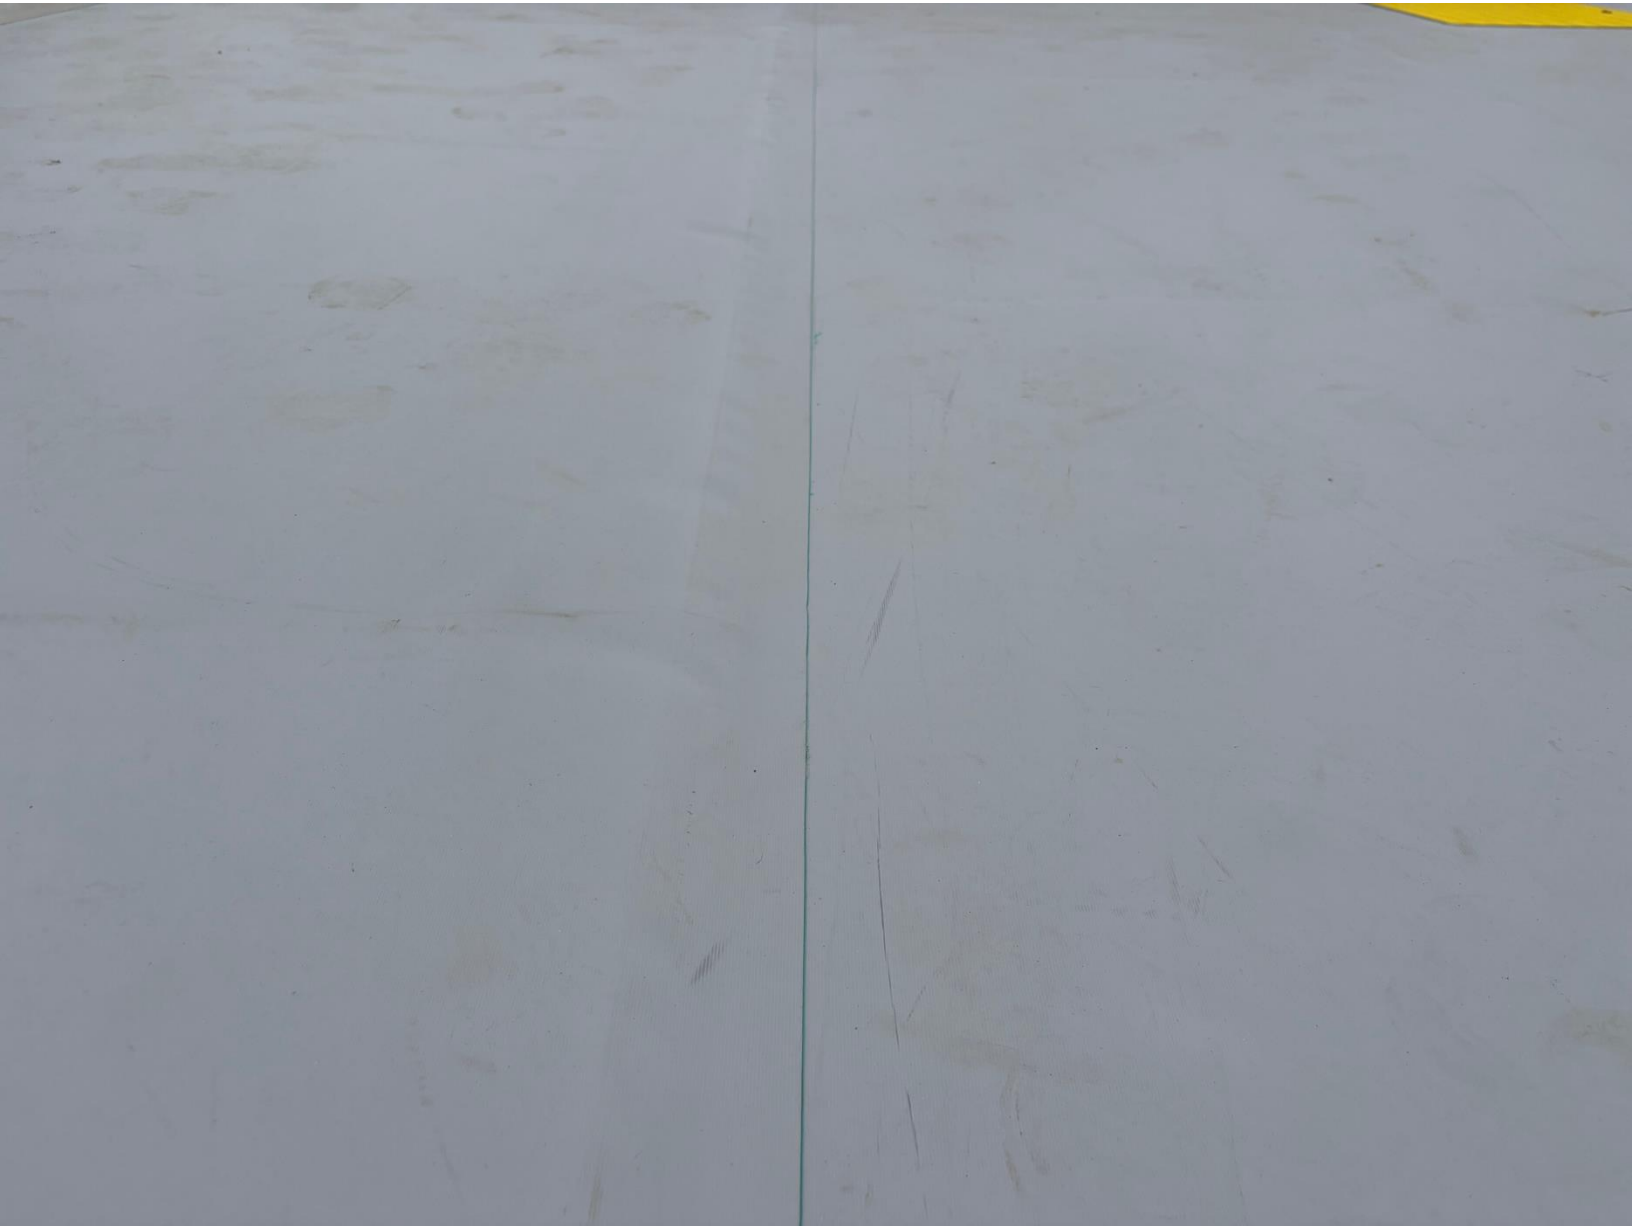
60 Mil KEE fleece-backed membrane seams water-tight
on Roof Area #3B

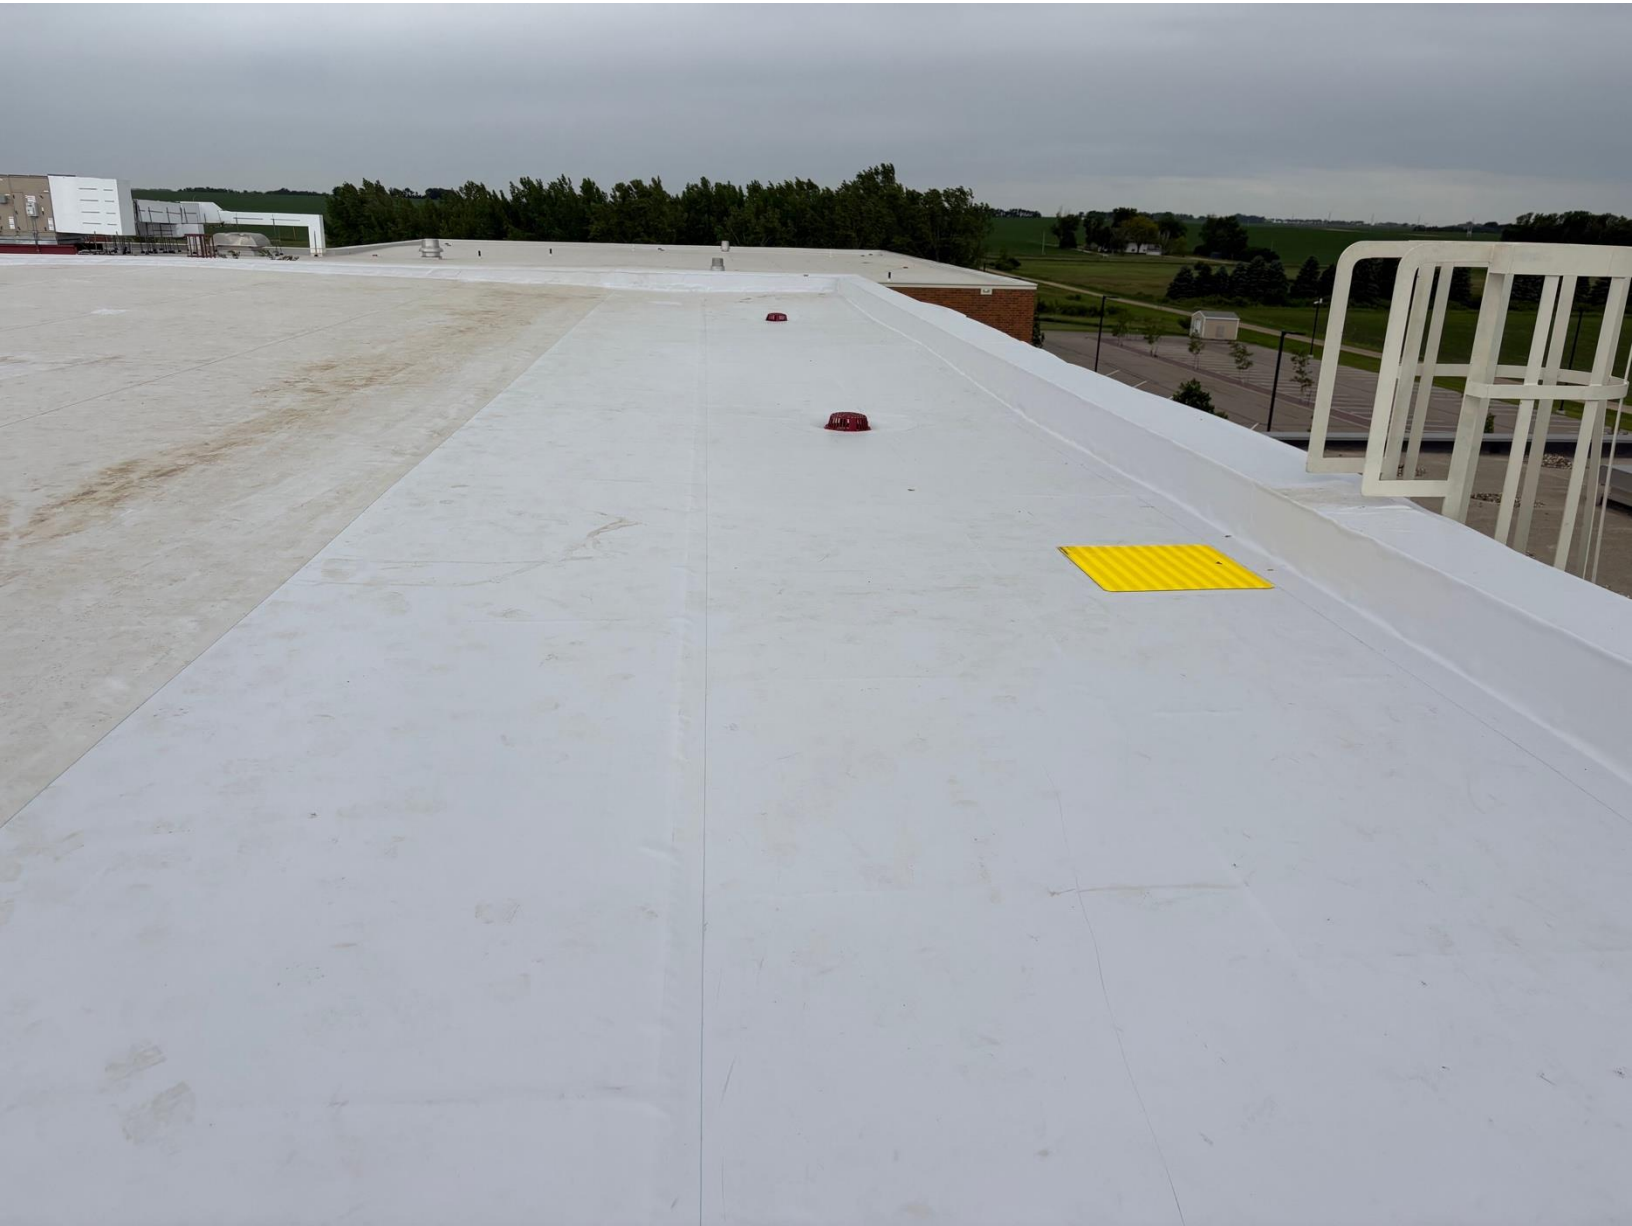
60 Mil KEE fleece-backed membrane adhered in
membrane adhesive on Roof Area #3B

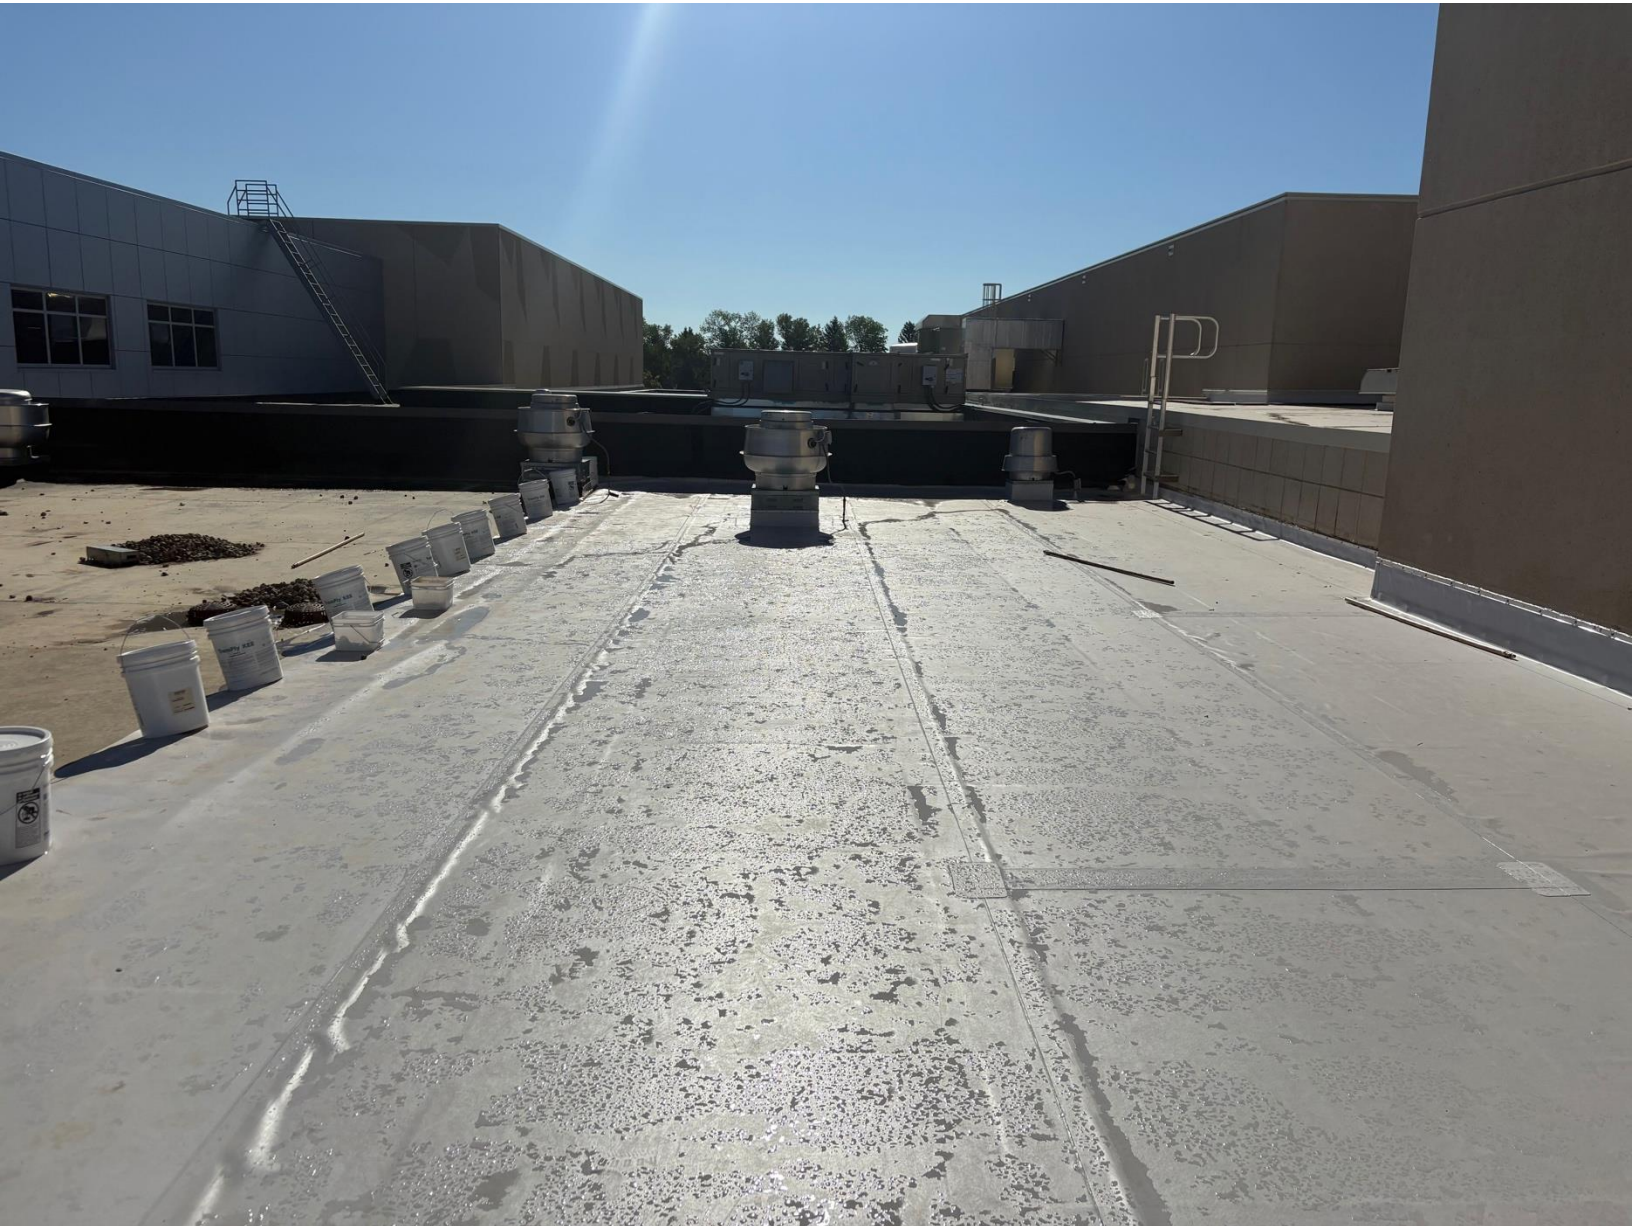
60 Mil KEE fleece-backed membrane adhered in
membrane adhesive on Roof Area #1

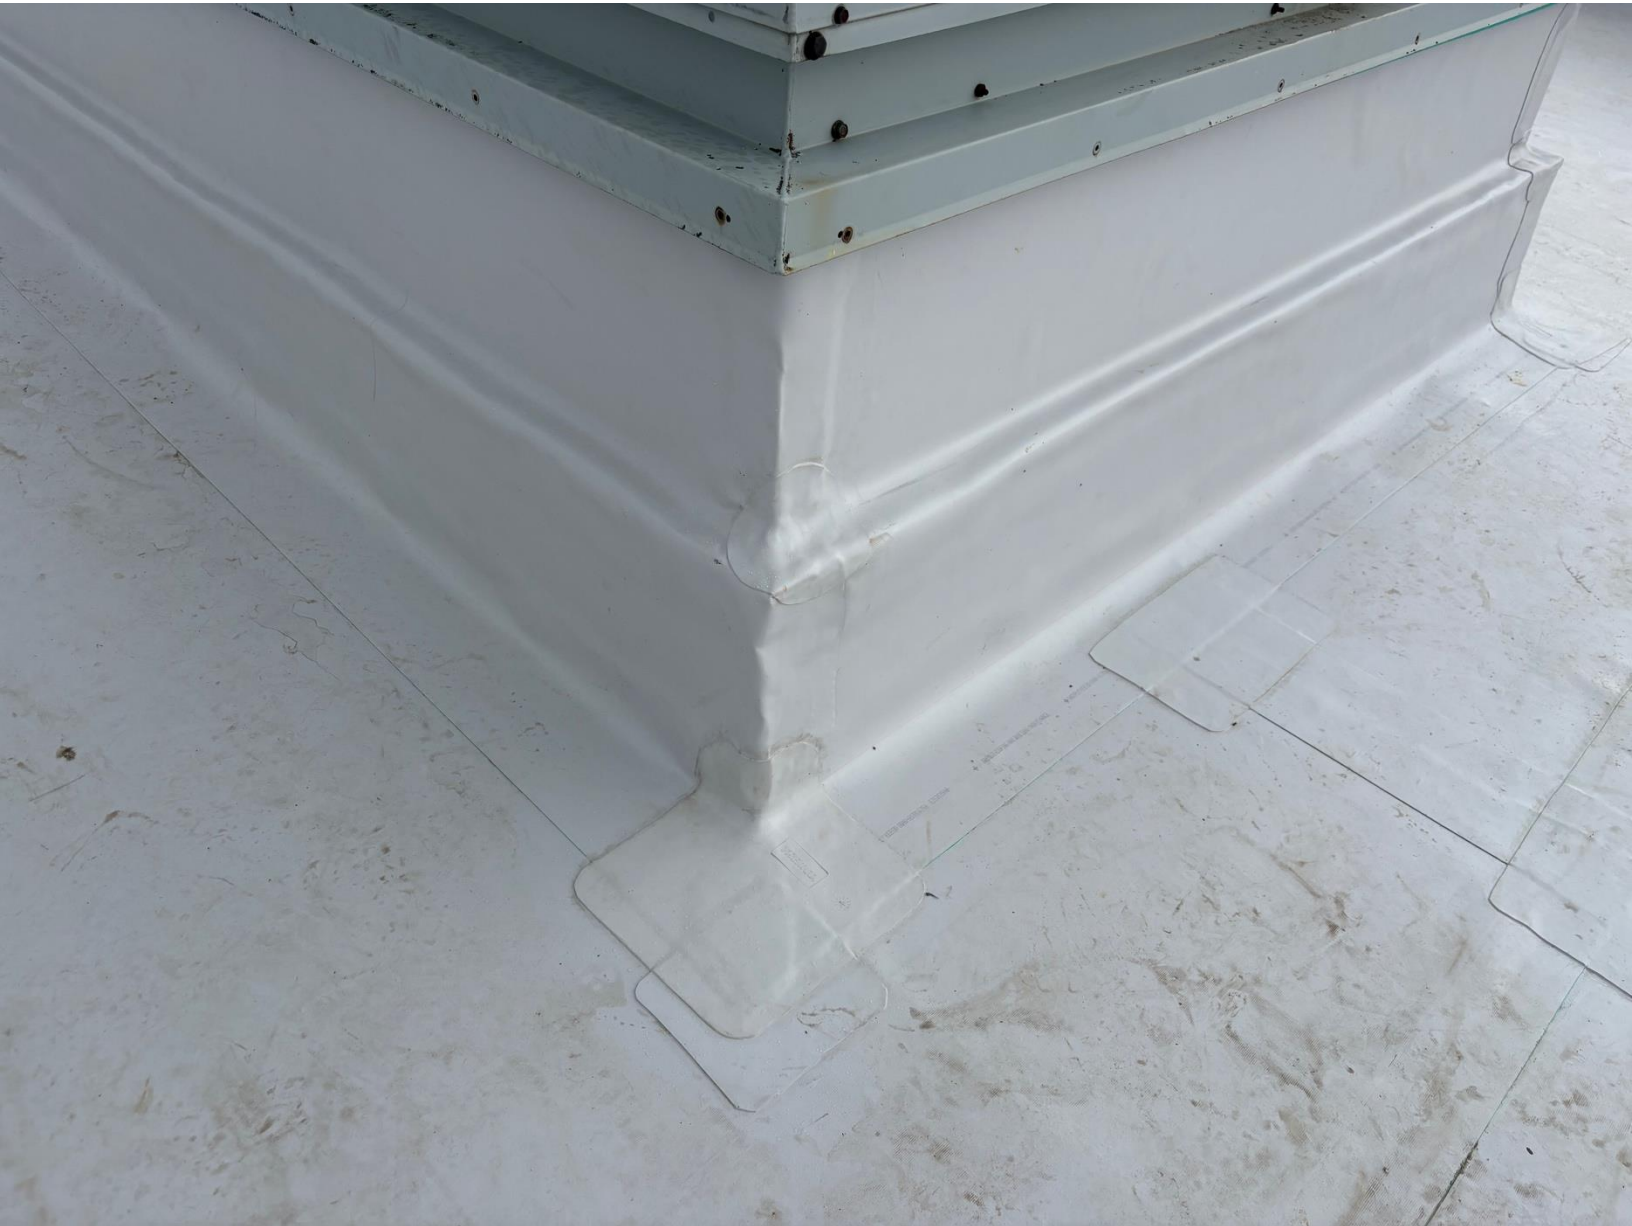
Curb detail is secured and water-tight on Roof Area #3A

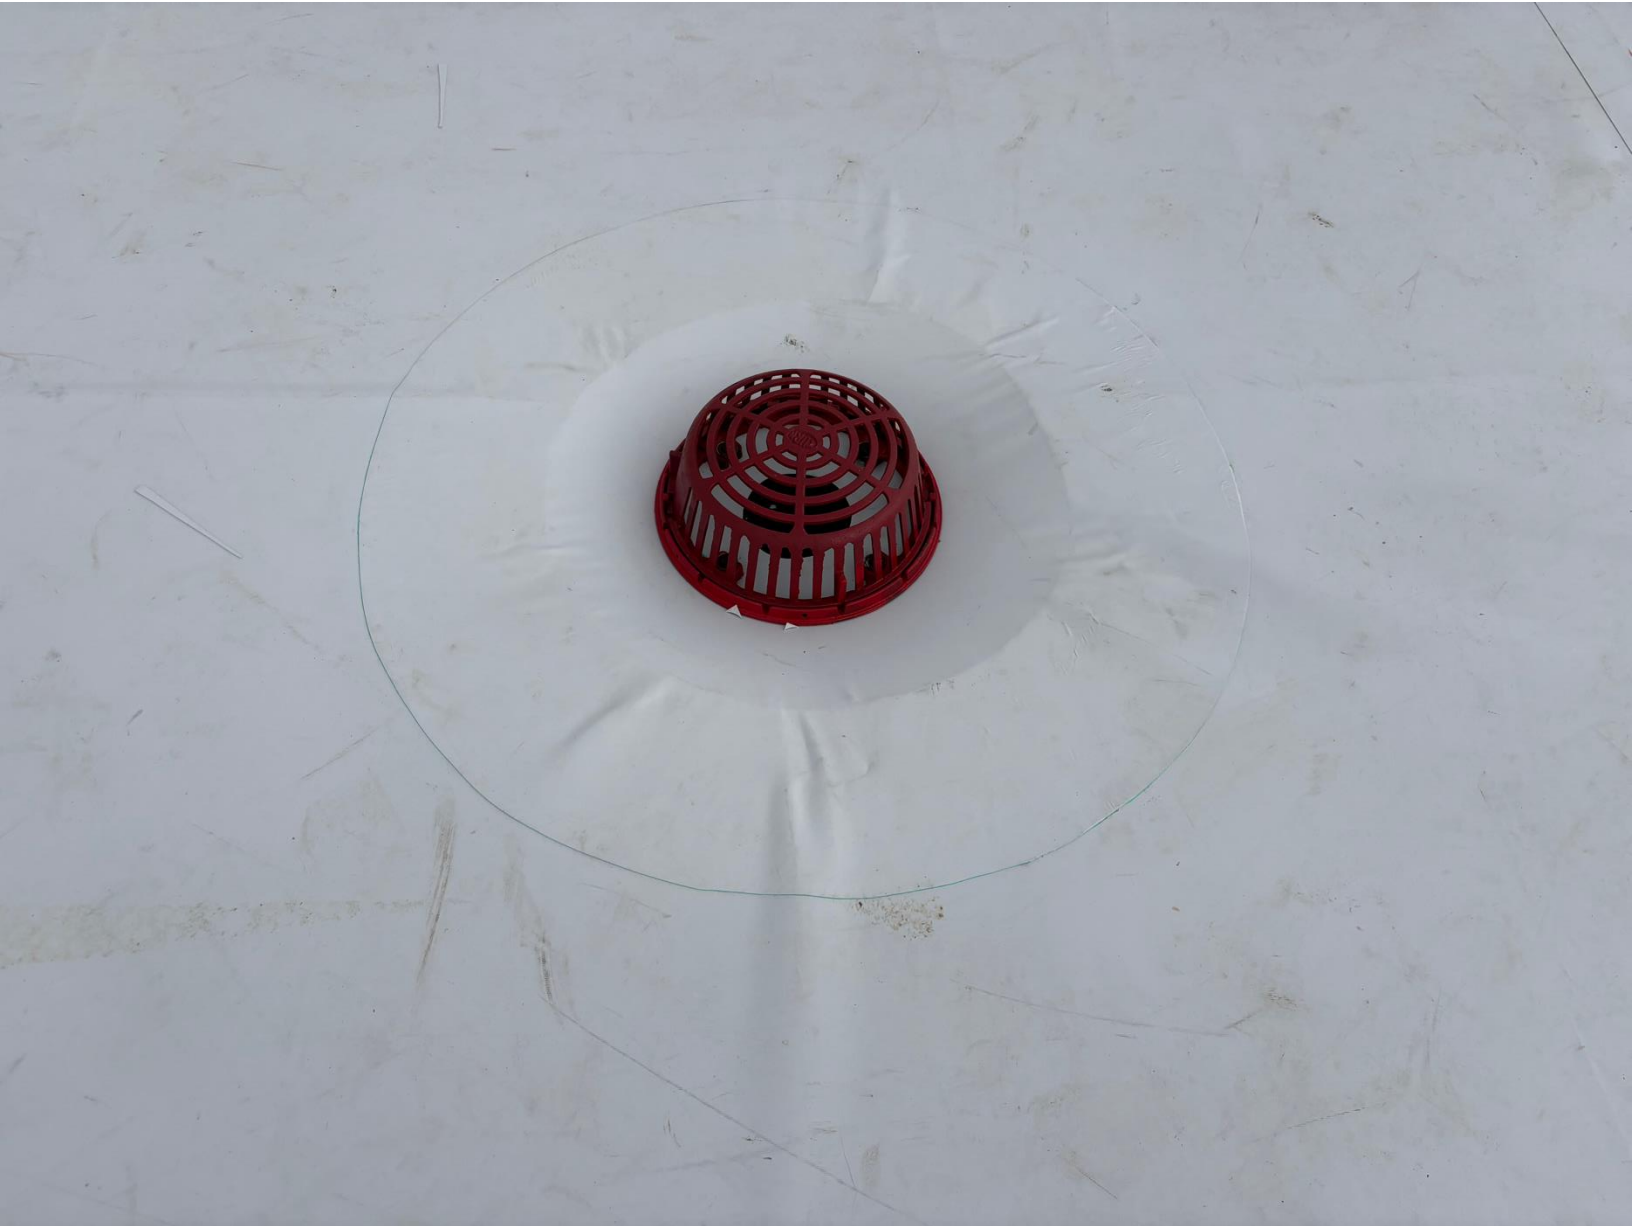
Drain and Sump Detail: KEE membrane is sealed to ensure watertight connection around drain on Roof Area #3B

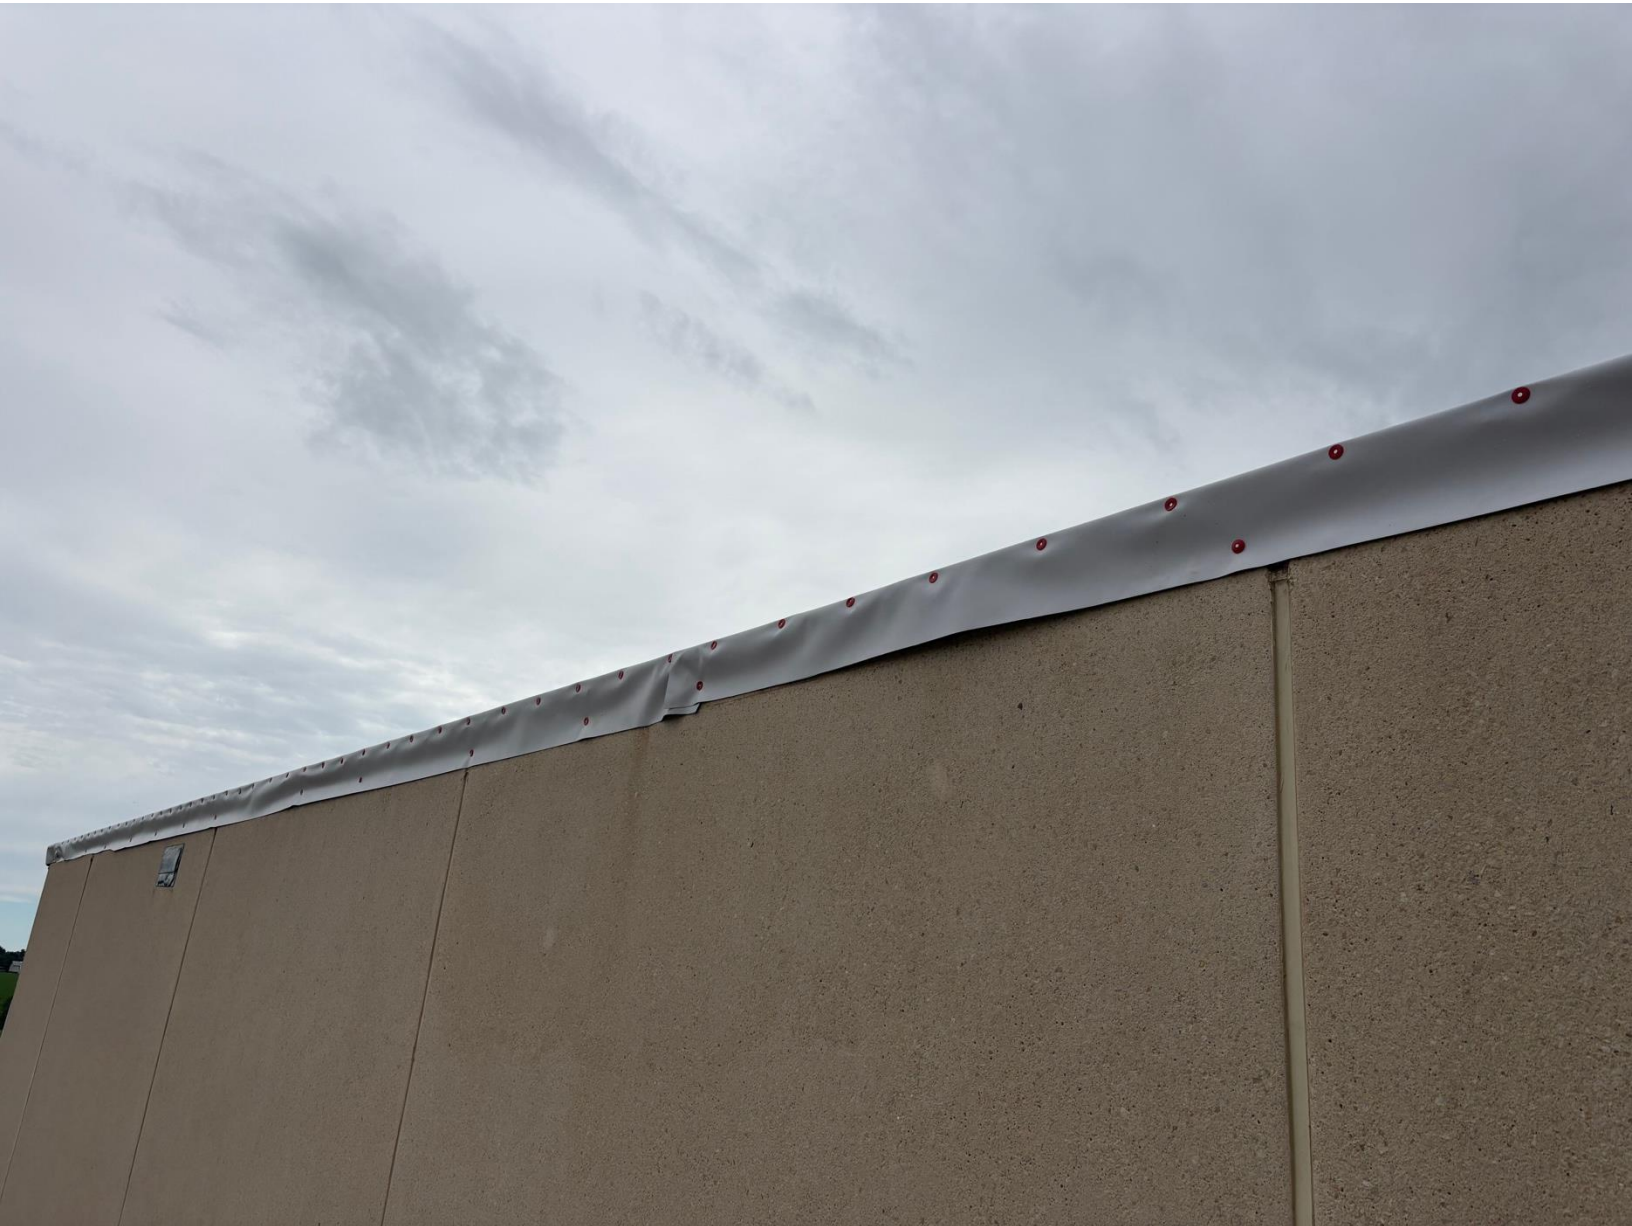
Membrane is fastened with an additional lower layer of nails spaced 3 feet apart. Ensures it is properly secured against wind uplift and remains fully watertight

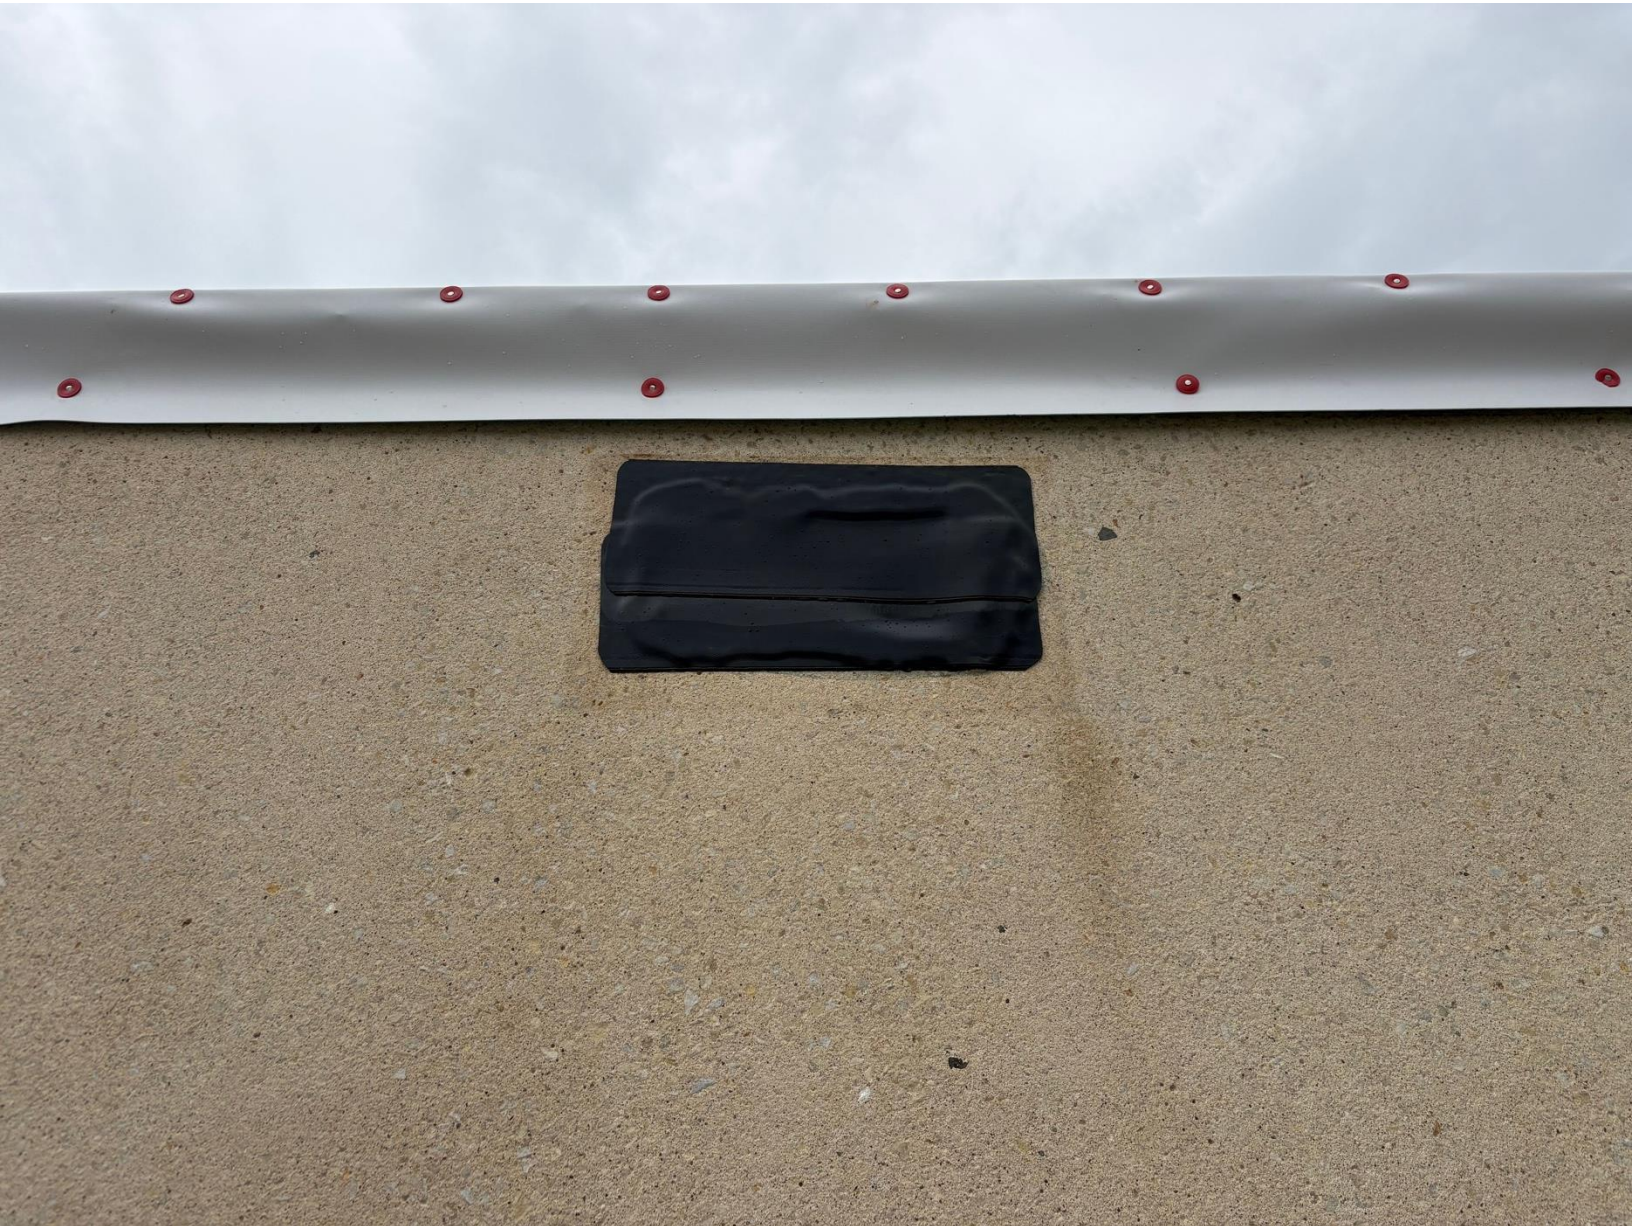
Scupper detail sealed and water-tight. Sheet metal crew to install scupper drain on Roof Area #3

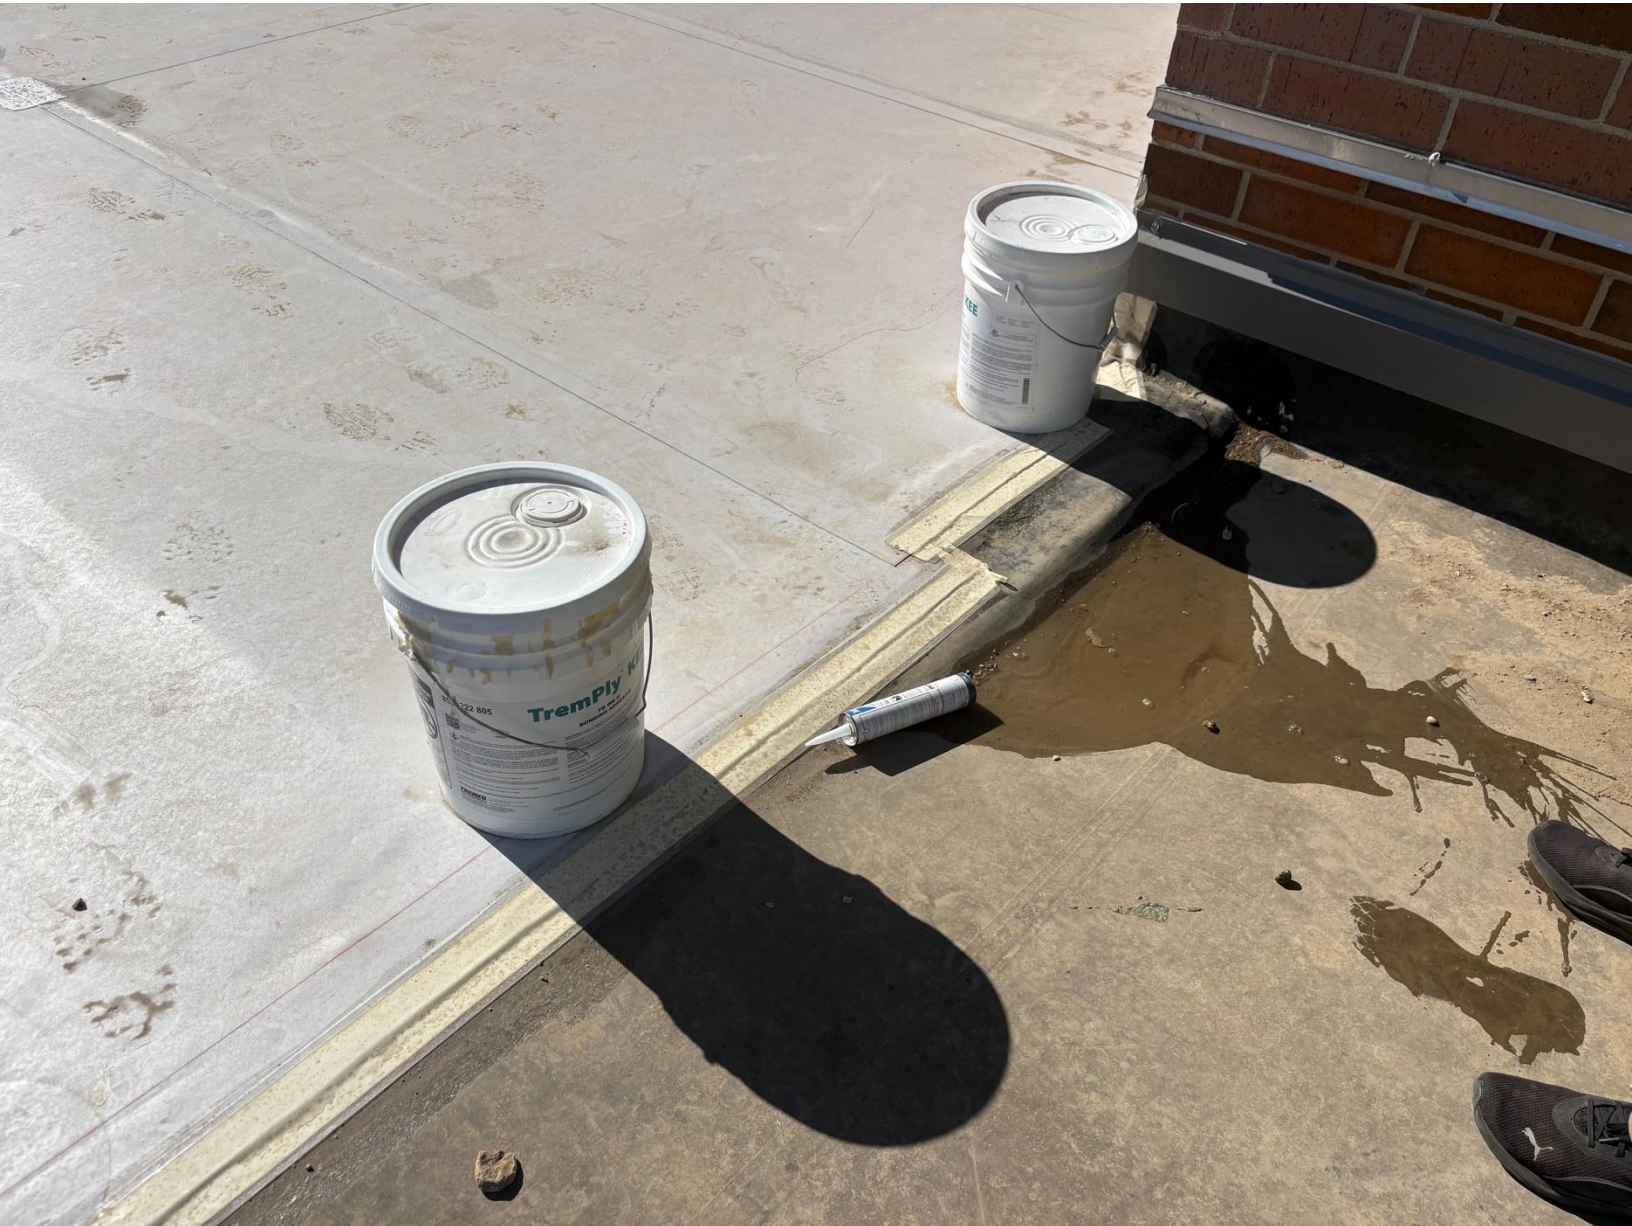
Daily Tie Off on Rood Area #1

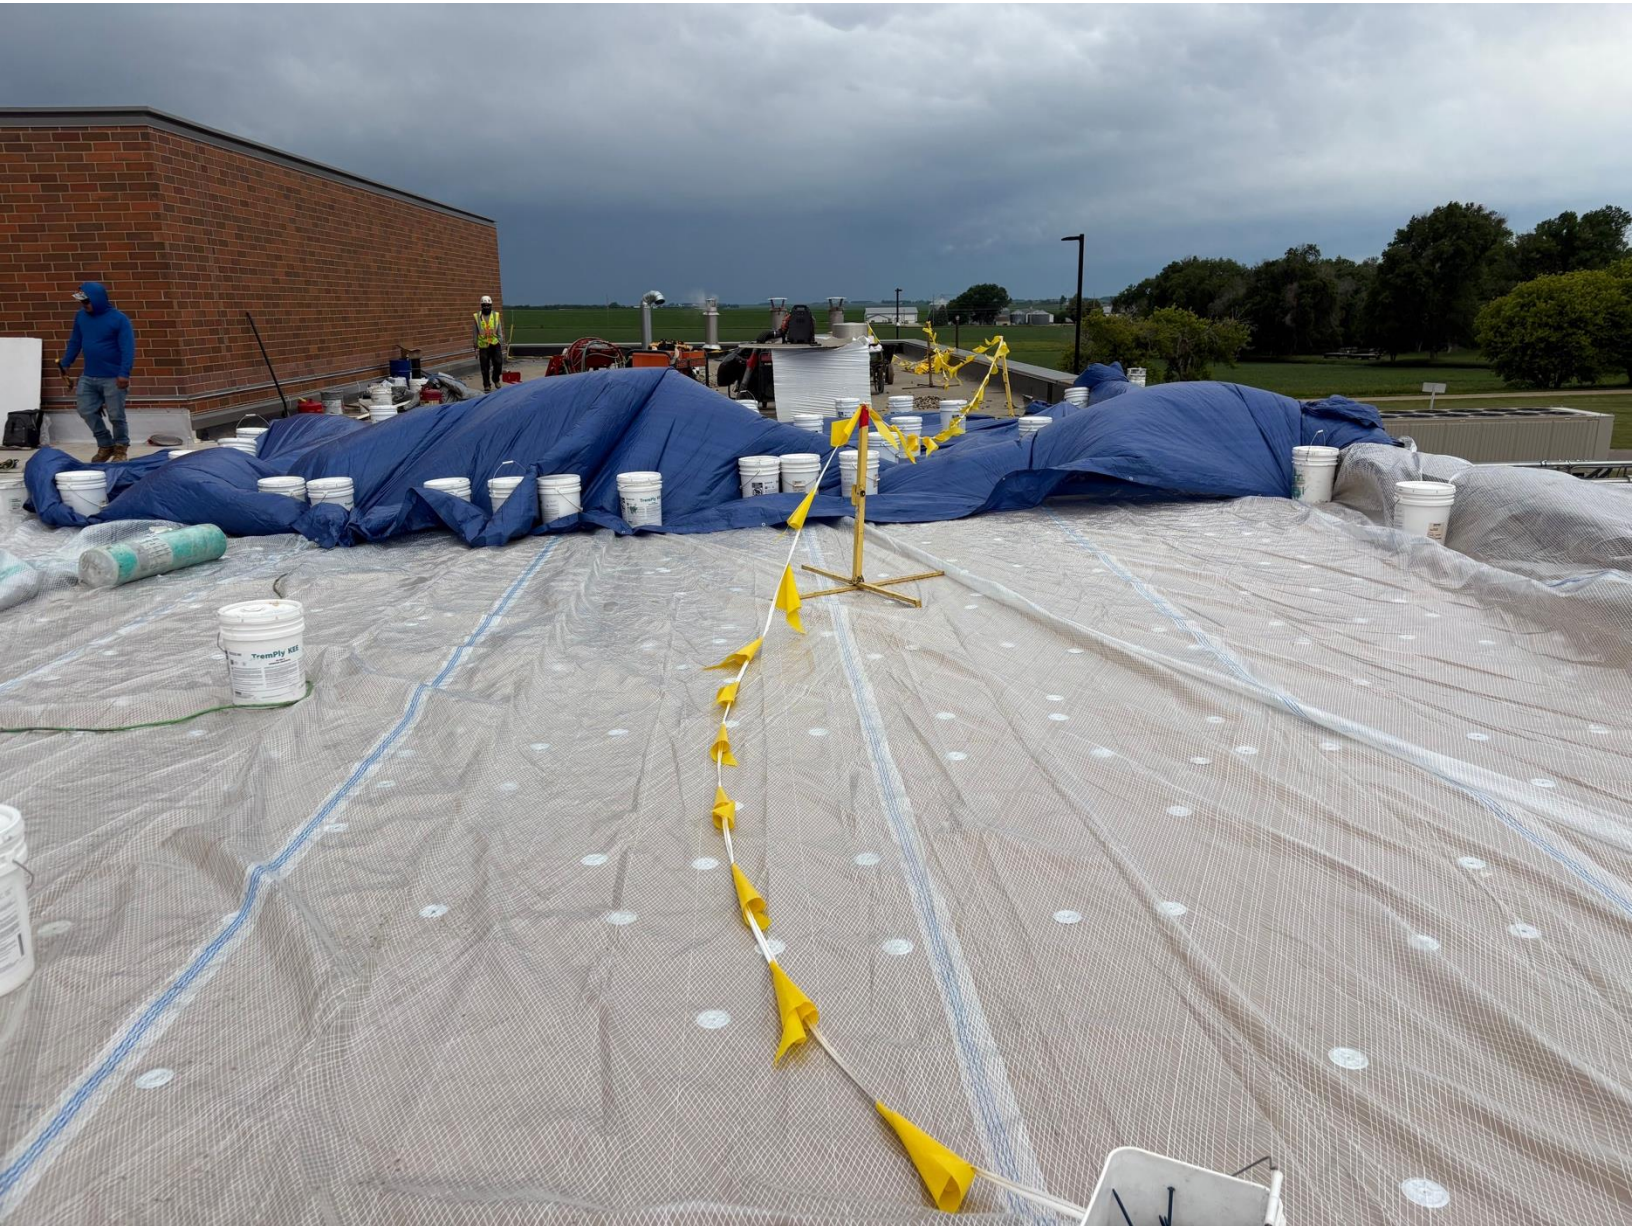
Tied off Roof Area #1 prior to storm
