ROOF PROGRESS REPORT THROUGH 06-19-2026

| Contractor: | Black Hawk Roof Company |

Areas of Work: Roof Area 1, 3A, 3B

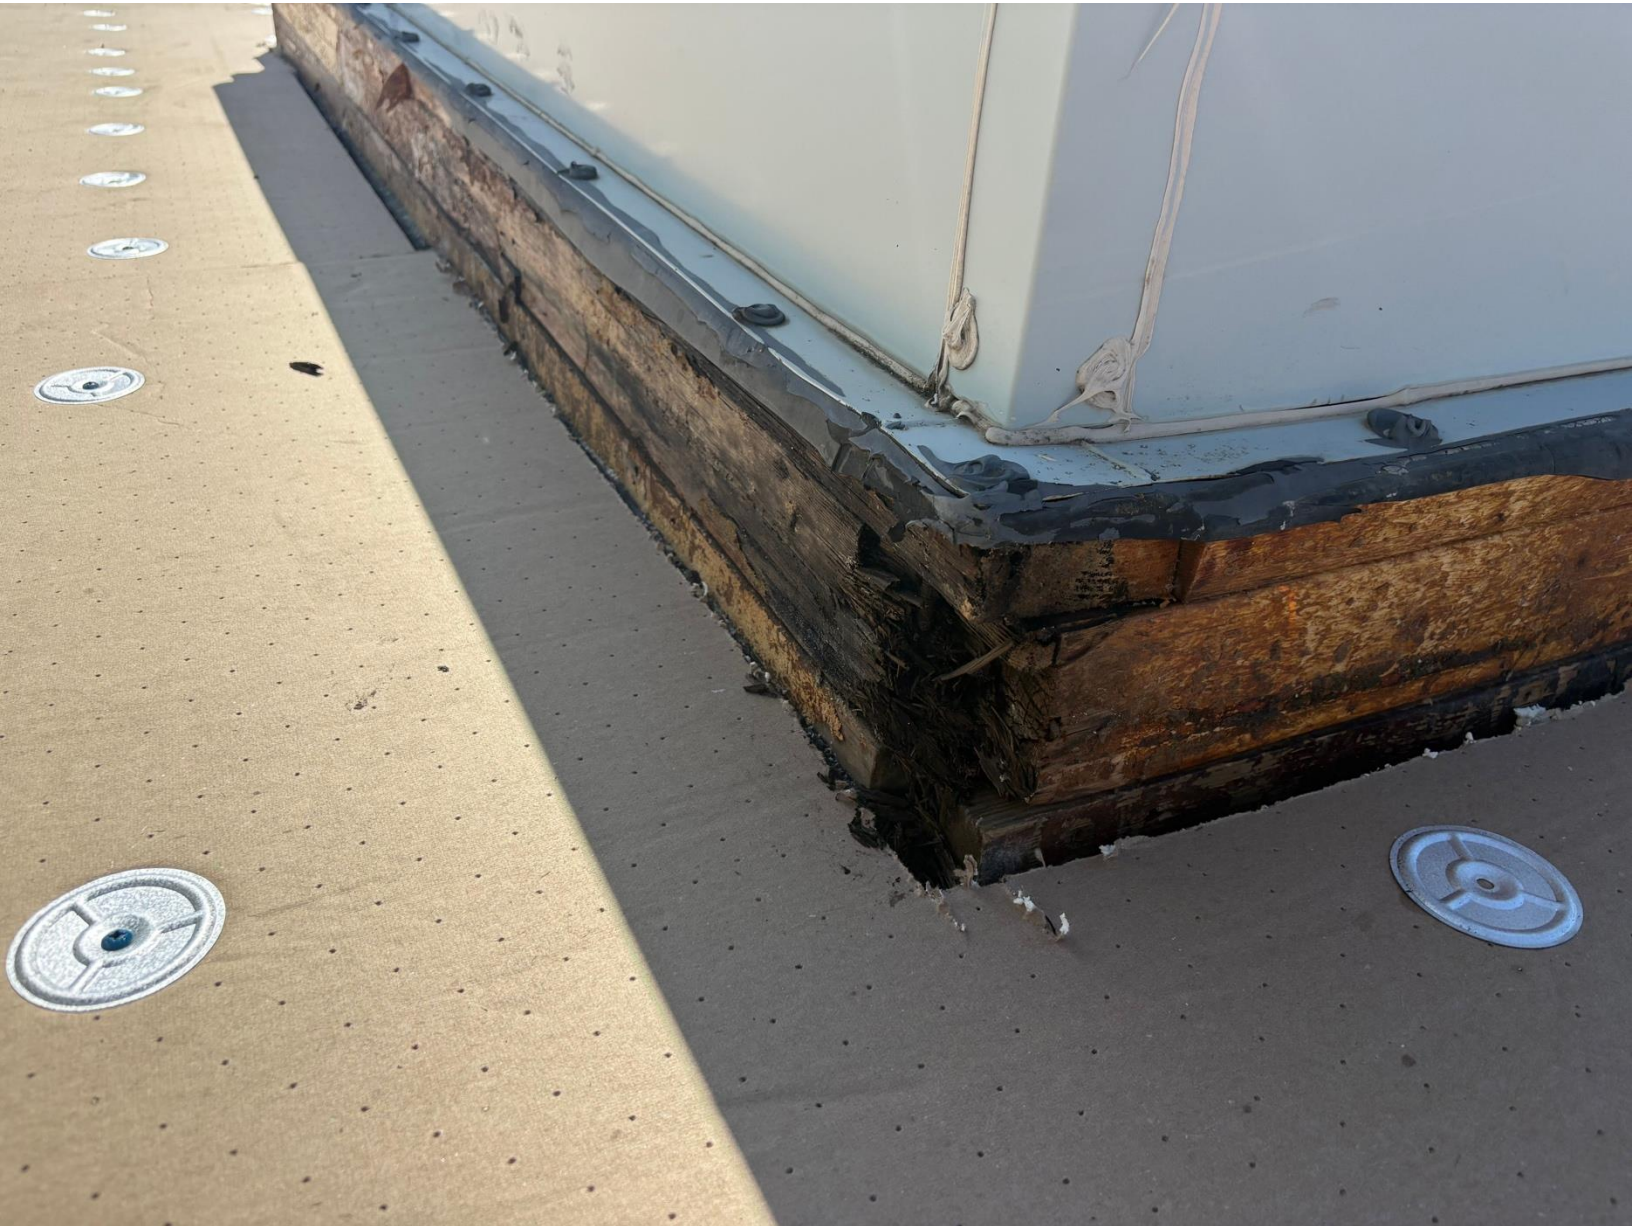
Deteriorated wood blocking was identified and replaced on Roof Area #3A

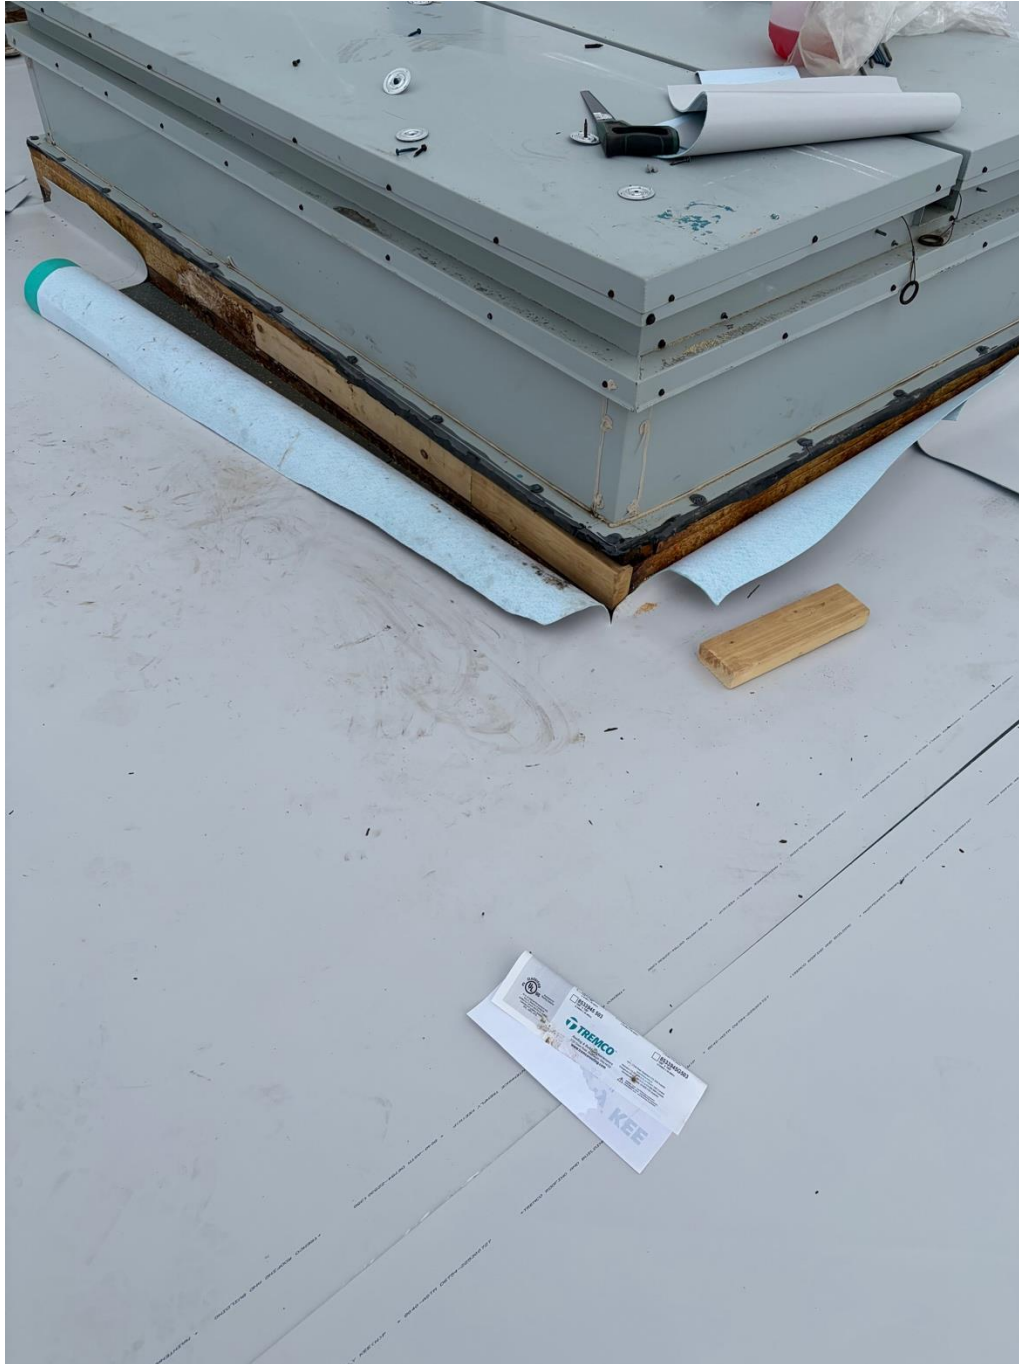
Deteriorated wood blocking was removed and replaced with 5 linear feet of new 2x4 lumber

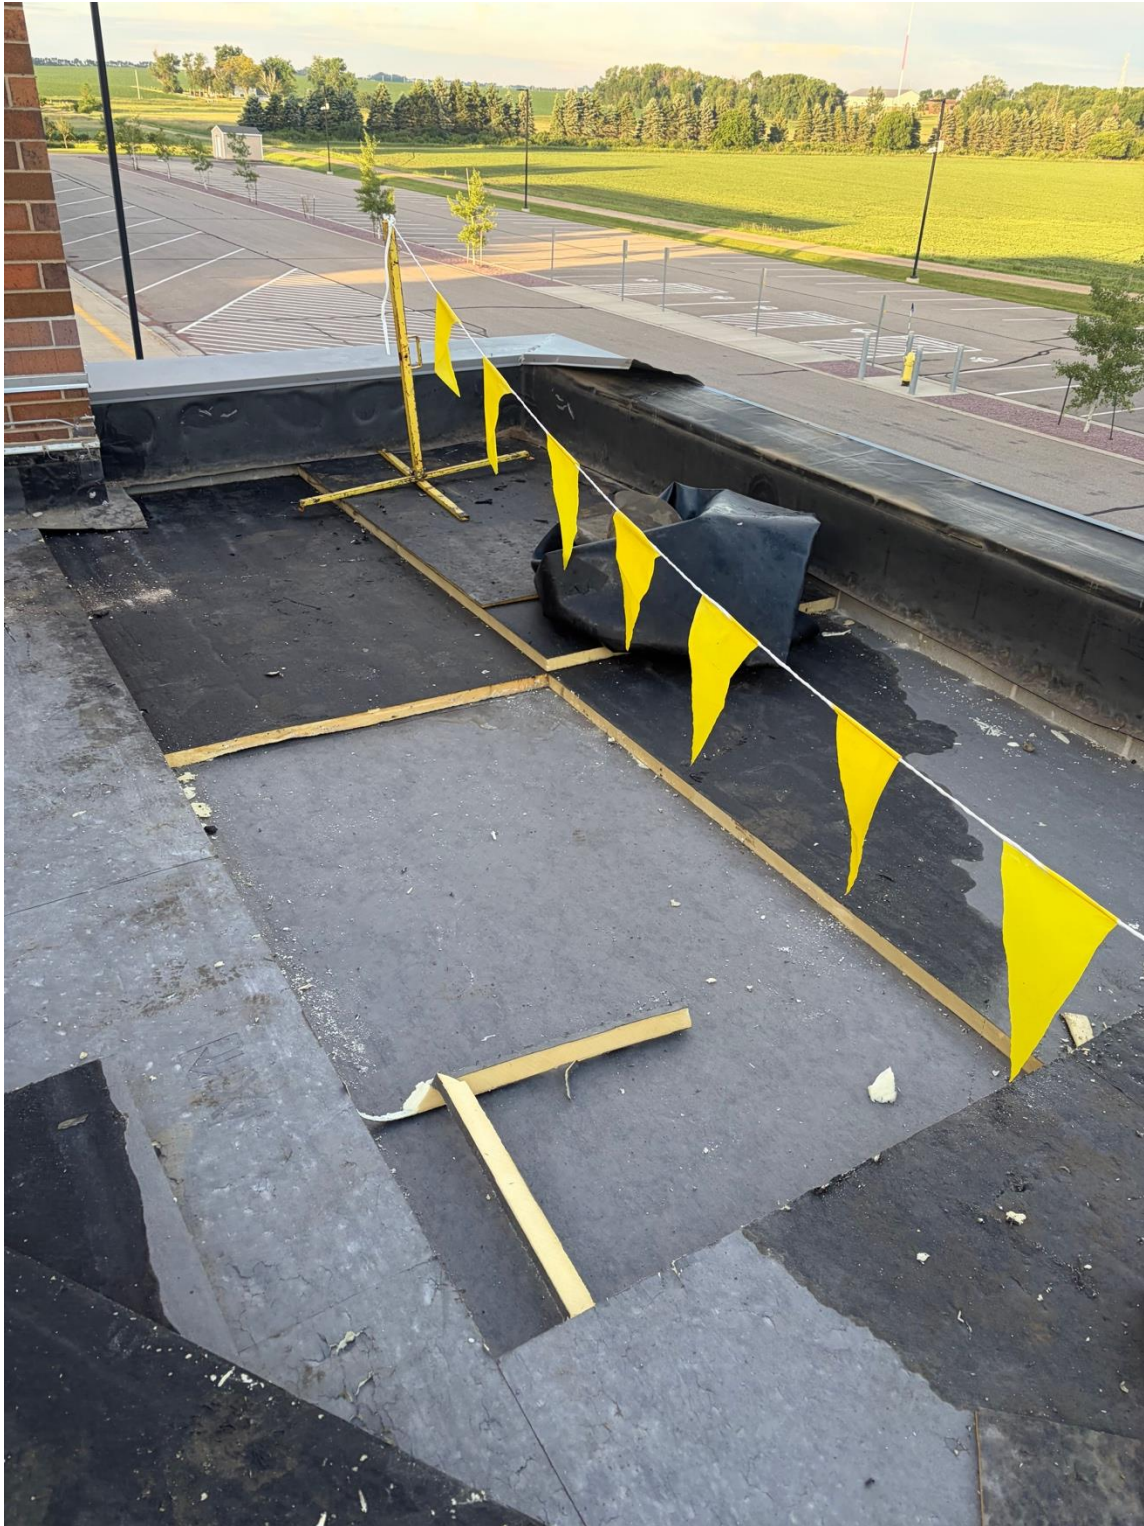
Identified and replaced 8 x 16 of wet insulation on
Roof Area #1

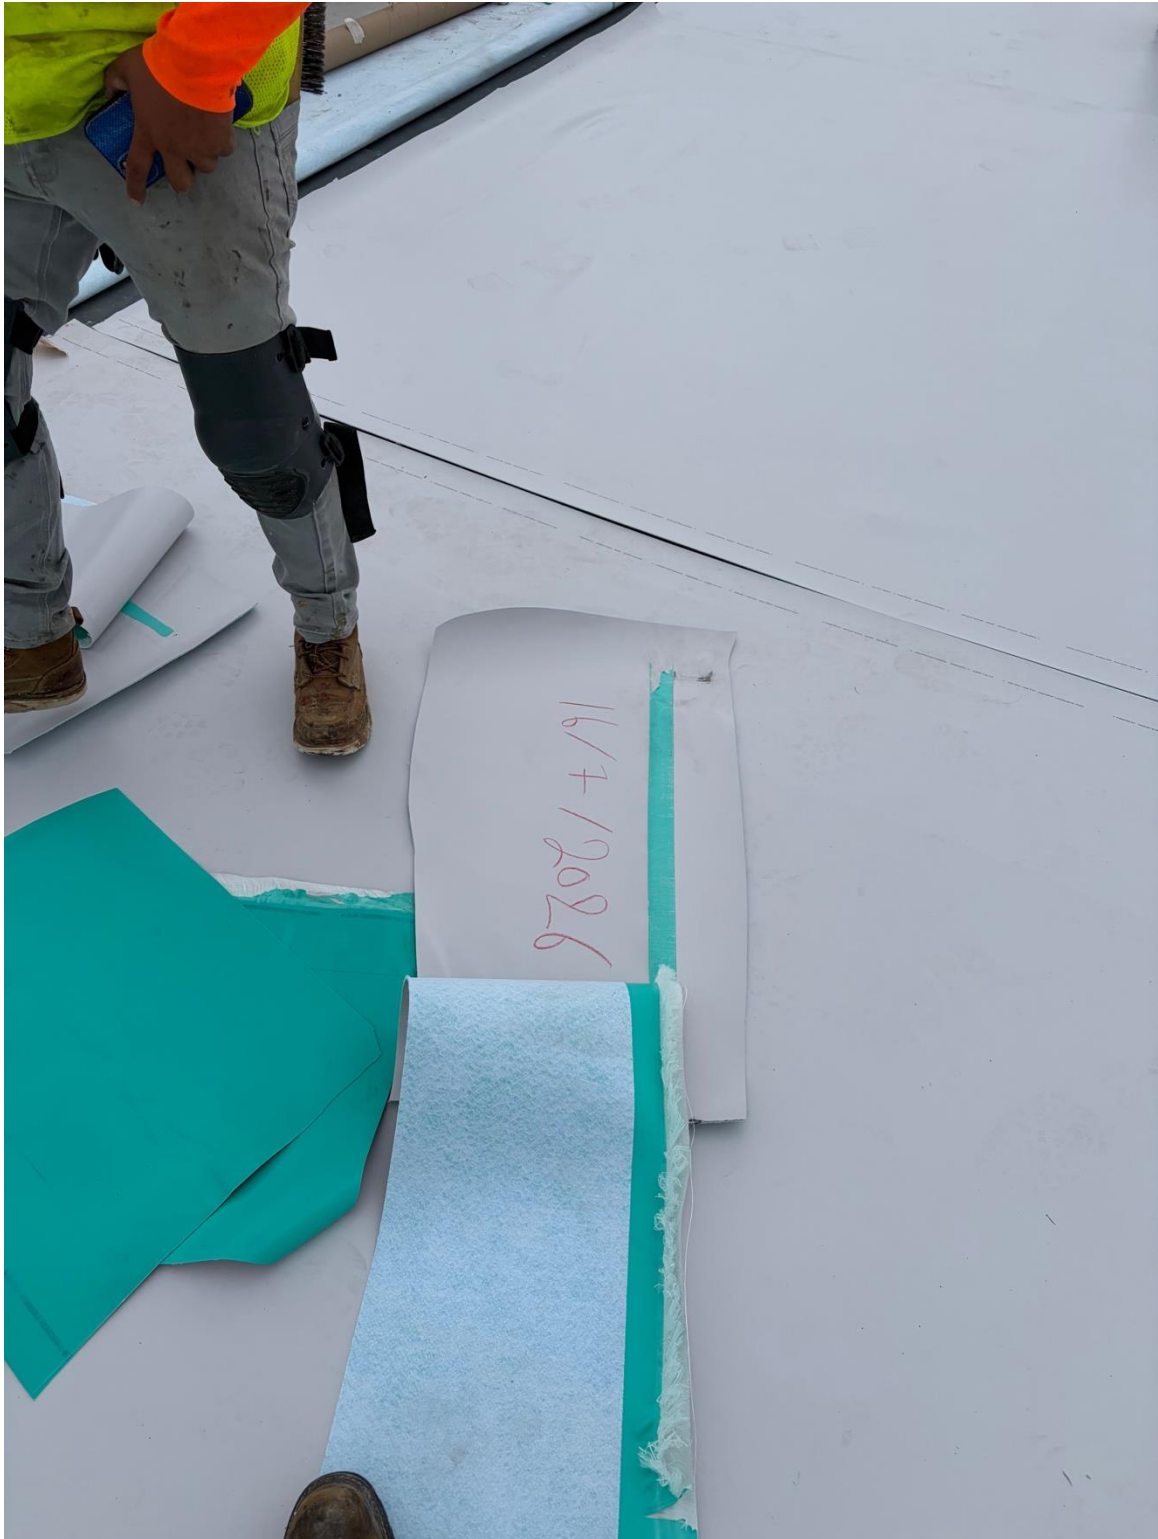
Daily Weld Test

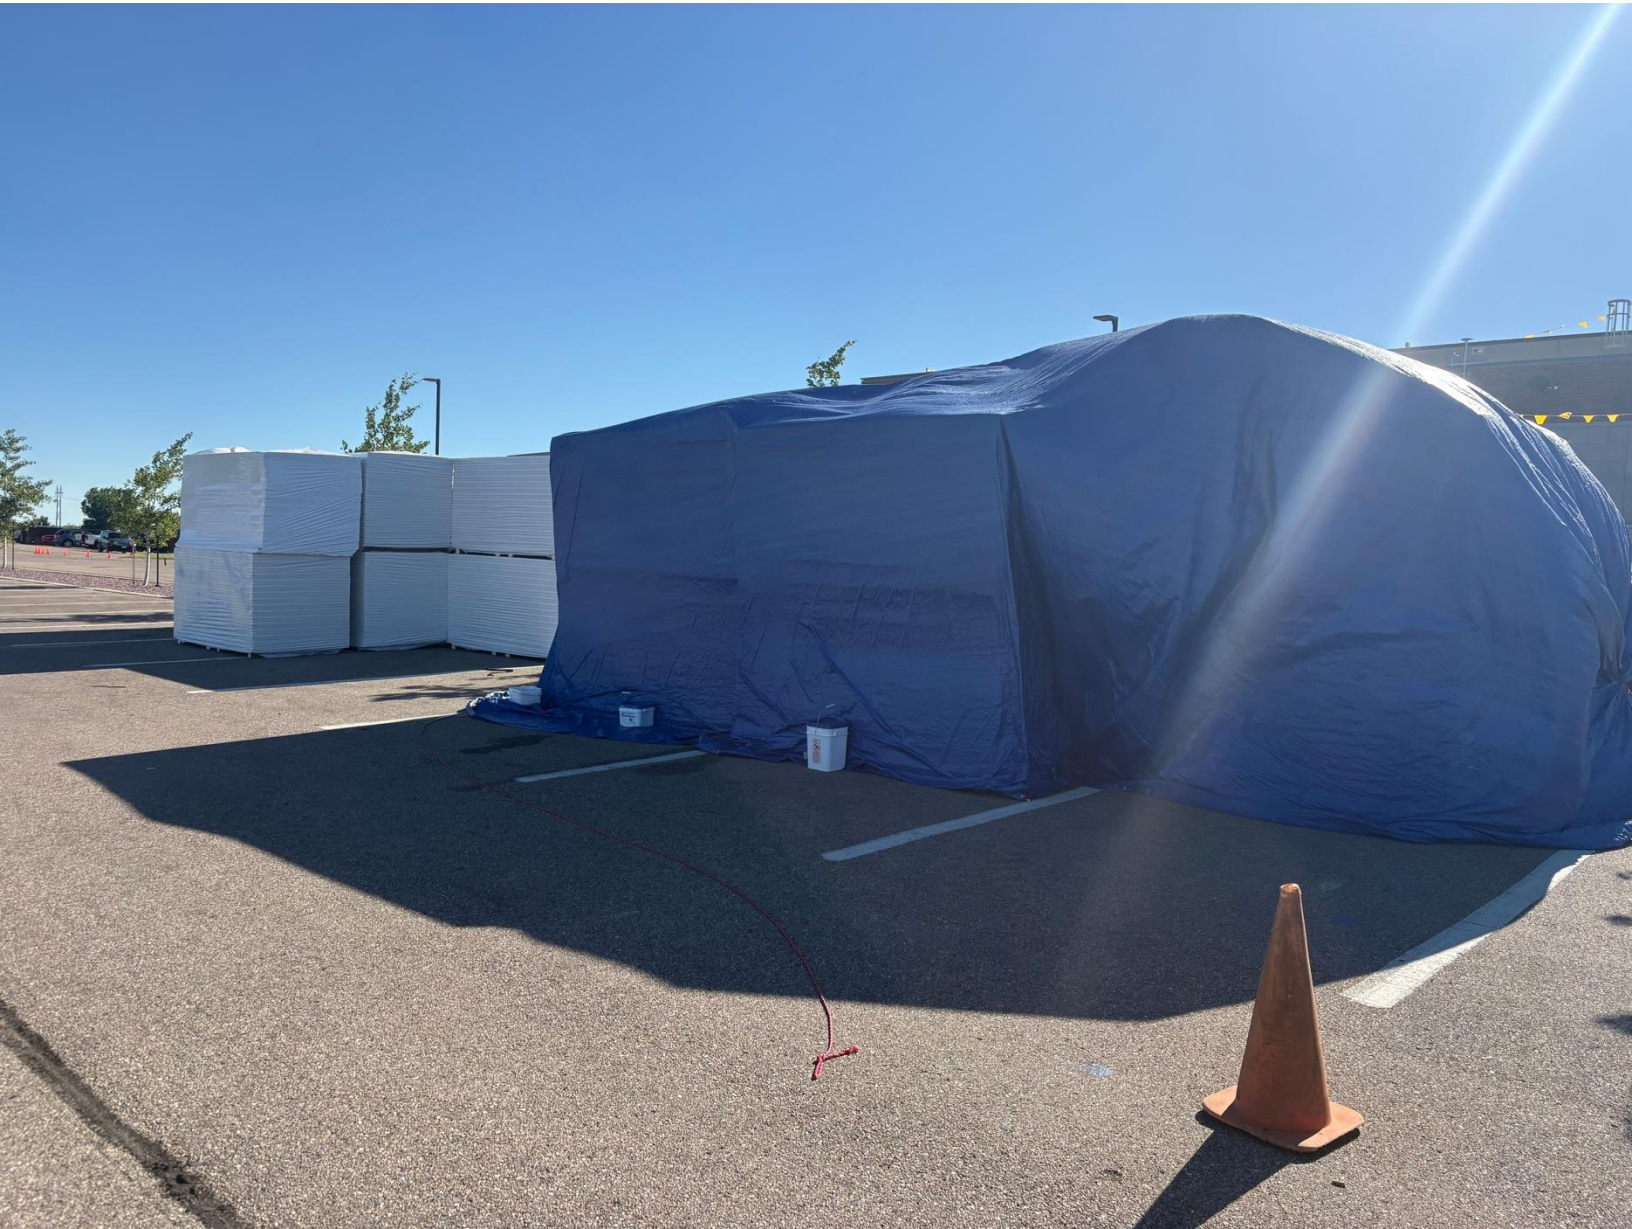
Staging Area located in west parking lot of school
