June Facilities, Finance & Operations Committee Meeting

**Subject:** 5 Year IAQ Report

**HVAC Ventilation Review**  
**Weston School District**  
**Intermediate School**

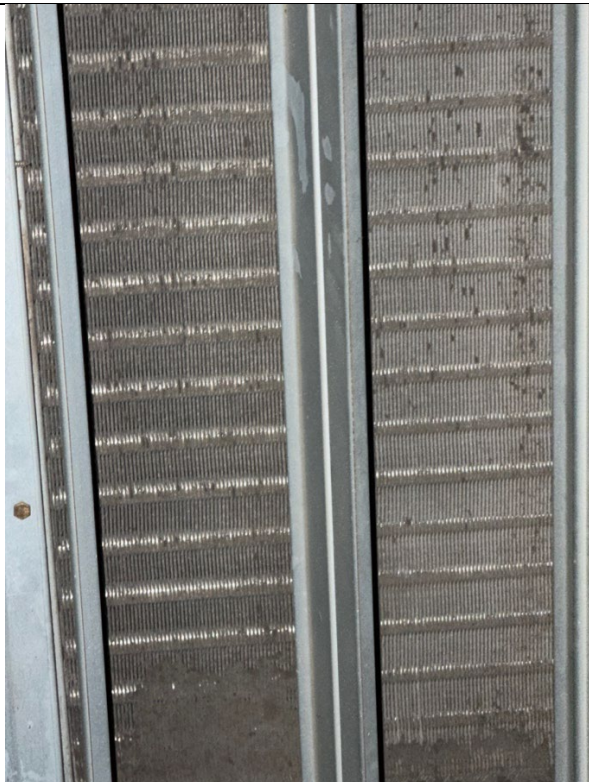
Dirty coil face inlet

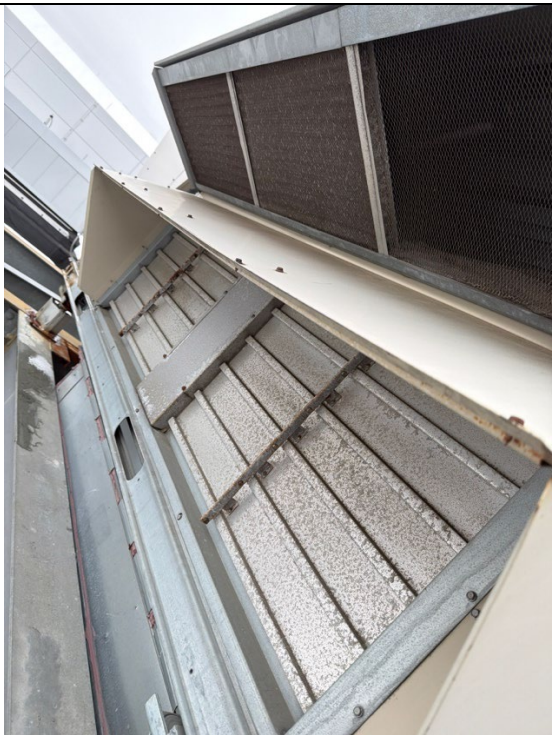
| Outdoor Air | Packing material at OA inlet screen has blown out |
| | Inlet screen fill has broken loose<br>– top<br>Relief dampers – bottom<br>(powered exhaust fan behind dampers) |

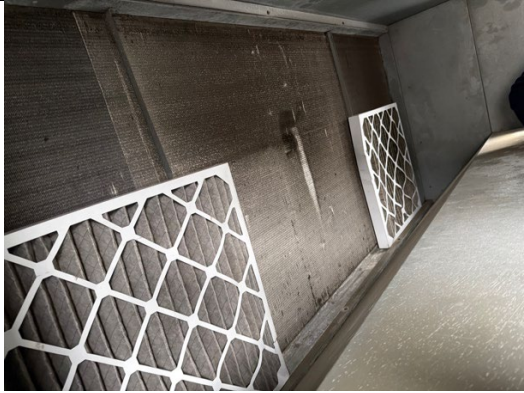
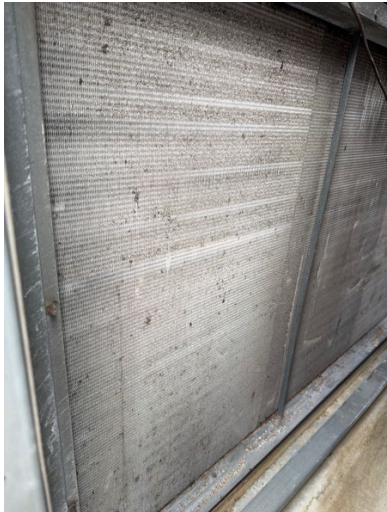
| Filters | 2 inch MERV-8. Filter blown out of rack. |
| <br> | Found filter blown out of rack and dirty coil inlet face |

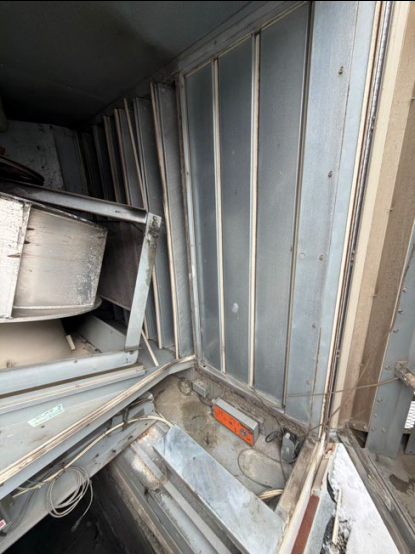
| | <p>OA damper right – wire wrapped around bottom of blade<br/>Return dampers left</p> |

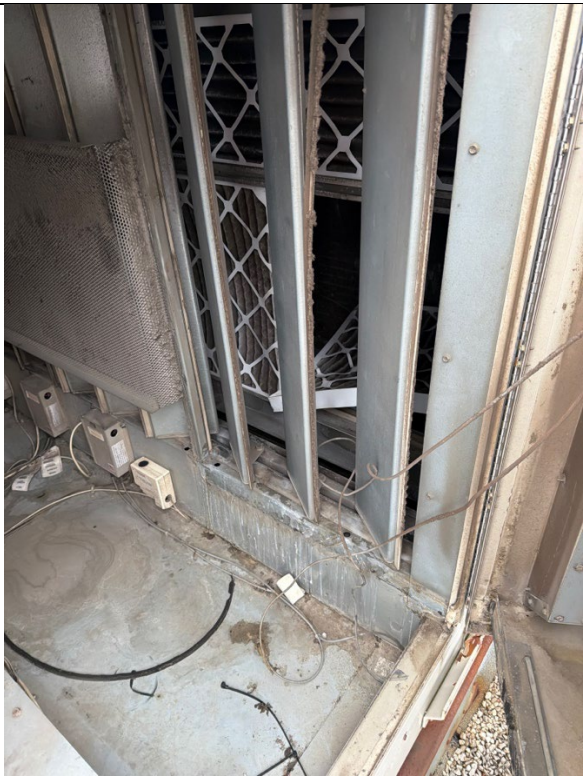
| RTU-6 | AFMS wiring is loose and sticks through OA damper opening. |

| | Outdoor air damper – filter blown out behind damper. Wiring is looped through damper blades. |

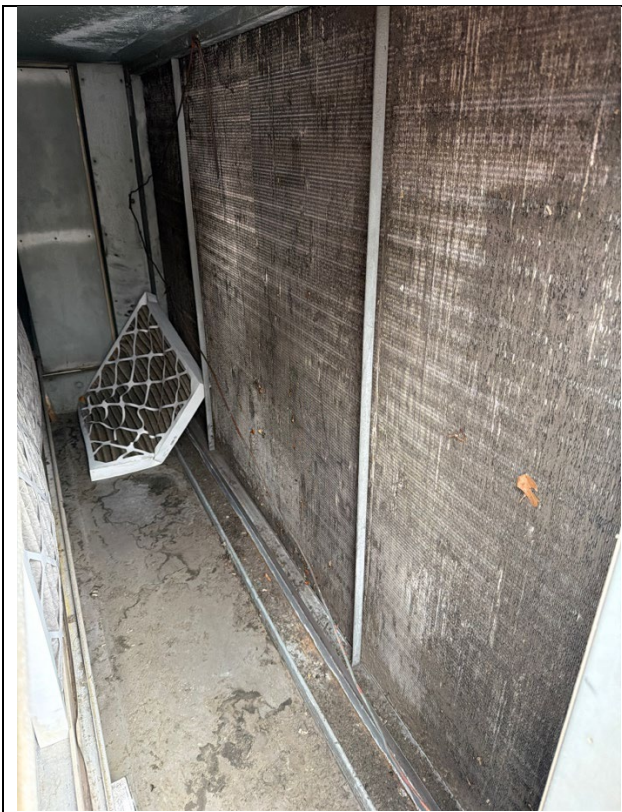
| RTU-6 | Found filter blown out from rack and dirty coil inlet face. |

Dirty coil inlet face. Filter blown out.

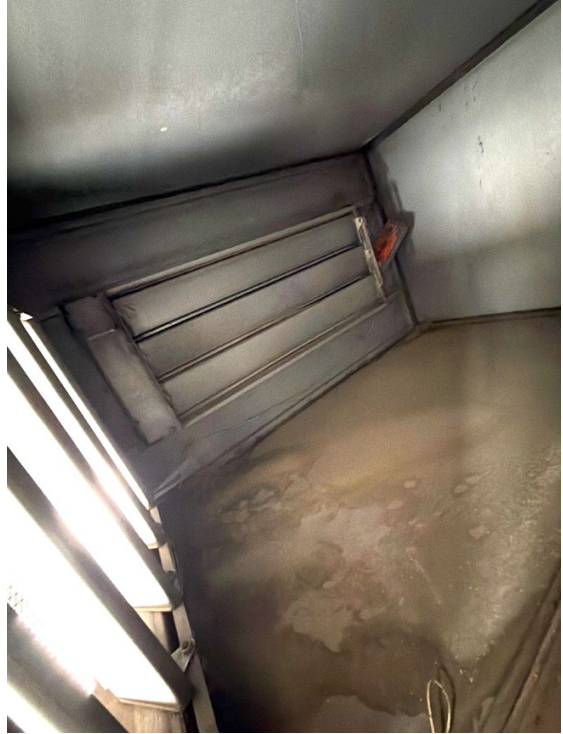
| | | <p>Damper is open when unit is off. Is actuator connected to closed damper? It is at an odd angle.</p> |

- RTU damper actuation should be verified. Observations noted some dampers open when the units are off or not closing completely. A relief damper that is erroneously open could contribute to the observed reduction in system air flow by exhausting excess return air.

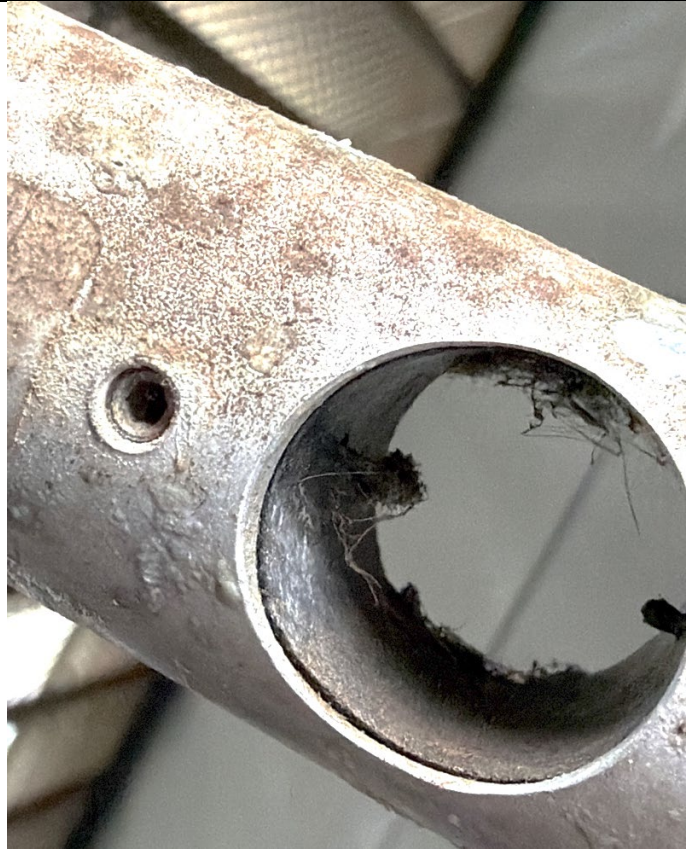
| A close-up photograph of a circular opening in a metal surface. The interior of the opening is dark and filled with a significant amount of debris, including what appears to be a large, dark, irregular mass and some fibrous material. | <p>Significant debris on outdoor air flow sensor element.</p> |

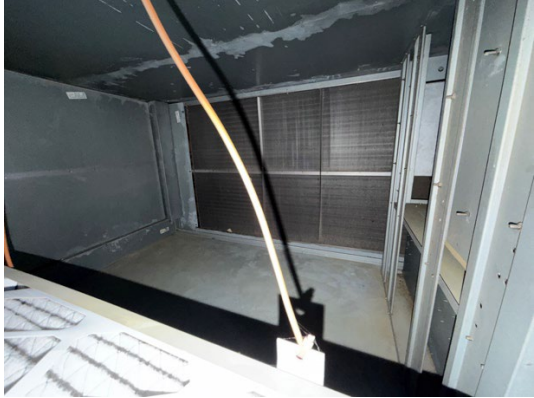
| | <p>Coil inlet face. Some dirt at bottom of coil.</p> |

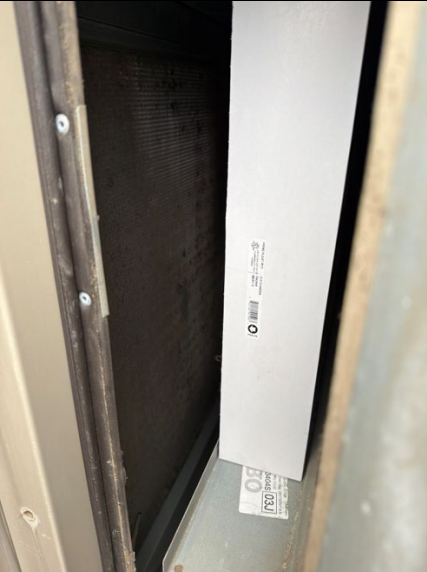
| | Filter racks are missing blank off plates at the end of the filter allowing air to bypass filter and clog coil |

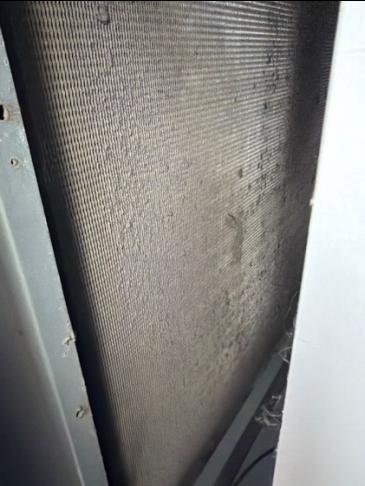
| | <p>Dirty coil inlet face</p> |

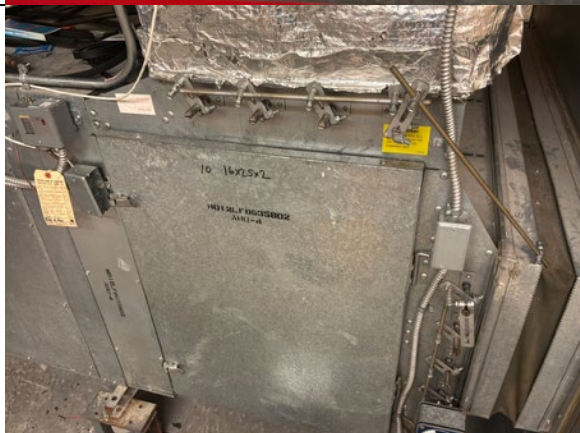
| Outdoor Air | Damper linkages are disconnected<br>Control actuator is disconnected<br>OA is closed<br>RA is loose and easily moved – found closed |
| | Return damper linkage connection to actuator is loose.<br>Outdoor damper linkage is disconnected |

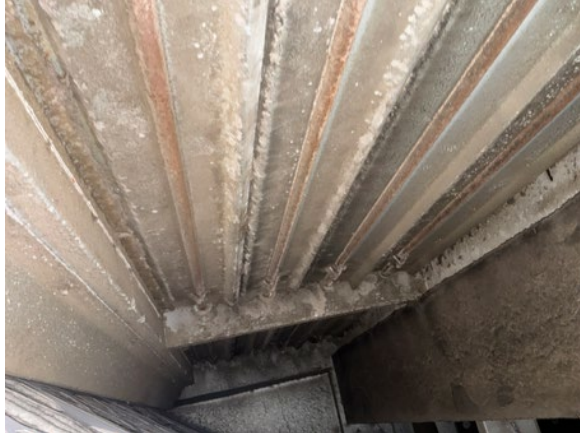
| | Outdoor air damper (top) is closed |

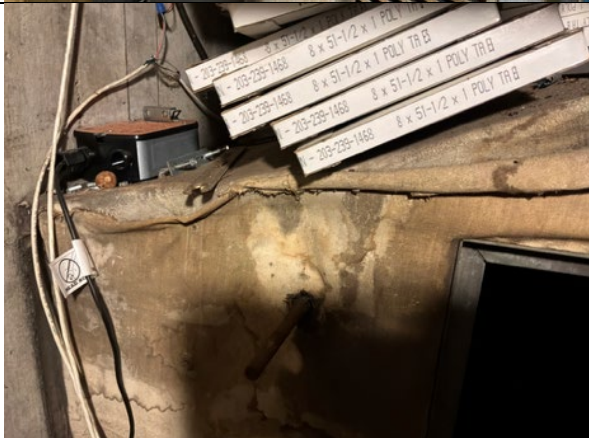
| Outdoor Air | Damper linkages are disconnected<br>Control actuator is disconnected<br>OA is closed<br>RA is open |
| | Damper actuator disconnected and set on top of unit |

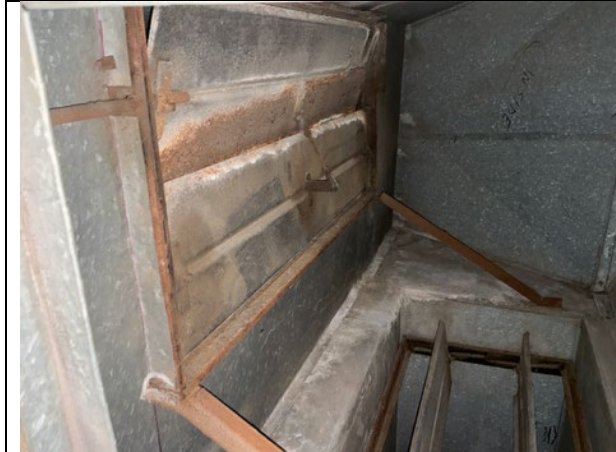
Outdoor air damper (left) is closed with one blade cracked open  
Return damper (bottom) is open

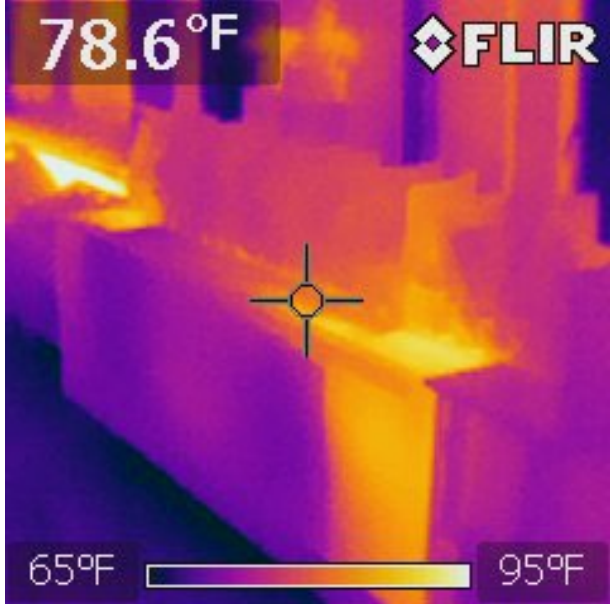
| | <p>Room N17<br/>End of unit with heat control valve stays hot</p> |
