Work Session with Vote on Consent
Agenda
Tuesday, November 18, 2025 6:00 PM

Building Assessment Report

PPS One North Commercial Building Inspection
2025-1106

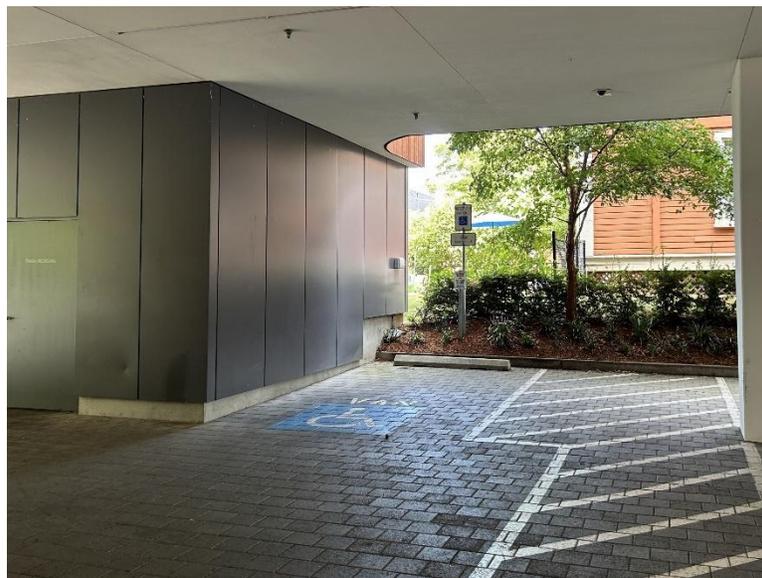
Figure A-6 Karuna II East Van Accessible parking signage non-conforming

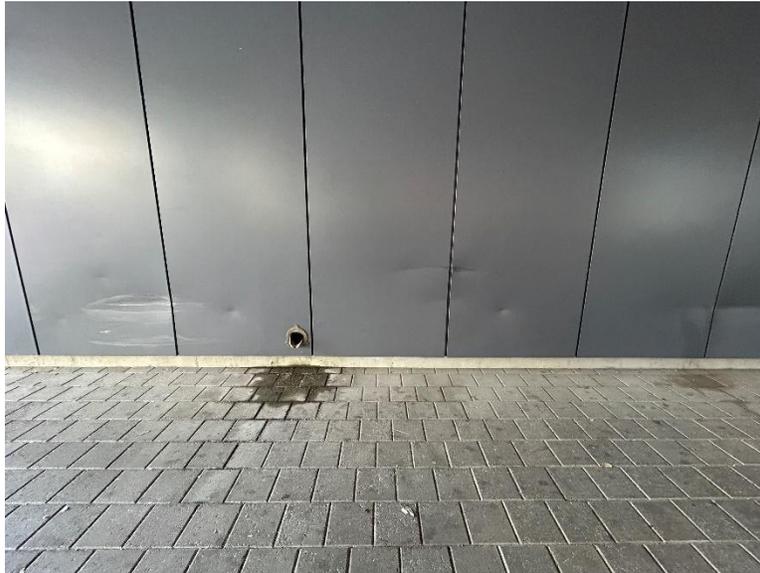
Figure A-10 Karuna II East parking wall damage from cars

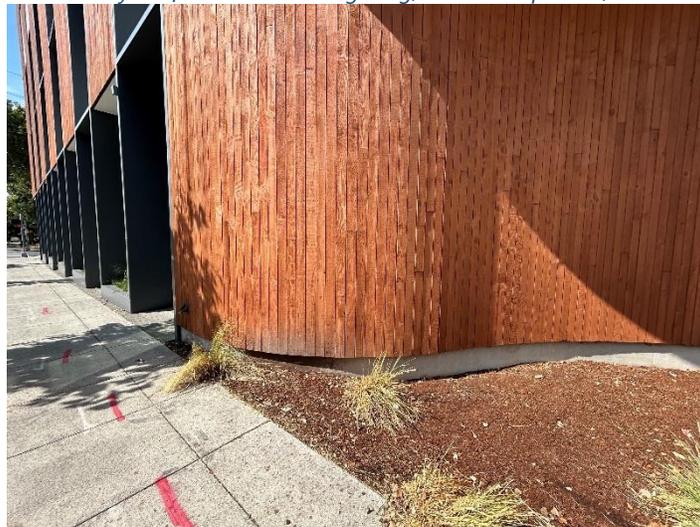
Figure A-15 Karuna II West southeast building corner at Fremont. Base of wood siding less than 7 inches above ground level. Debris on wood veneer. Grass plantings are fair to poor condition.

- Maintain wood veneer, sealants, and roof flashings proactively.
- Repair uneven courtyard paving system, particularly at paths along building entries/ exits.
- Evaluate bicycle parking for zoning compliance.

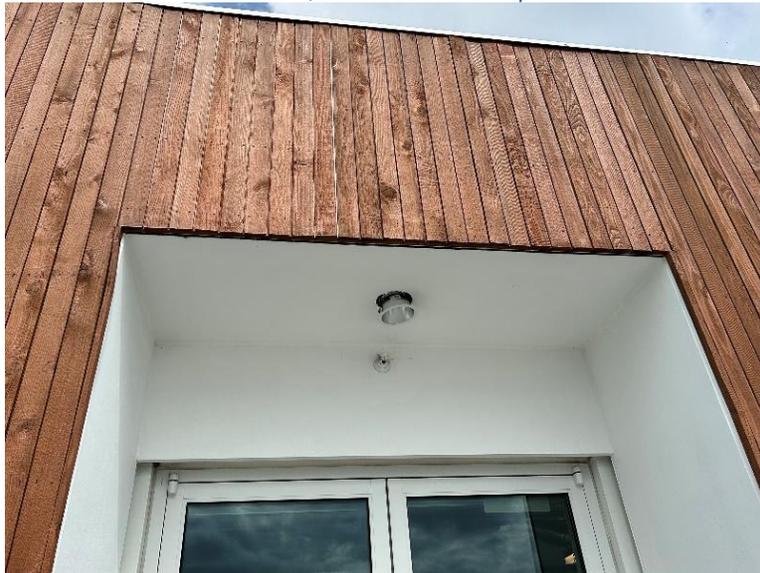
*Figure A-21 Karuna II West South terrace doors in alcove with sprinkler and downlight.
Downlight repair recommended.
South terrace at level 2.*

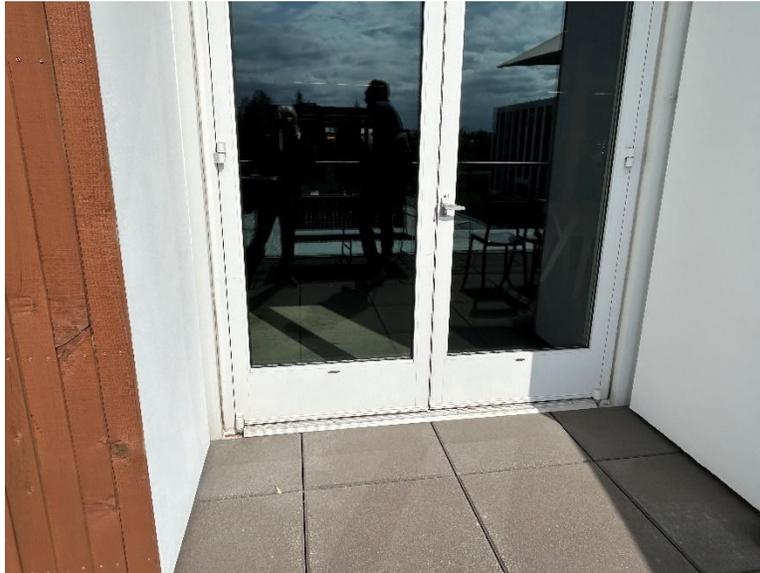
Figure A-22 Karuna II West South terrace door alcove from tenant space. Verify terrace door opening forces conform with accessible requirements.

- Install and secure roof drain strainers where missing.
- Improve roof walkway access around solar panels for code compliance.
- Repair sagging mechanical screen enclosure gates.
- Verify terrace door opening forces meet accessibility standards.
- Consider additional fall protection measures with PPS standards.

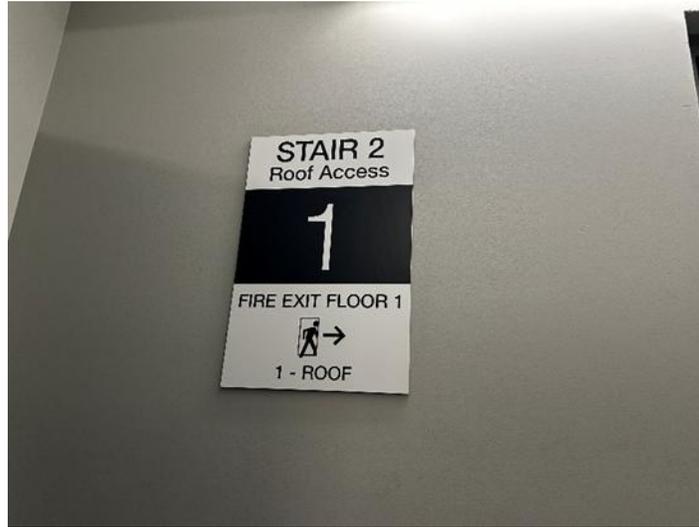
Figure A-34 Karuna II West and East Stair signage conforms with code.

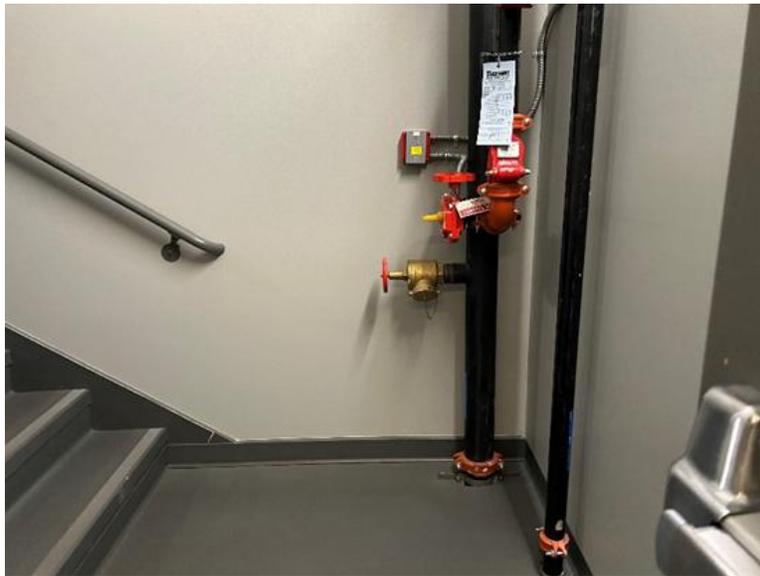
*Figure A-37 Karuna II West and East stair landing walk lines.
Fire standpipe drain valve beyond walk line conforms with codes.*

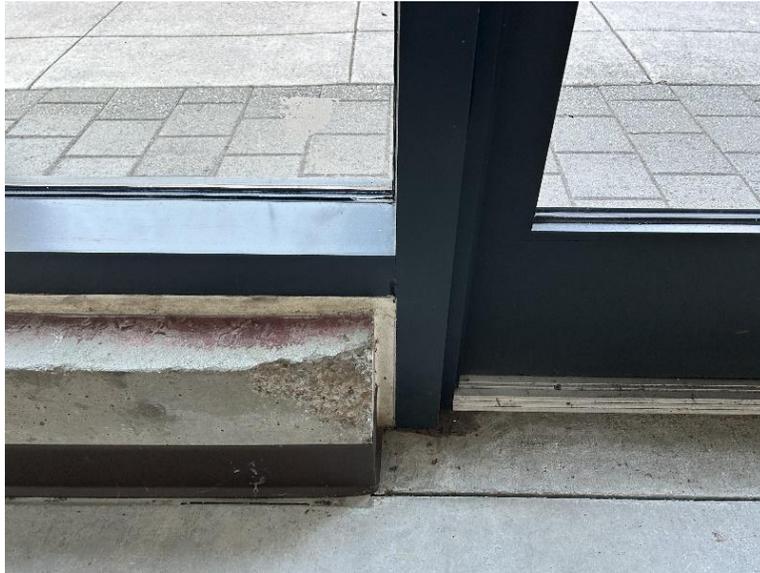
Figure A-50 Karuna II West Level 1 Storefront sill at curb condition

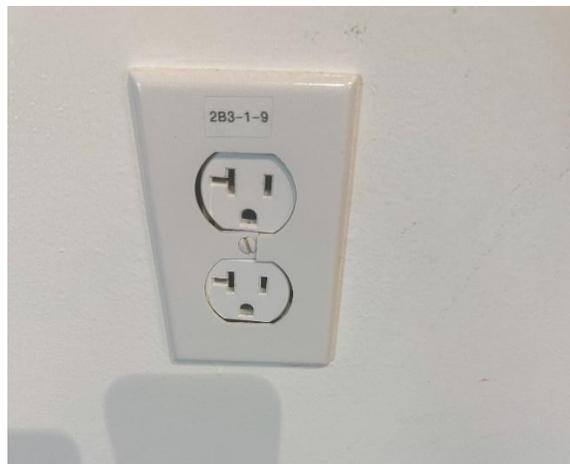
Faceplates on some receptacles are cracked. Recommend replacing faceplates as needed.

Figure E-80 - Cracked Receptacle Faceplate

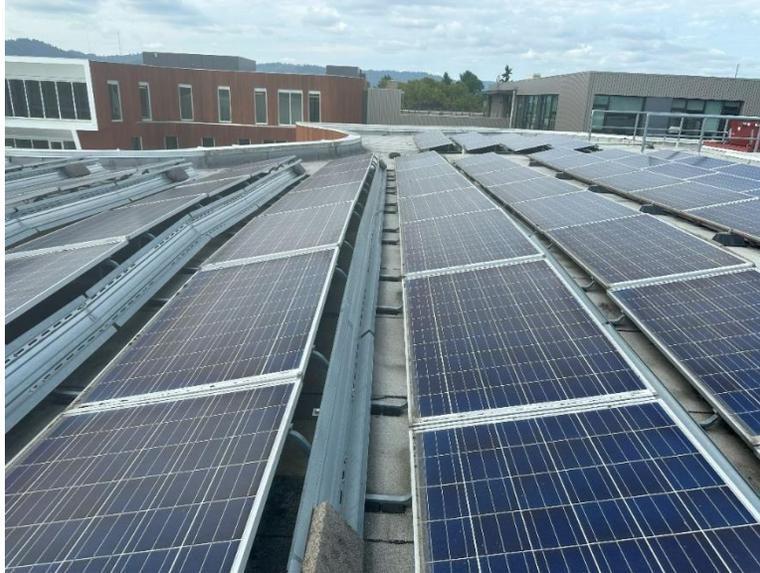
Figure E-81 - PV Array on Roof

There are (2) 23 kW PV arrays located on the roof. An inverter and PV disconnect for each array are located in a recessed enclosure in the exterior parking area. DC disconnects are located on the roof. The PV arrays appear to be in good condition, however debris is building up at the bottom portion of the panels and should be cleaned. Consider a maintenance and cleaning plan for the PV arrays.
