## **Board of Education Study Session**

School District of Seward

# Condition Summary

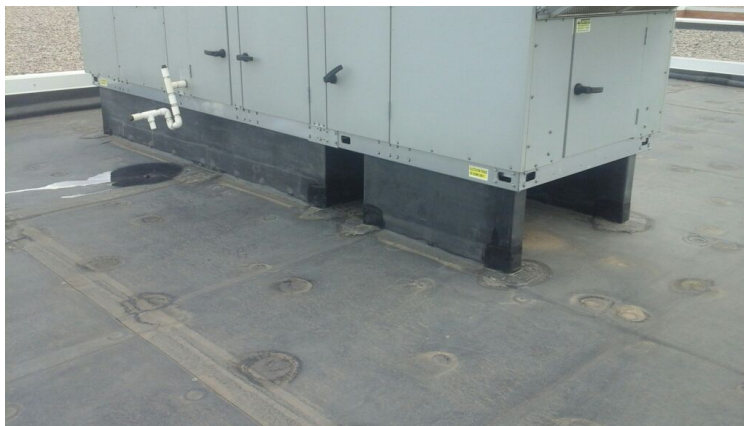
This roof is in good condition. There is some ponding water around the central drain do to missed taper design. There was one hole found in the field membrane.

Photo showing ponding water due to lack of sump.

I recommend patching hole and continued inspections and maintenance.

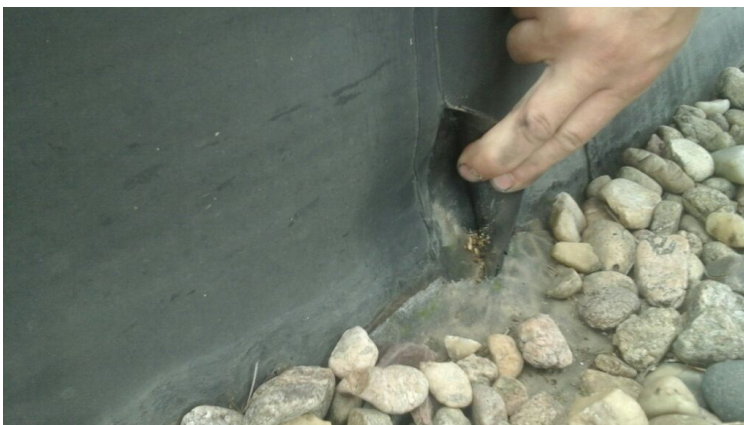
This roof is in fair condition due to the aging and tenting perimeter flashings. There were several areas where flashing patches were pulling loose.

Photo showing patch pulling loose on perimeter flashings.

I recommend repairing holes and monitoring perimeters which may eventually need to be relaxed. I recommend continued inspections and maintenance.

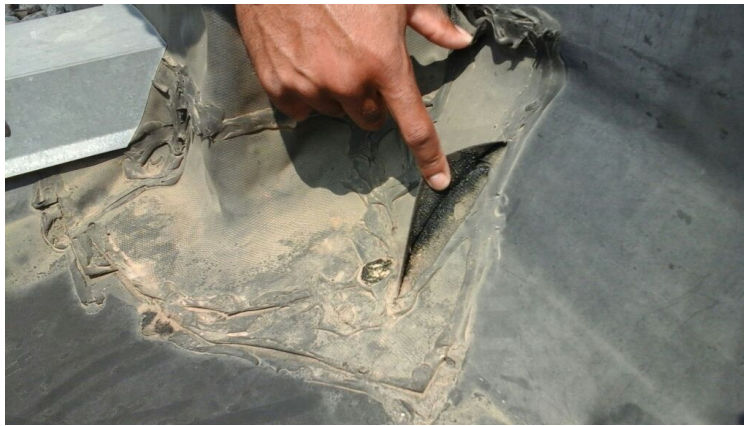
This roof is in fair condition and has deterioration around the projection and perimeter flashing seams due to age.

Photo showing additional blowout patch pulling loose.

I recommend restoring the problem areas in the flashings and continued inspections and maintenance to extend the life of this roof. The estimated budget number for restoring this roof is \$30,000.

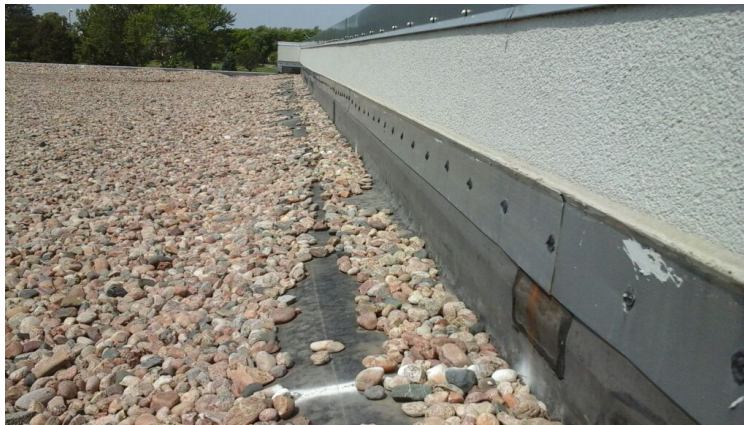
This roof is in fair condition but has several areas where blowout patches are beginning to pull loose. There was also a hole found in the perimeter flashing that was open down to deckin.

Photo showing a blowout patch in the perimeter flashing beginning to pull loose.

I recommend restoring the problem areas in the flashings and continued inspections and maintenance to extend the life of this roof. The estimated budget number for restoring this roof is \$30,000.

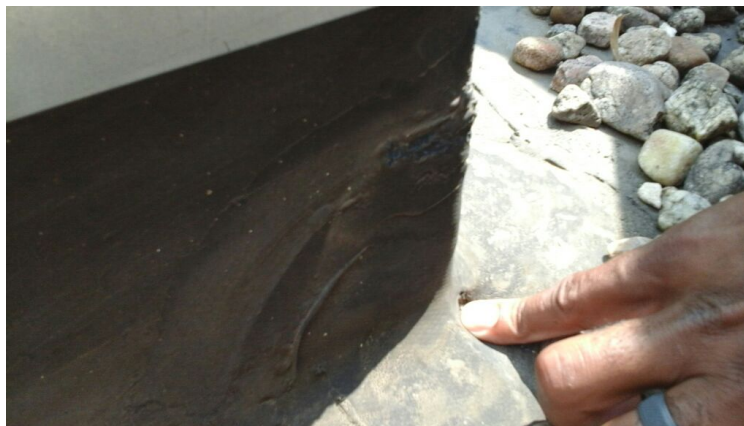
This roof is in poor condition. There are numerous holes in the projection flashings that need attention.

Photo showing another hole in a projection flashing.

I recommend scheduling a restoration on the problem areas of this roof as budgets allow. I also recommend continued inspections and maintenance. The estimated budget number for restoring this roof is \$50,000.

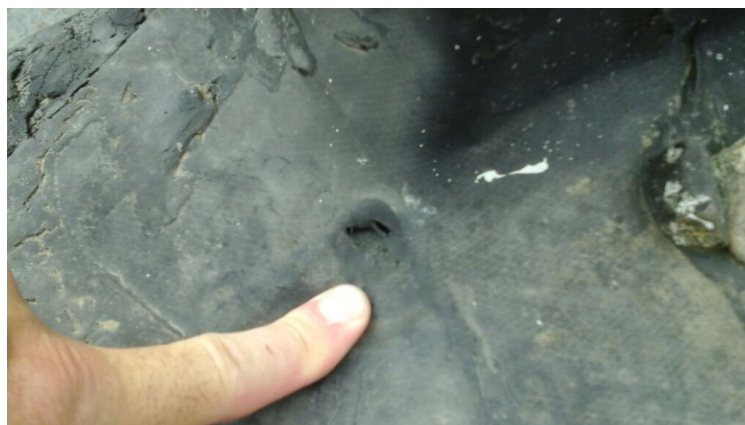
This roof is in fair condition and appears to be performing well. There may be future issues along the perimeter flashing along the EIFS that should be monitored. There was a hole found in the corner of the perimeter flashings.

Photo showing a hole in the projection flashing.

For future budgeting considerations the estimated restoration cost on this roof is \$15,000. The estimated replacement cost of this roof is \$65,000.

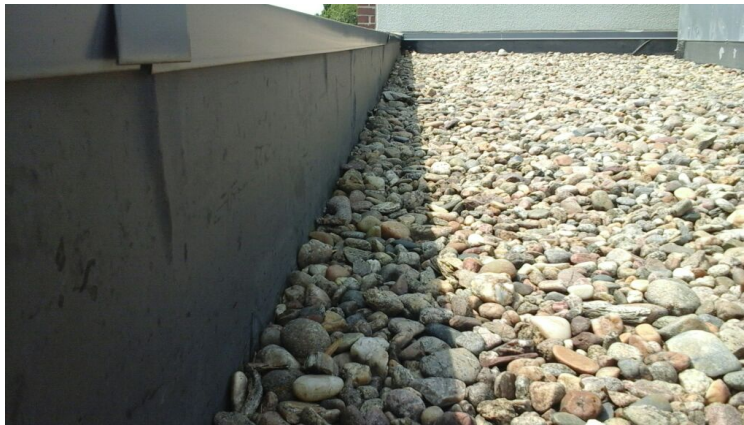
Photo showing condition of the perimeter flashings.

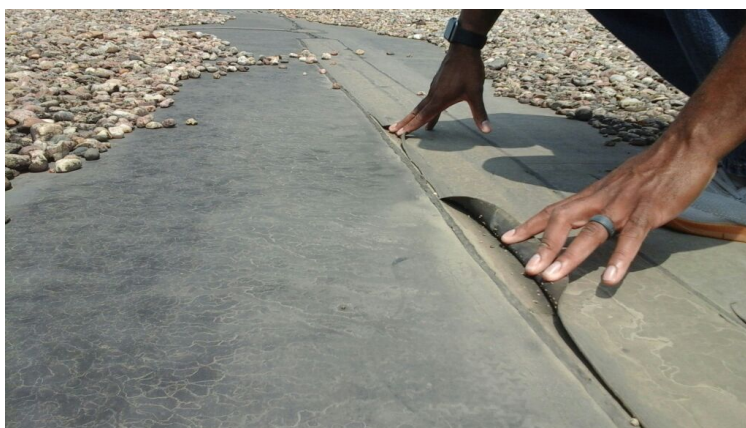
Photo showing patch along seam beginning to pull loose.

For future budget consideration the estimated replacement cost for this roof is \$70,000.

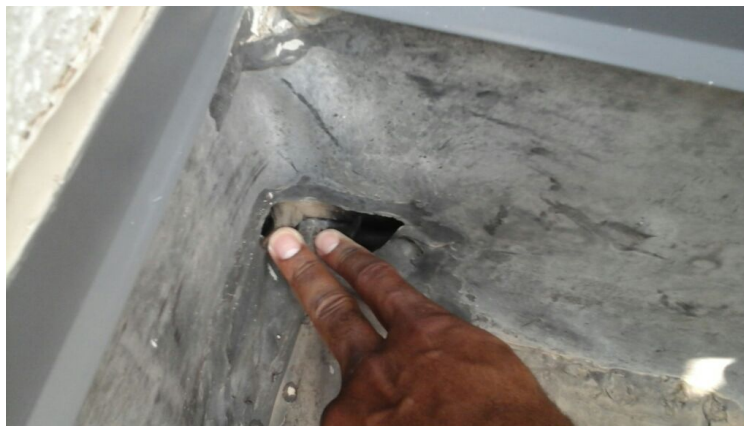
Photo showing patch in the perimeter flashing pulling loose.

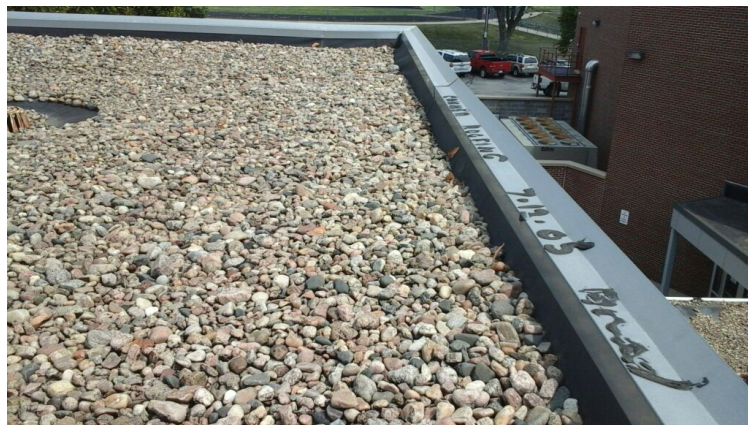
This roof is in fair condition and is beginning to tent and deteriorate along the perimeter flashings.

Photo showing form flashings opening up due to metal displacement.

I recommend restoring the perimeter flashings along with continued inspections and maintenance.
