City of Franklin
May 27, 2025 10:00 AM City Hall

3.b. Discussion and action report on the structural status report from Erickson Sullivan Architect (ESA) of the Marcellus building project for the NAHTF grant.

OBSERVATION REPORT

PROJECT: Franklin Apartments

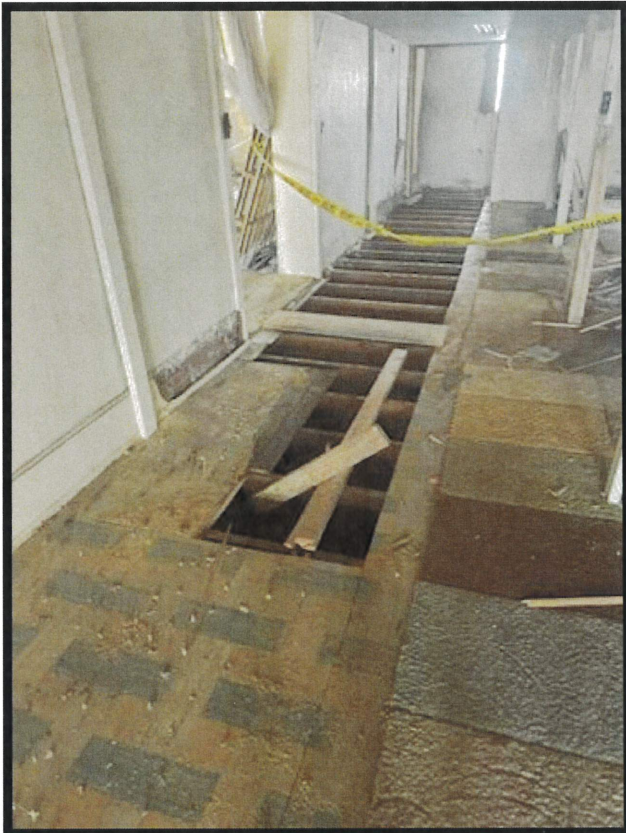
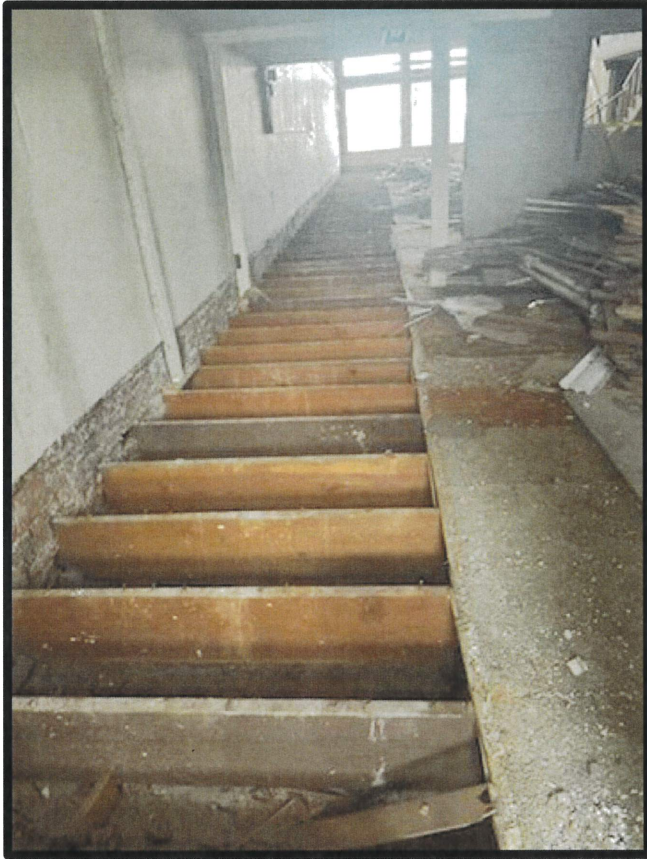
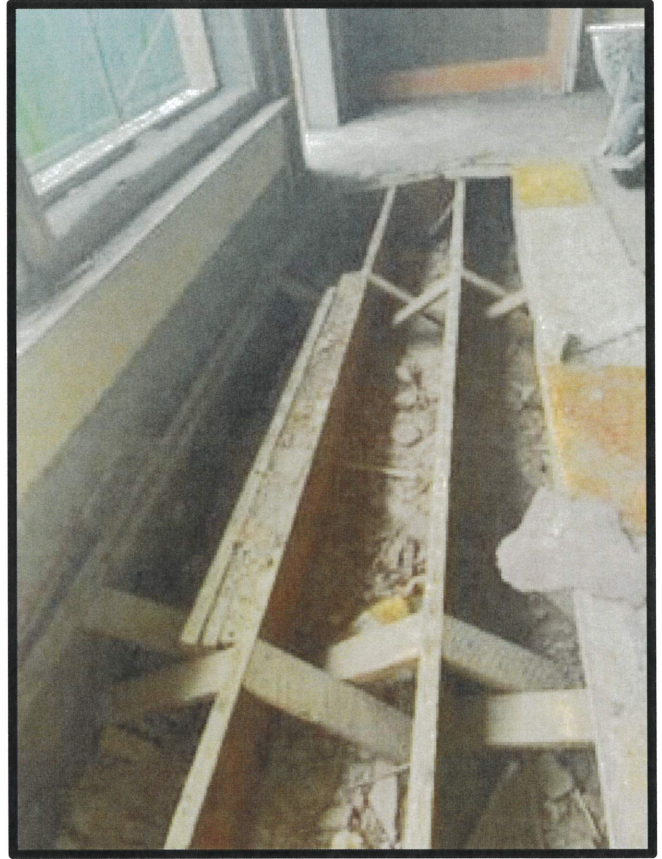
Midwest Plaster & Construction has proceeded with removing some of the existing floors in the north portion of the 1st floor. It is approximately 4' wide and to the extent depicted in the drawing and pictures.

Is Midwest Plaster & Construction replacing what they removed or how are we to proceed?

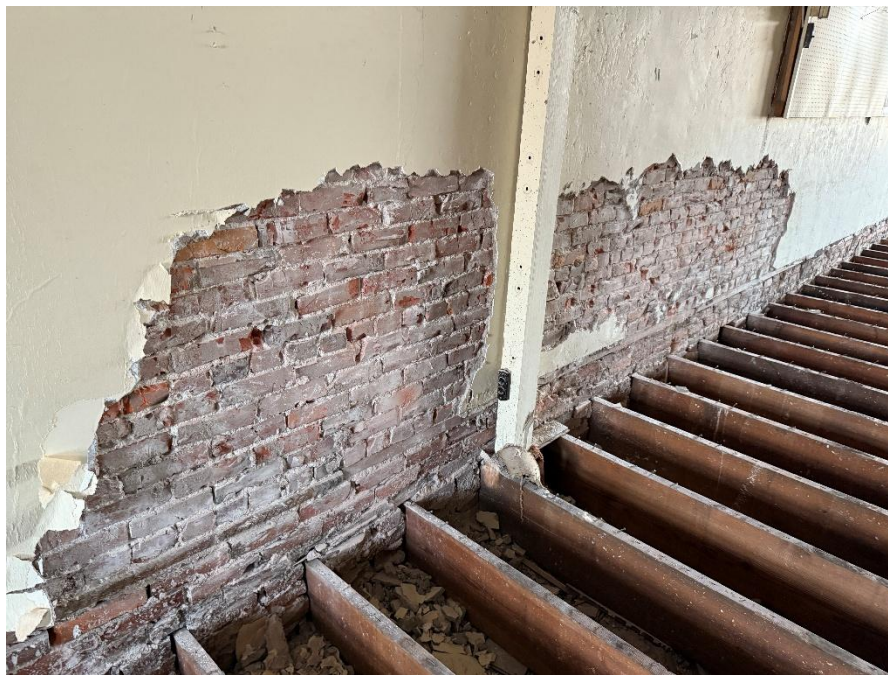
2. The plaster on the inside face of the first-floor north wall was more easily removed. See photo 2. The demo subcontractor was directed to focus on the areas that were loose and easily removed.

Photo 2 - Plaster removal at first floor north brick wall.

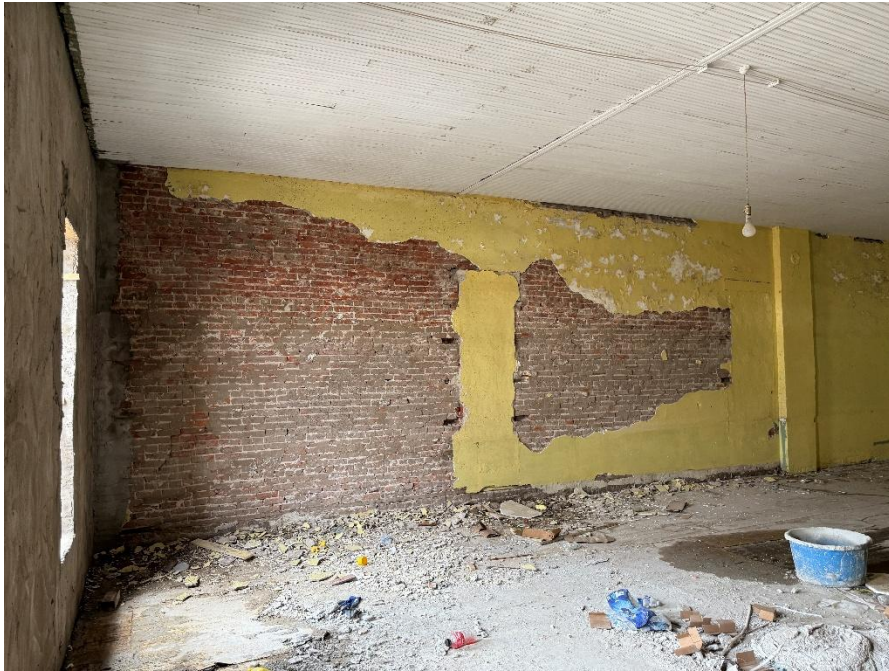
3. Larger areas of plaster had been removed from the north wall on the second floor. More areas are loose on this wall, requiring removal. See photo 3.

Photo 3 - Plaster removal at second floor north wall.

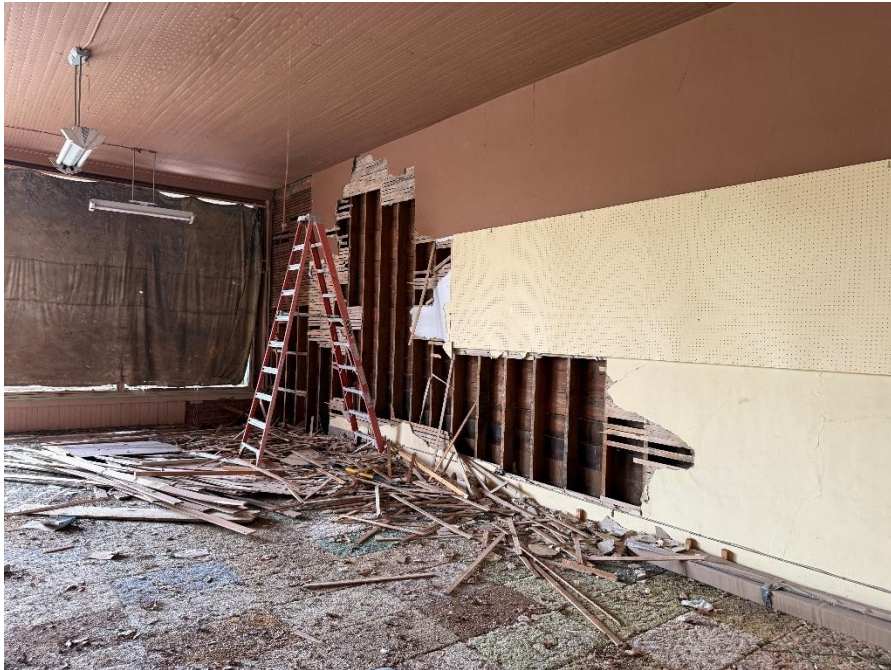
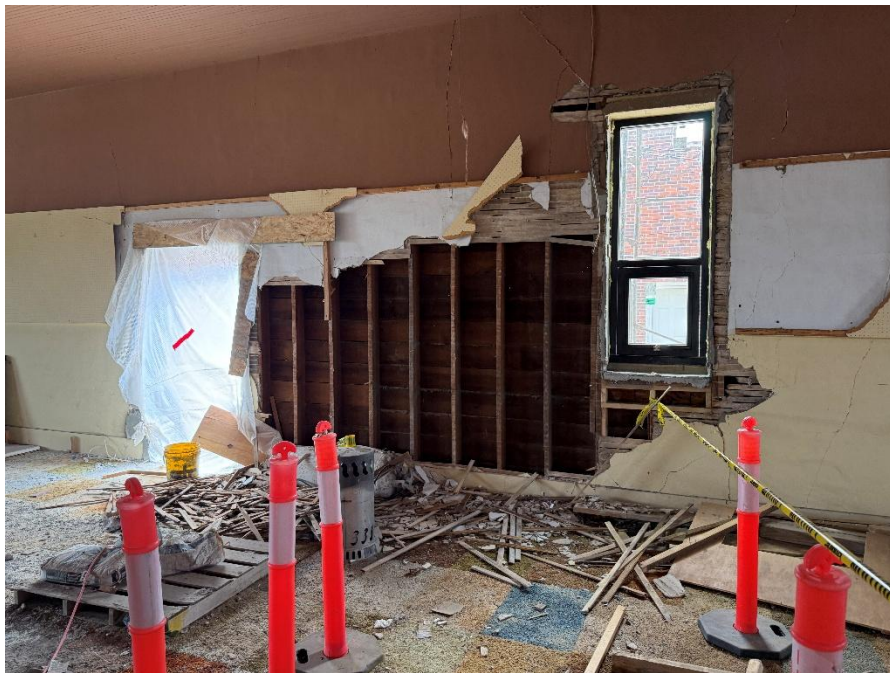
5. Portions of plaster were removed from the interior of the first-floor south wall while I was on site. See photos 5 & 6.
6. The plaster was removed from the second-floor wall framing. See photo 7.
7. Some lag screws were visible at both levels. These were random and the ones that visibly missed studs. They appeared to be 1/4" diameter screws of varied lengths. See photos 8 & 9.

Photo 5 - East end of south first floor wall.

Photo 6 - South first floor wall.

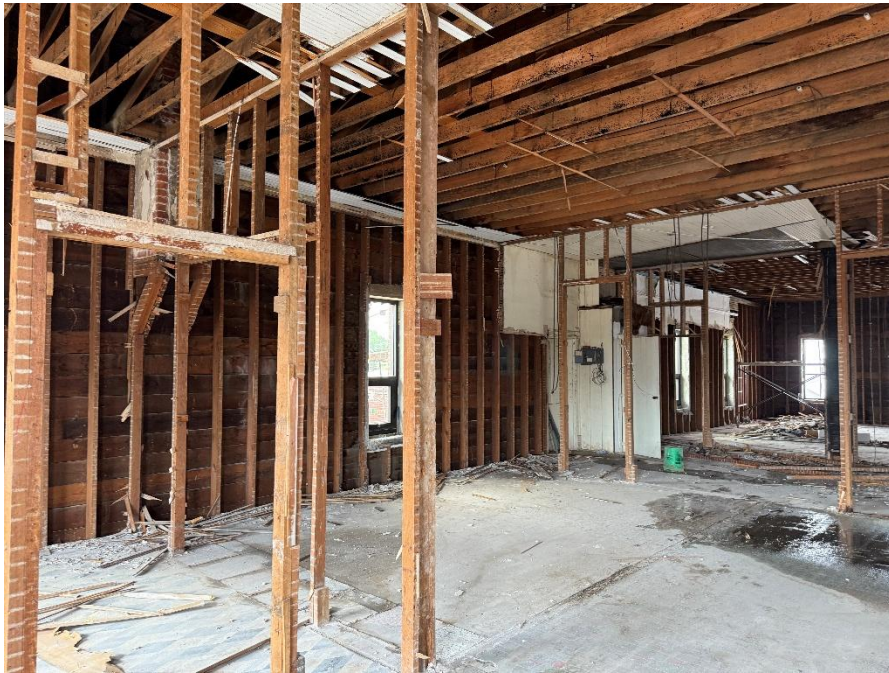
Photo 7 - Second floor wall framing.

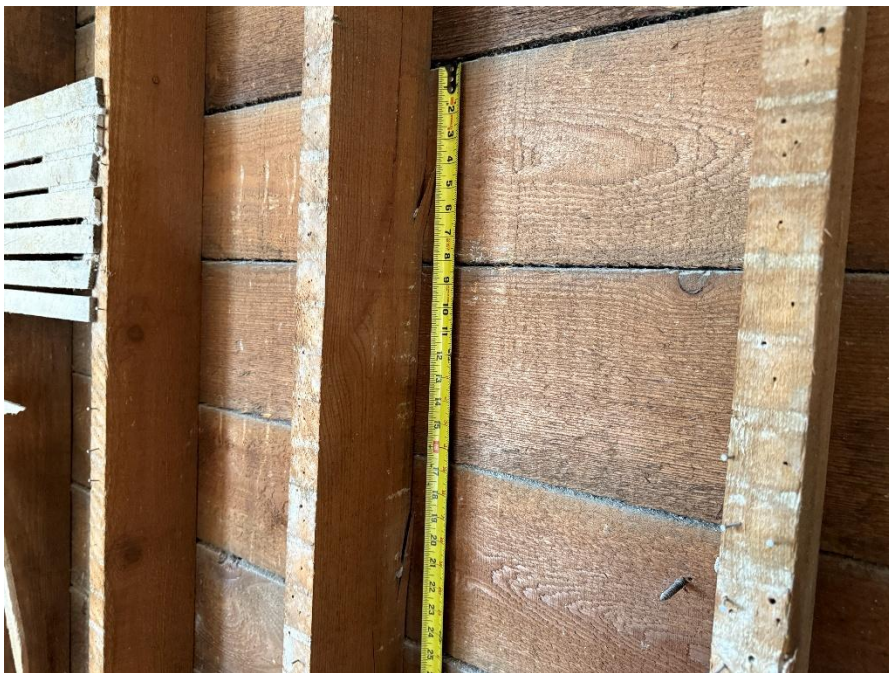
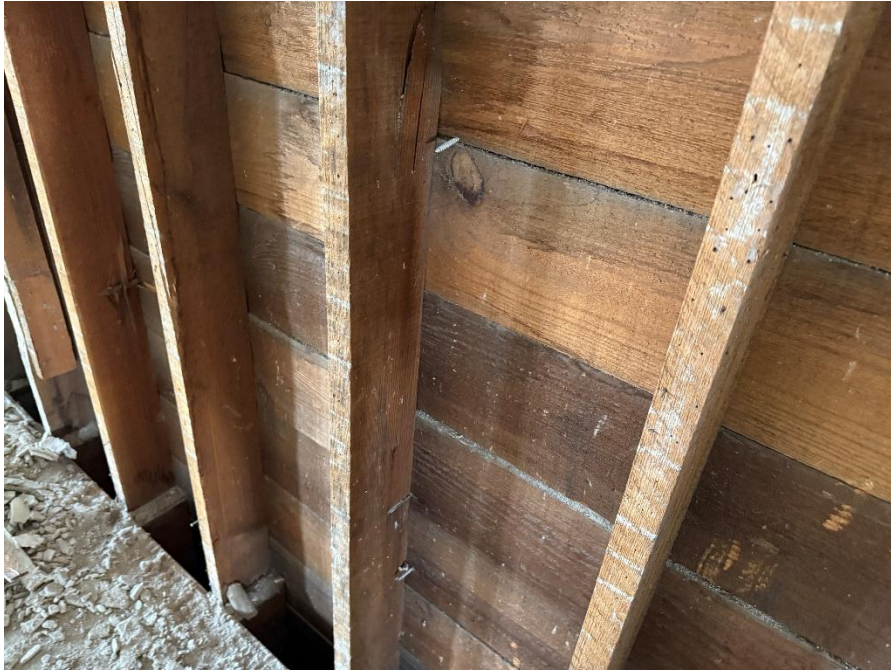
The calculated wind pressure for fasteners on the walls is approximately 38psf (LRFD)/23psf (ASD). Assuming a 1/4" diameter screw was embedded 1 1/2 inches, excluding the tapered tip, the allowable withdrawal capacity of the lag screw is approximately 195 lbs. Comparing these values, lag screws of this diameter and embedment can resist approximately 8.5 square feet of wind load on the wall per anchor. This would be an area approximately 16" wide and 6 feet 4 inches high per anchor. If the screws were installed as assumed and spaced equal to or less than that noted, the anchorage of the exterior wall modifications back to the wood framing should be adequate.

Photo 8 - Lag screws exposed at south wall.

Photo 9 - Exposed lag screws at south wall.

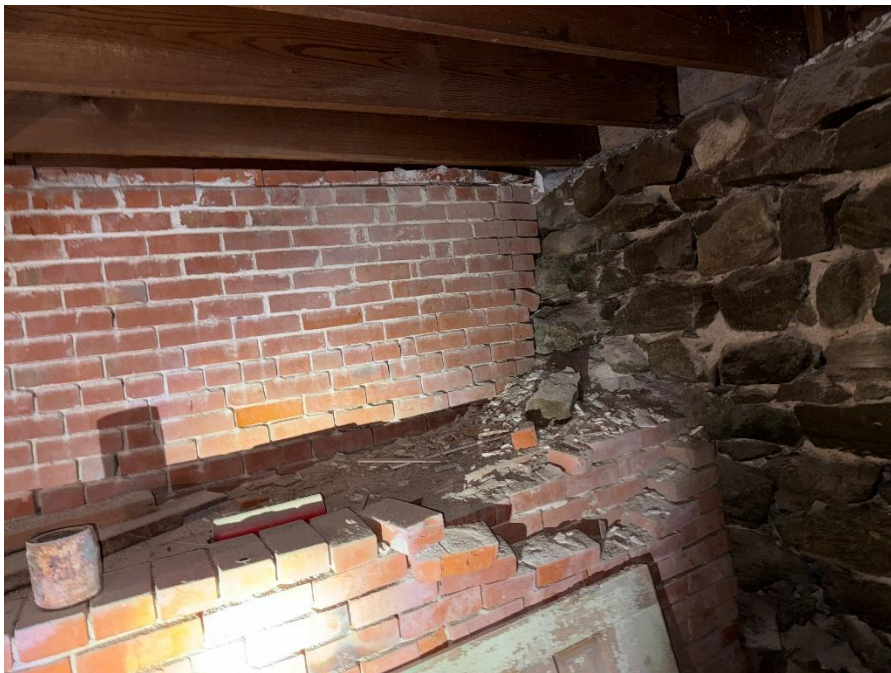
8. The basement was limited to approximately 30 feet of the west end of the south building. The remaining area to the east was crawlspace. The exterior walls were limestone. The center wall was approximately 20 inches thick. A brick wall was present dividing the basement from the crawlspace. See photo 10.

Photo 10 - Basement looking southeast.

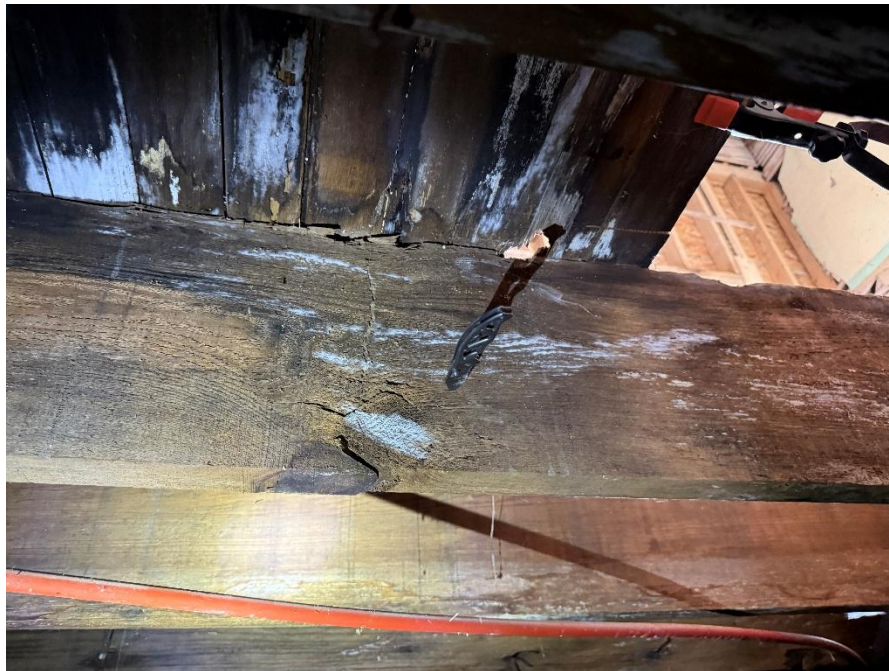
9. The interior wall and north wall have been previously repointed/mortared. See photos 11 & 12.
10. The south basement wall had severely weathered mortar joints, most likely due to the adjacent alley. See photo 13. This wall requires repair. A detail for this will be provided separately.
11. One of the first-floor joists near the west end of the building was split at a knot and requires repair or replacement. See photo 14. This shall be sistered with an 1 3/4x11 1/4 LVL like the floor above.
12. The second first floor joists in from the west wall at the north building was rotted at the north end. See photo 15. This requires repair. A detail for this will be provided separately.

Photo 14 - Split first floor joist.

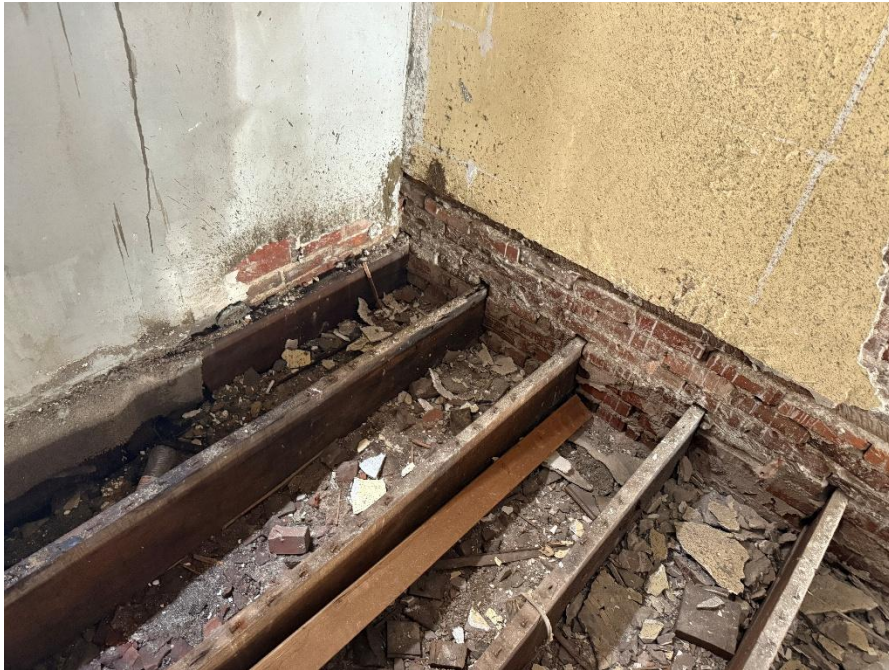
Photo 15 - Second first floor joists in from the west wall at the north building.

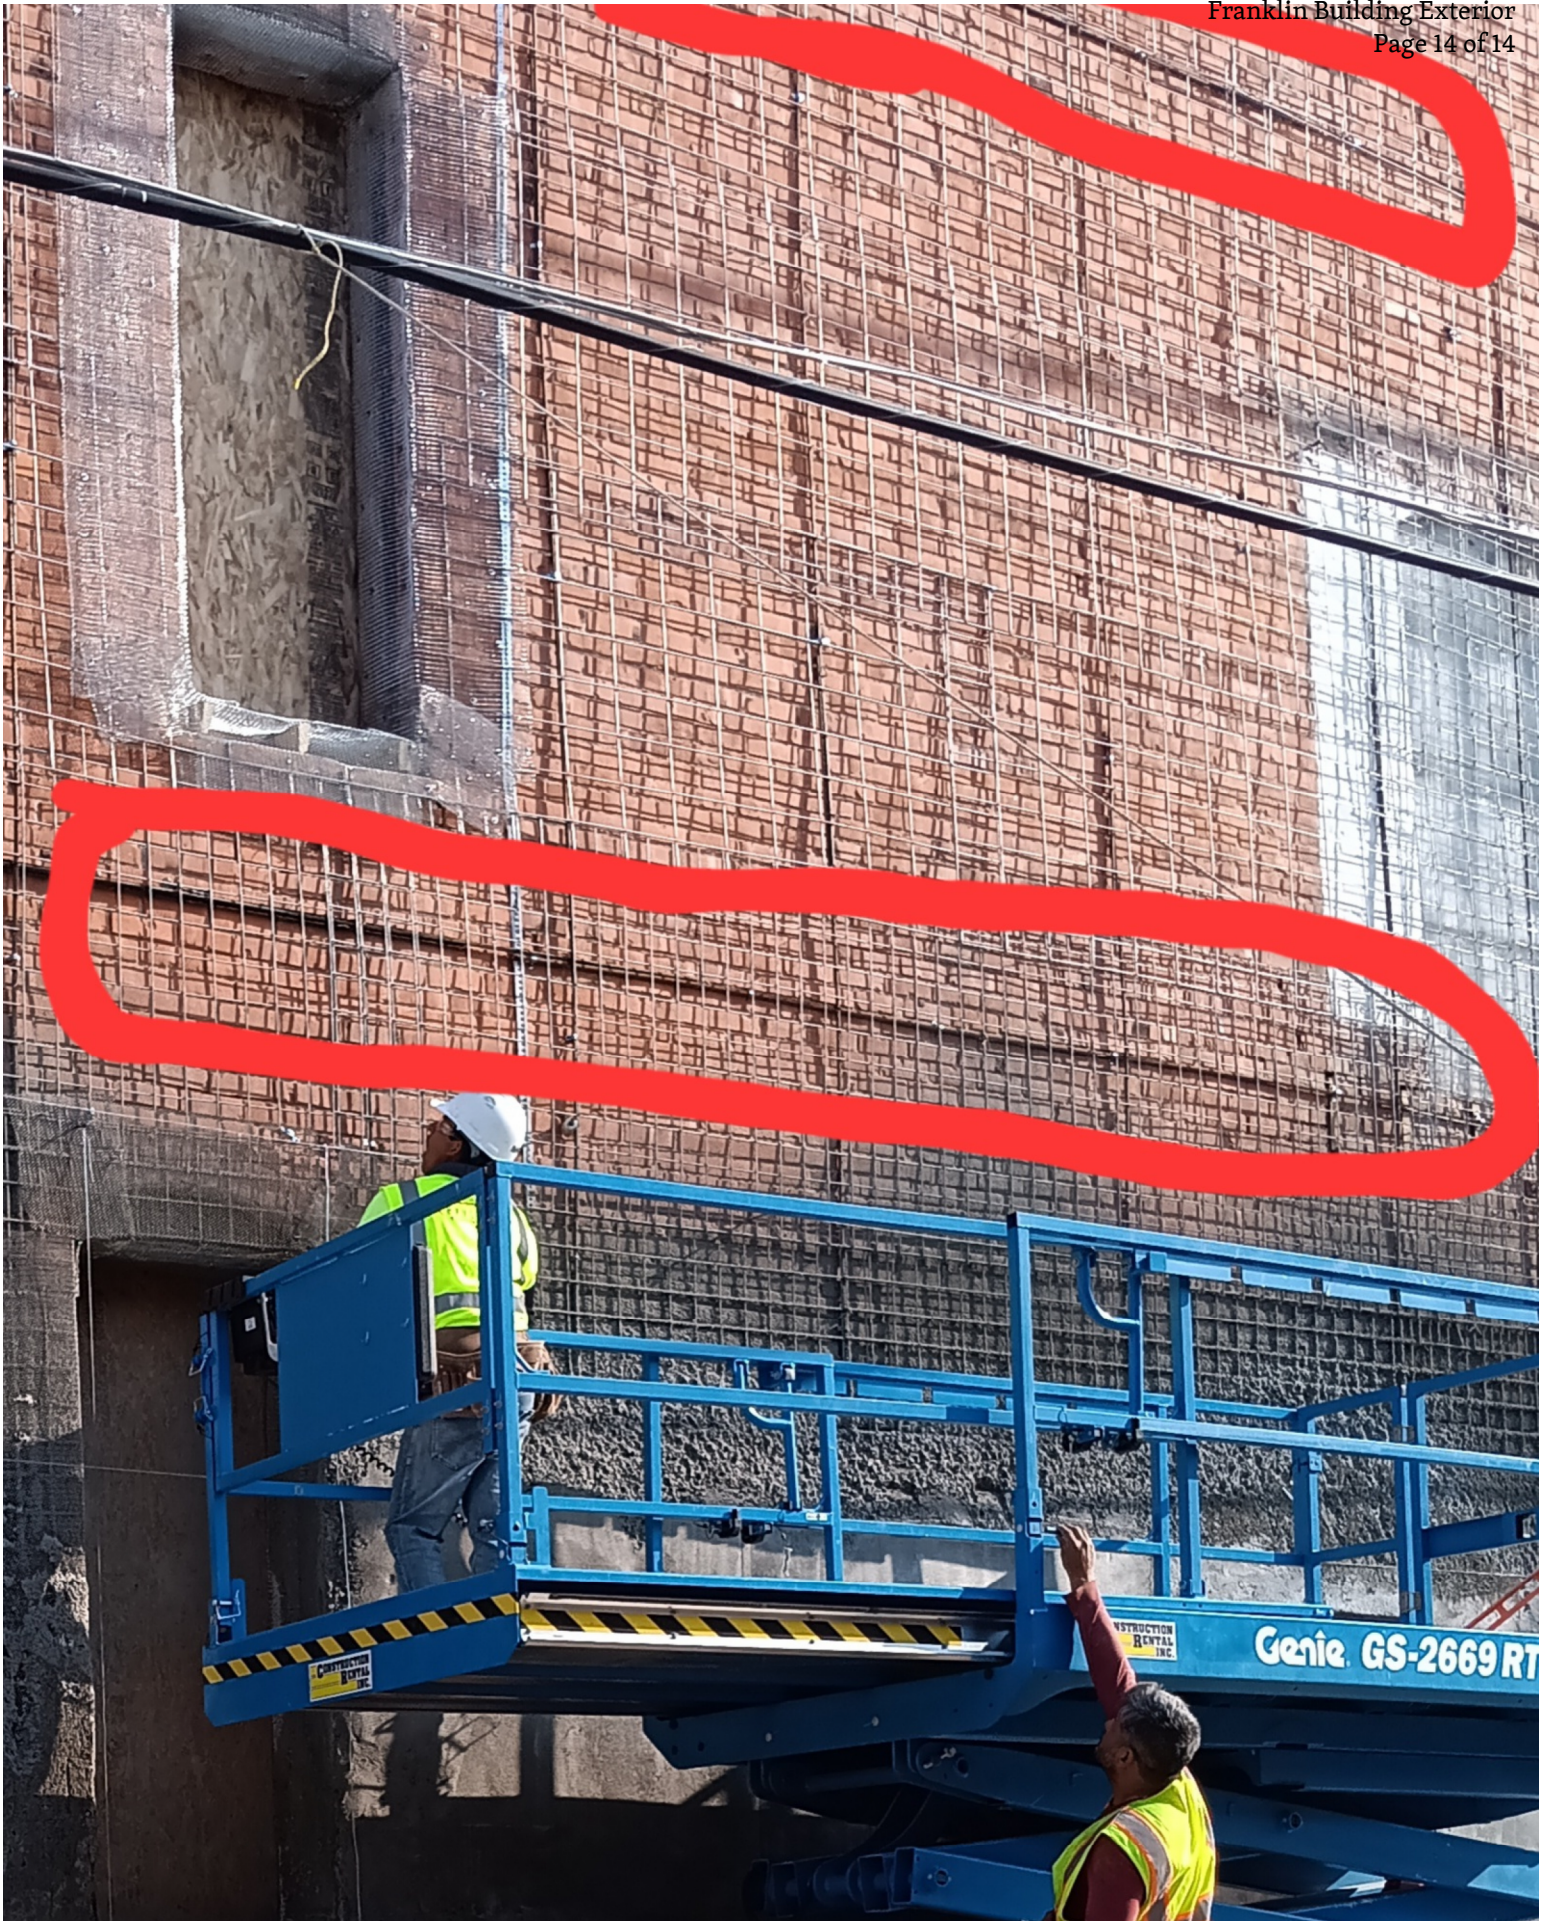
In the email communication and photo dated January 22 & 23rd, 2025 (attached), it was noted that mechanical fasteners were installed at 16 inches on center and there were areas circled in the photo. That was not clear whether that was 16" o.c. in one or both directions or how much embedment into the stud framing was achieved with the fasteners.

Grid system is screwed back into original 2x8 wall 16 on Center with 10 inch mechanical fastener 1200 lb per square inch resistance fasteners fasten to Interior floor joists for stabilization
