# NYE COUNTY SCHOOL DISTRICT

# **Debt Management Policy**

**Fiscal Year 2027**

# July 2025 thru June 2030 MASTER PLAN UPDATE FOR THE

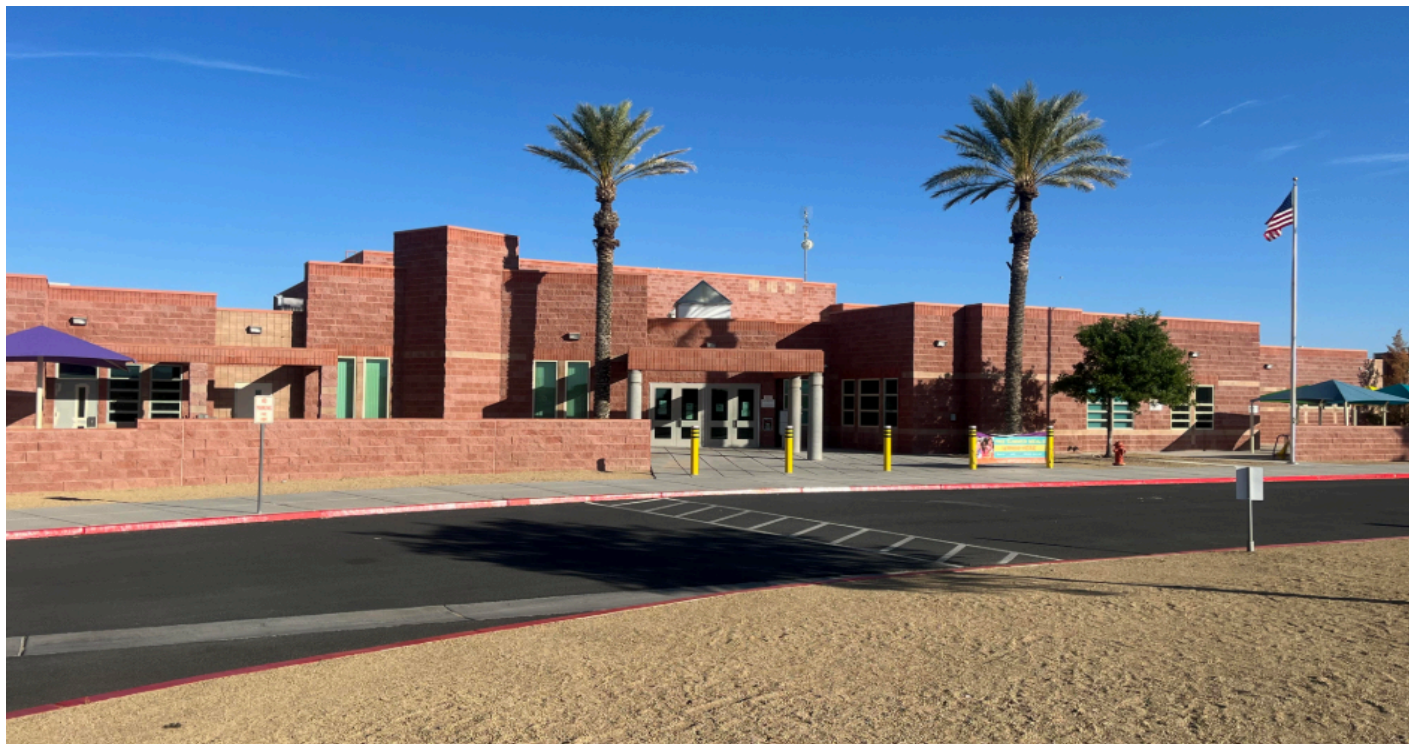
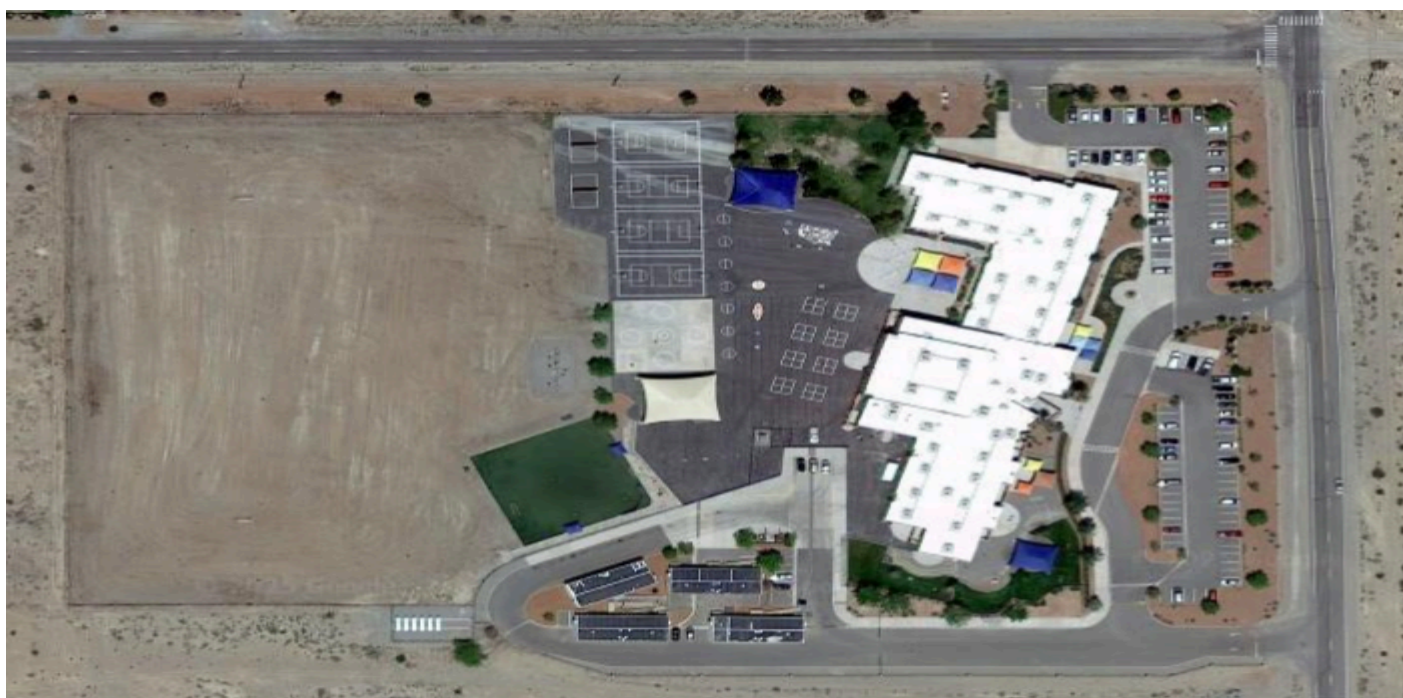
# Tim and Jackie Hafen Elementary School

- The rooftop HVAC units contain R-22 refrigerant and must be replaced with updated units as mechanical parts and freon are unavailable. This is tentatively scheduled for the 2025-2026 school year based on the available budget.

- The playground A.C. paving surfaces are scheduled to undergo maintenance in the 2025/2026 fiscal year, including crack repairs, a slurry coating, and restriping. The parking lot was recently recoated in the summer of 2024, ensuring its current condition remains optimal.

- The carpet in the main halls is original and starting to show its age and is in need of replacement. Other options will be considered, such as VCT or polished concrete, and a decision will be made based on cost and maintenance requirements.

- The serving steam table is original and has failed. This is scheduled for replacement with two new tables in 2025. The upgrade will also include an electrical sub panel to handle the new electrical requirements.

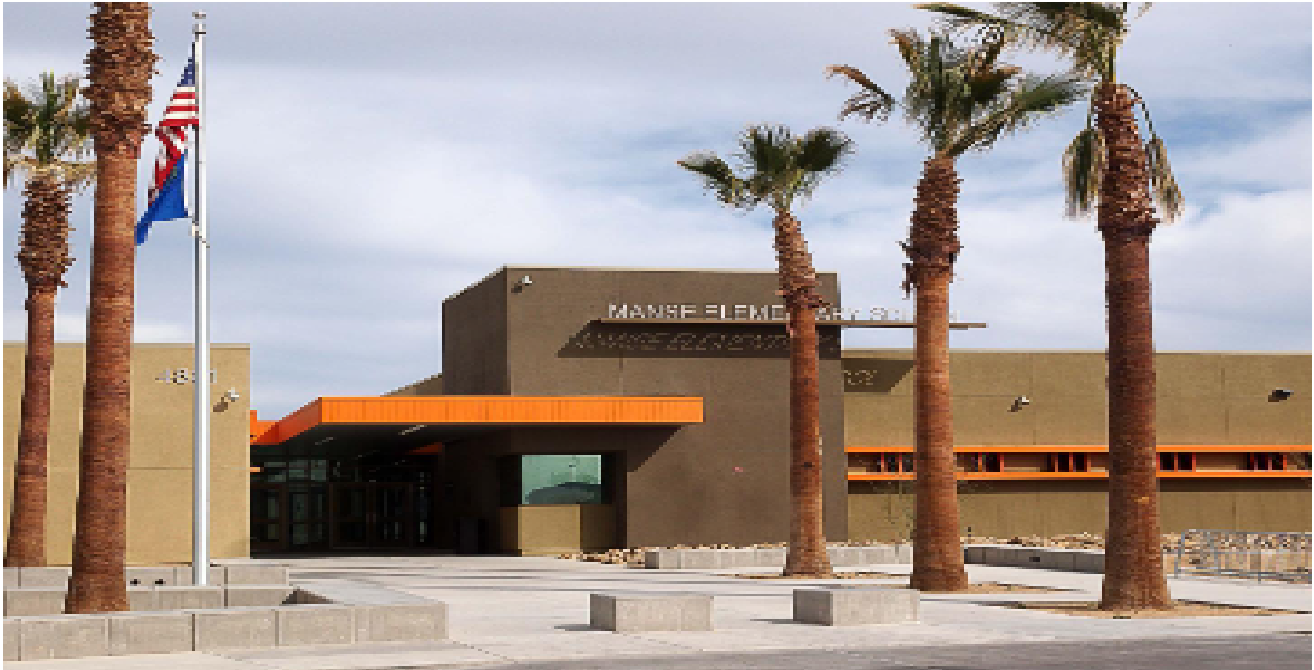
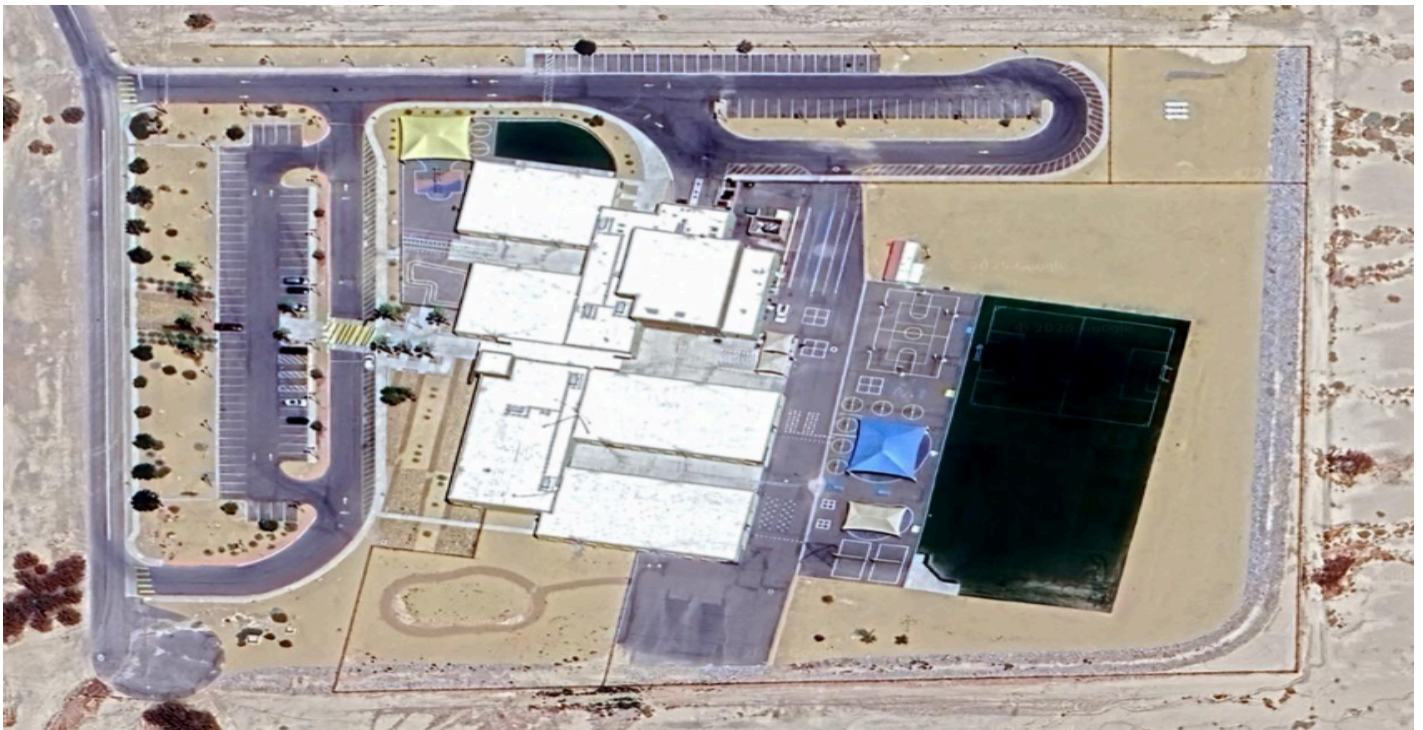
# Manse Elementary School

The roofing system is original and not in need of replacement. It requires minimal maintenance. The HVAC geothermal-based system and refrigerant is R410A and should need no major service in the next few years. The interior of the school has been well maintained, painted, and recarpeted as needed.

- The A.C. paving surfaces will undergo maintenance, including crack repairs, a slurry coating, and restriping, scheduled for the 2026/ 2027 fiscal year.

- The Technology Department is set to implement a comprehensive computer refresh across the campus in the summer of 2029.'
- The refrigerator and freezer box has begun to fail due to moisture in between the panels and will require replacements when a window of time is available. The combo will require a window of 6 weeks of availability to replace them. Tentatively scheduled for the summer of 2026-2027 fiscal year.

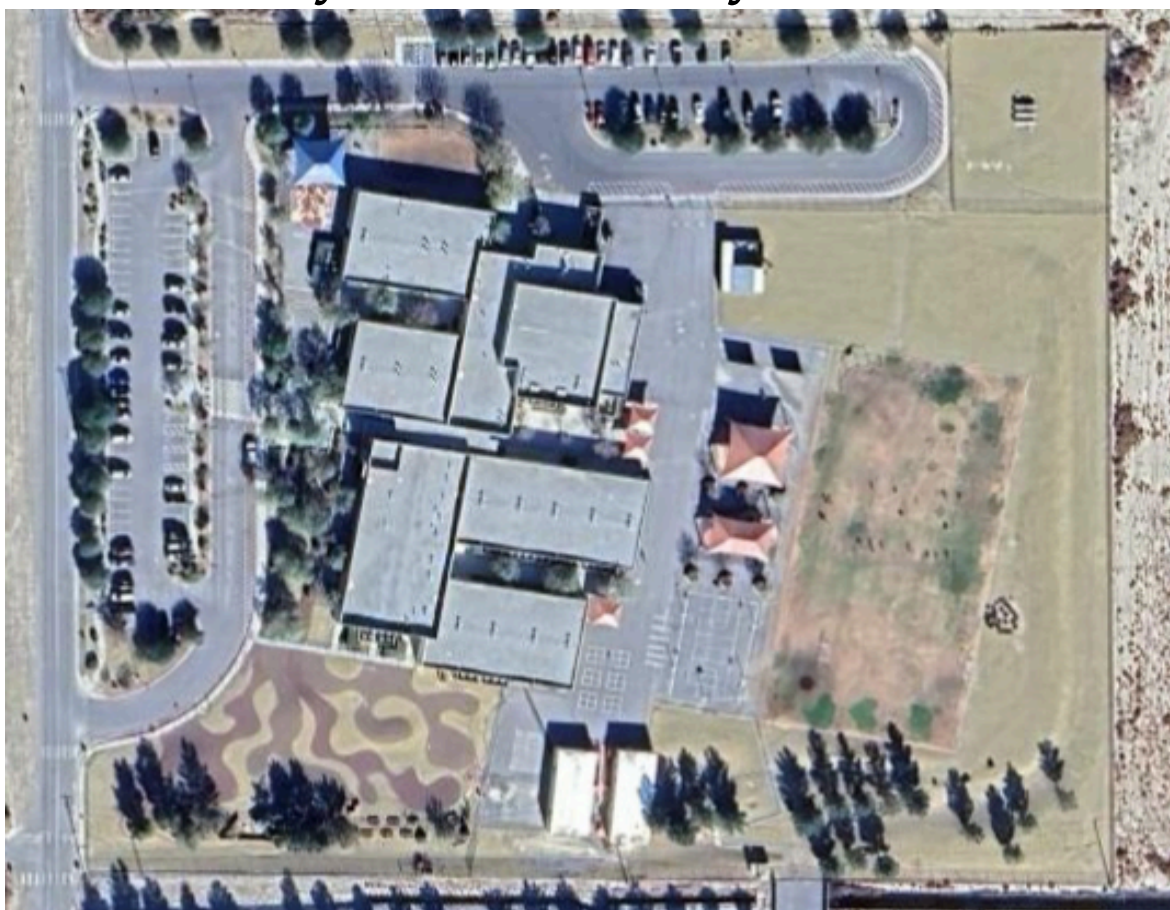
# Floyd Elementary School

- The option of an interlocking door system will be reviewed to control both main entry doors. This would ensure visitors can be easily vetted before being allowed into the main school areas. Preventing tailgating, where individuals might attempt to gain entry by closely following an authorized person through the unlocked door.
- The parking lot A.C. paving surfaces will undergo maintenance, including crack repairs, a slurry coating, and restriping in 2025/2026. The playground was recently recoated in the summer of 2024, ensuring its current condition remains optimal.
- The Technology Department is set to implement a comprehensive computer refresh across the campus in the summer of 2026.
- The dishwasher is original and scheduled for replacement during the summer of 2025. It is beginning to show its age and requires multiple repairs, leading to long downtime.

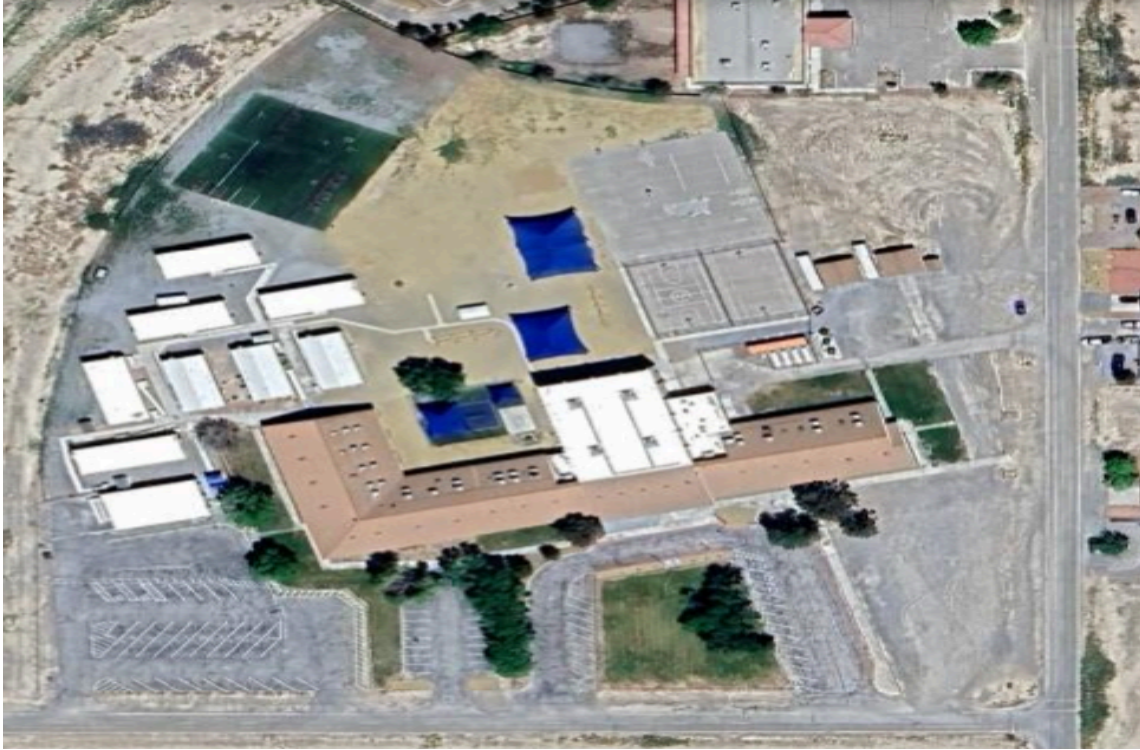
# J.G. Johnson Elementary School

The heating and cooling for the main building is provided by propane gas package units, while the modular classroom units utilize all-electric heat pumps for climate control. The school underwent improvements in 2021, including the painting of corridors and the replacement of lighting with energy-efficient LED technology. In the summer of 2024, the main building's rooftop units were replaced with units containing 410a. The campus is equipped with a comprehensive fire alarm system, and all areas meet the required safety standards. The metal ramps to the modulares have been inspected for safety and many replaced in 2024.

- Much of the front landscape areas have been switched to a desert-friendly design. The remaining areas should be evaluated and either overhauled or replaced with desert scape.

- The building-wide communication system is showing its age and has had multiple disruptions. It is currently working, but the system should be replaced to ensure all areas can be alerted to an emergency and emergencies may be reported from multiple areas of the campus.

- The Technology Department is set to implement a comprehensive computer refresh across the campus in the summer of 2027.
- The artificial turf play area was installed using recycled turf and is starting to deteriorate and should be replaced when funds are available.

- The walk in refrigerator and freezer are original and need to be replaced due to age when funding is available.
- The playground basketball court AC surfaces are deteriorated and are original and scheduled to be resurfaced and repaired in the 2025 fiscal year.

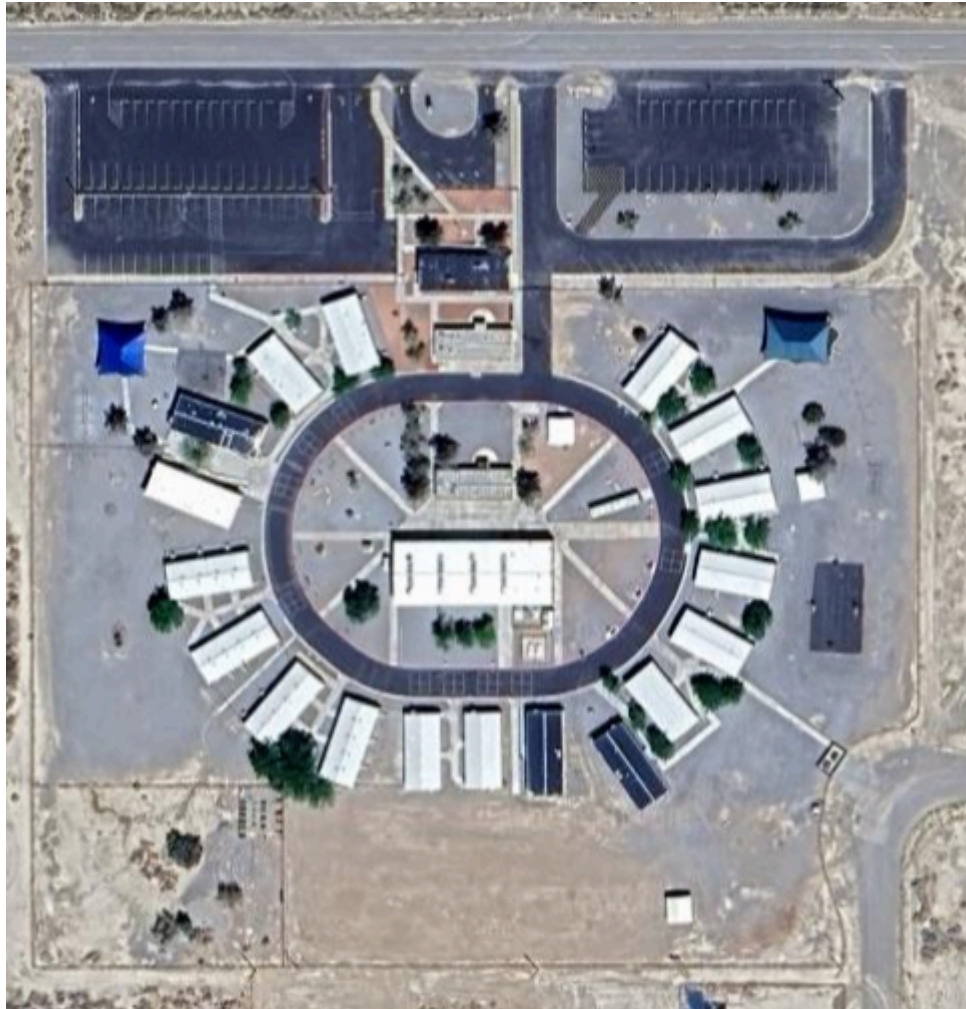
# Mt. Charleston Elementary School

In 2009, the entire campus was evaluated for compliance with the Americans with Disabilities Act (ADA), revealing multiple deficiencies. It is assumed that most of these deficiencies have not been remediated. As funds become available, it is recommended that remediation work be initiated to address these issues.

- The building-wide communication is non-operational. This system is the first intercom system that will be replaced in the summer of 2025. The new system will ensure that all areas can be alerted to an emergency, and emergencies may be reported from multiple areas of the campus.

- The school currently utilizes many HVAC units containing R-22 refrigerants. These should be identified and upgraded to refrigerant as failures occur.

- The play area is not age-appropriate, and replacement with an age-appropriate play system that could be utilized should be considered when funds are available.

- The addition of an ADA-compliant ramp at the office exit will be considered when funds permit, ensuring proper visitor flow and compliance with the district's single-point entry protocols.

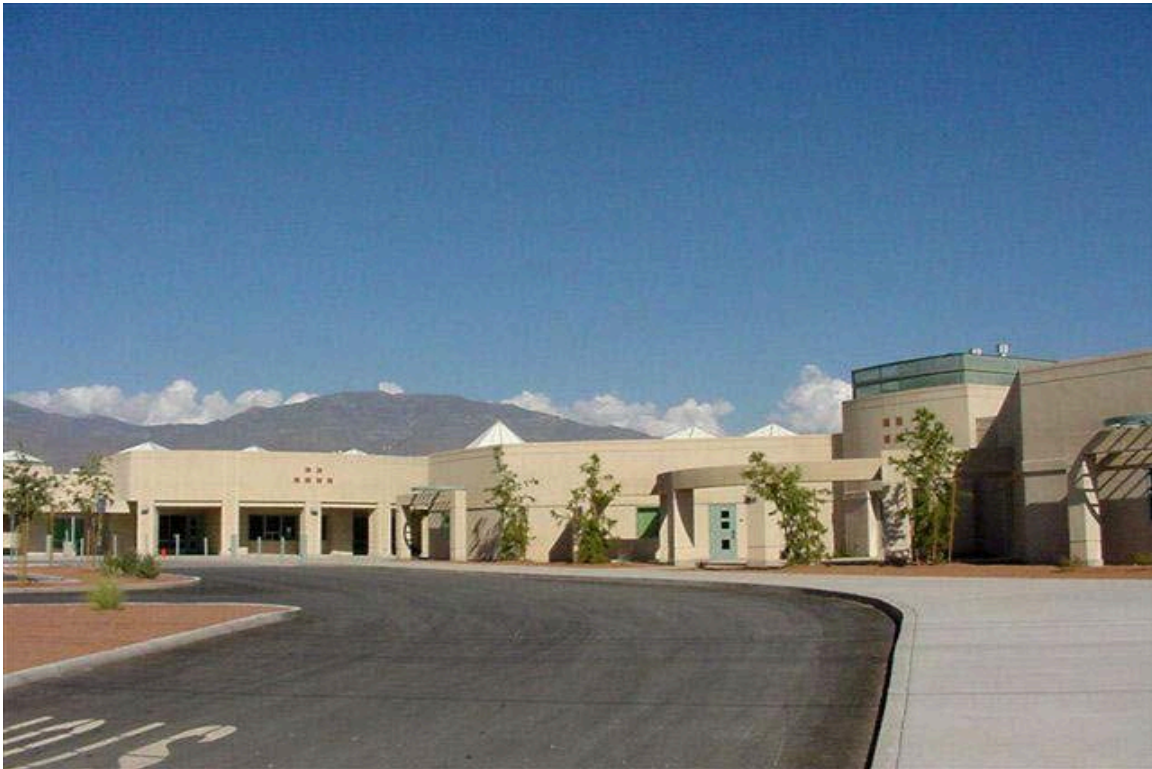
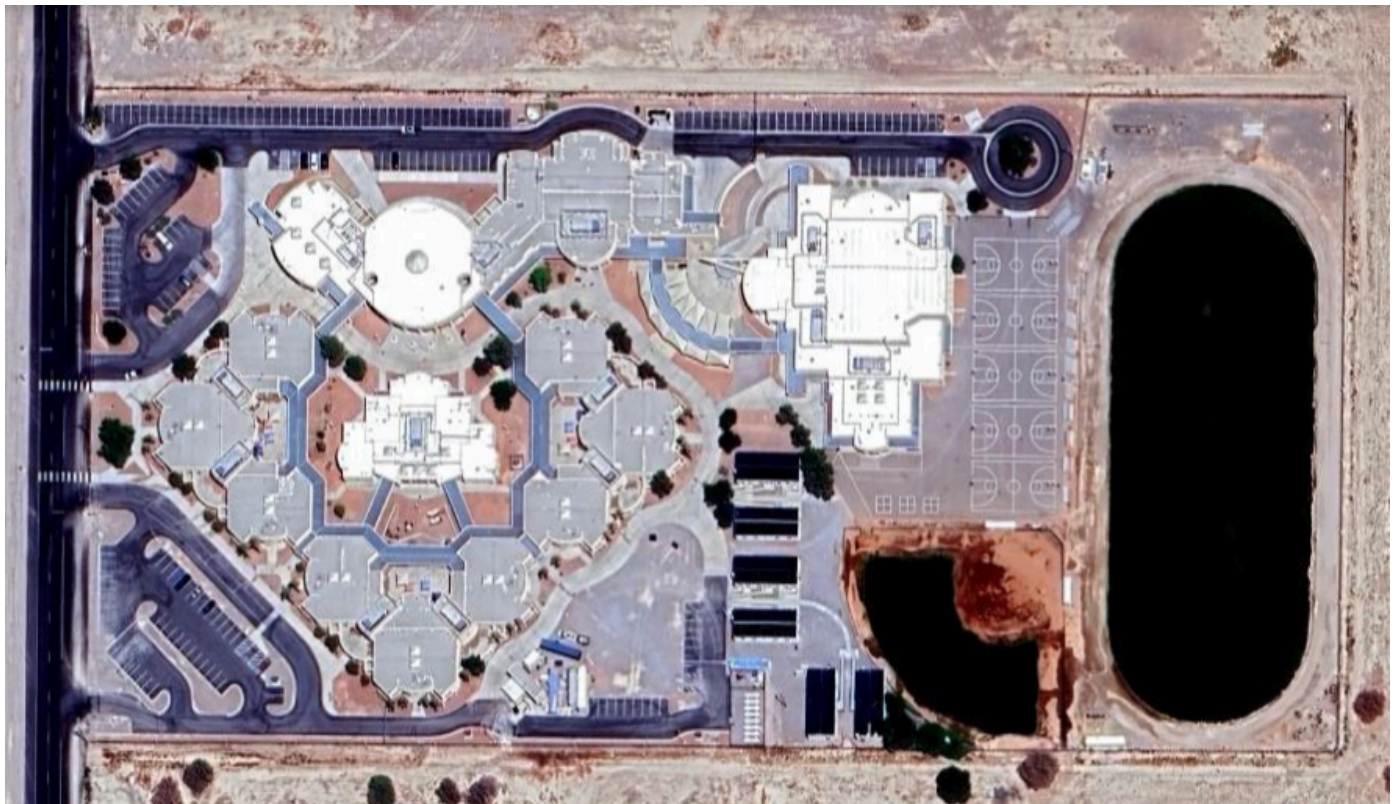
# Rosemary Clarke Middle School

The roofing system has been replaced or recoated in two phases, starting in 2023 and completed in the summer of 2024, and is under warranty for 10 - 20 years, depending on the system used. The overall condition of the building is good. Paint and carpet are replaced as needed. Additional concrete will be poured as needed to keep water from infiltrating the base under the building and to prevent buildings from settling due to the collapsible soil.

- The remaining multi-zone rooftop HVAC units are based on R-22 refrigerant and need to be converted to an upgraded freon. The second phase of this replacement is already in progress and is expected to be completed in the summer of 2025.

- The A.C. paving surfaces will undergo maintenance, including crack repairs, a slurry coating, and restriping, scheduled for the 2026/ 2027 fiscal year.

- The Technology Department is set to implement a comprehensive computer refresh across the campus in the summer of 2025.
- To mitigate future settling, as funds become available, additional concrete should be poured to replace landscape areas throughout the campus.

- Structural settling has caused drywall cracks behind the wallpaper, resulting in peeling and shifting throughout the campus. The wallpaper should be removed, walls repaired and textured, and all affected areas repainted as funding allows.

- The serving speed line equipment is original, and multiple units have already failed and can not be repaired. This has been approved for replacement in the 2025- 2026 fiscal year.

- The reach through hot and cold cabinets are original and have required multiple repairs. Due to their age, parts are not available and will be replaced when funds are available.

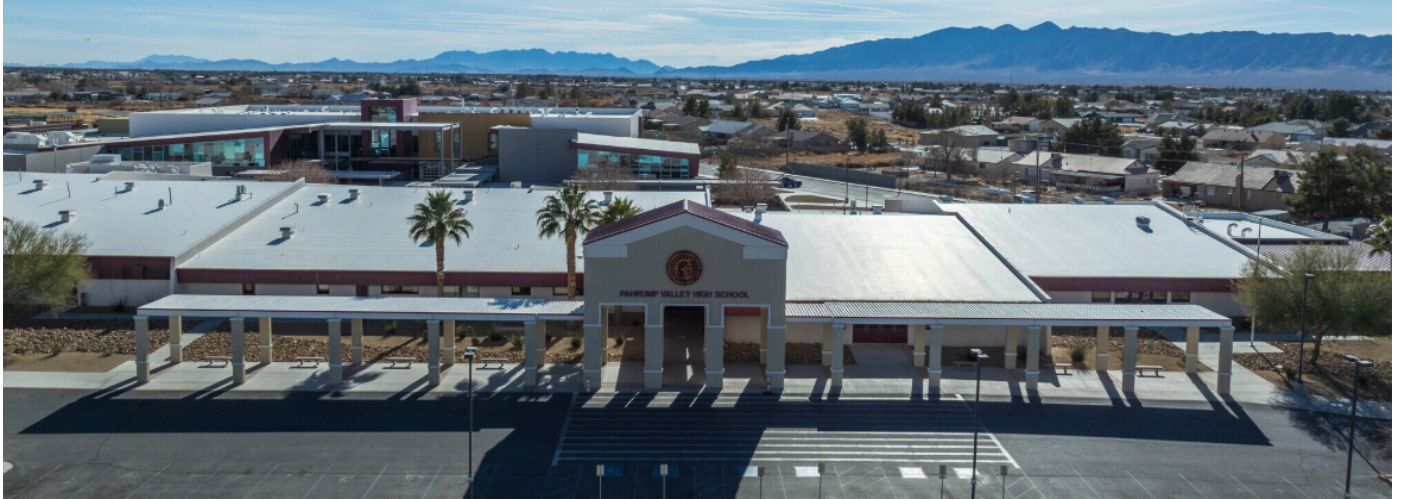
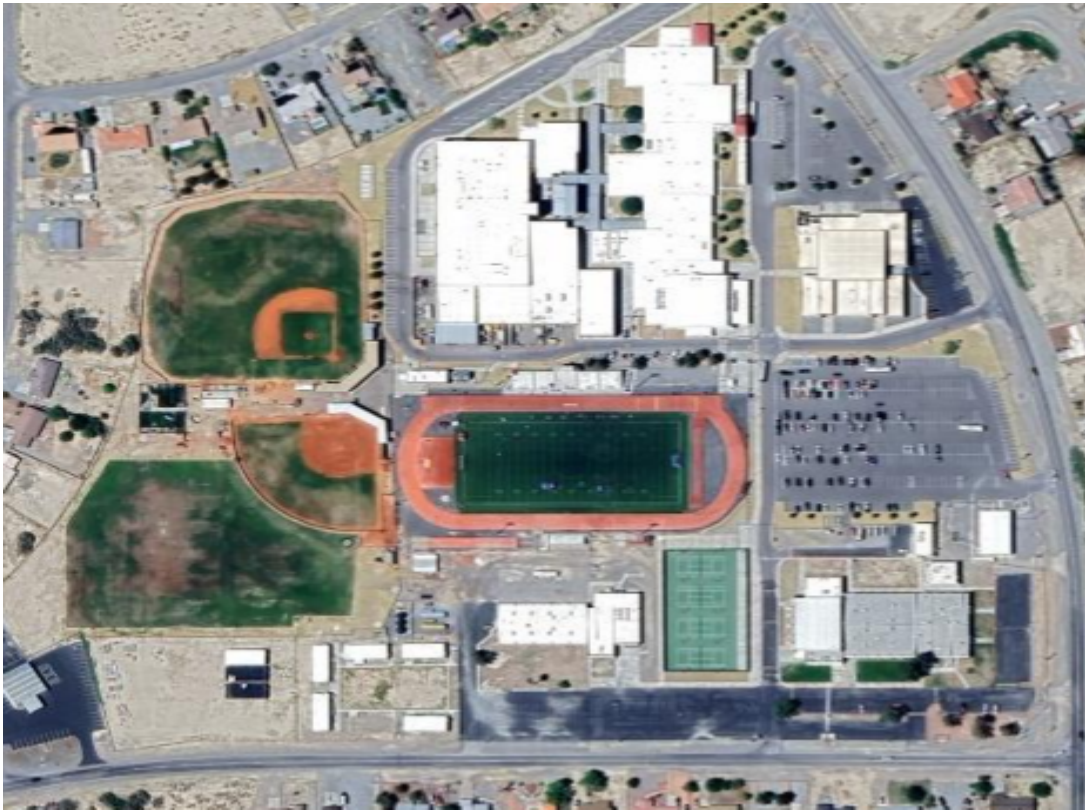
# Pahrump Valley High School

- The indoor bleachers used outside on the softball and baseball field need to be replaced with proper exterior bleachers that meet ADA and other code requirements.

- The A.C. paving surfaces will undergo maintenance, including crack repairs, a slurry coating, and restriping, scheduled for the 2028/ 2029 fiscal year.

- The running track around the field should be evaluated for replacement or resurfacing due to cracking and repaired when the budget is available
- The option of artificial turf will be looked at for the baseball and softball fields, and a decision will be made based on funding

- Pathway/ Adult Ed roof is original and scheduled to be replaced based on the budget in the 2025- 2026 fiscal year
- When PVHS has heavy rains, water pools on the softball field. This has been an issue since the field has been there. When funds are available, the addition of drainage should be considered.

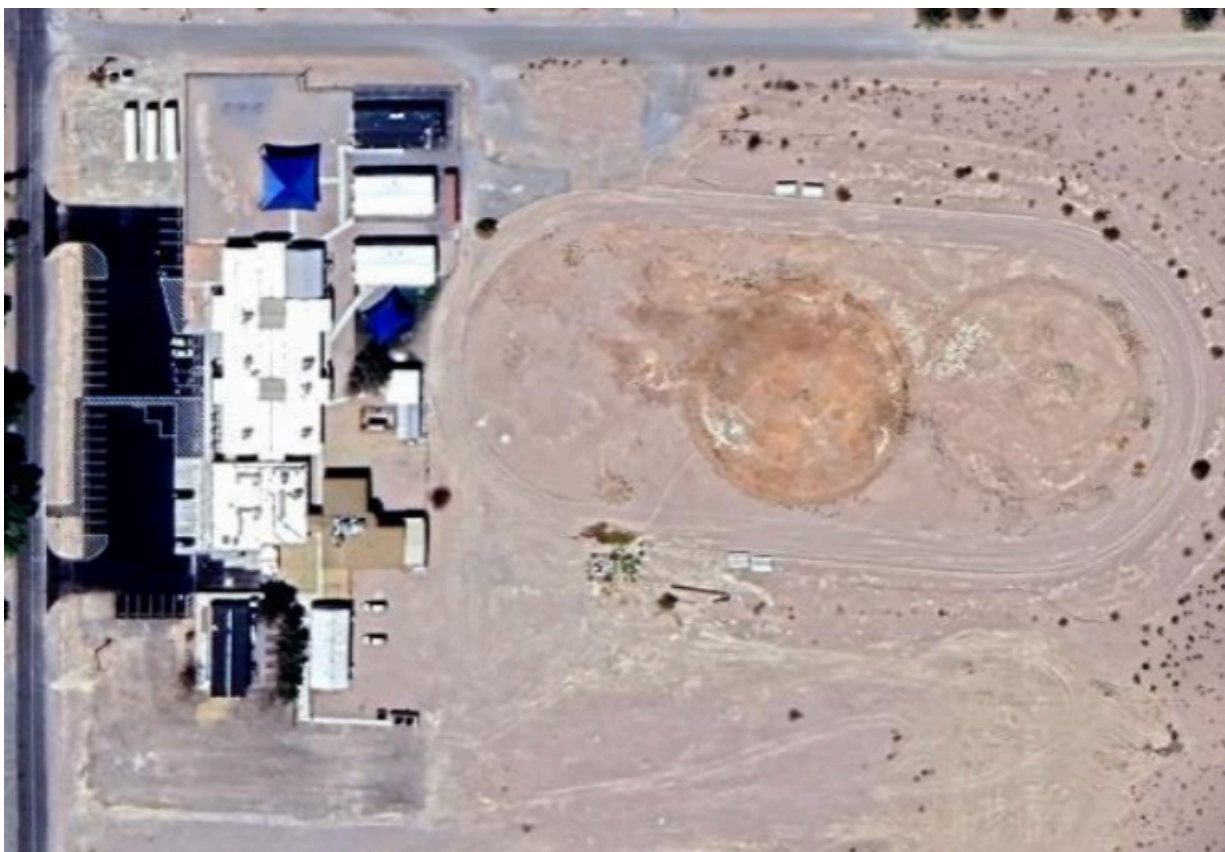
# Amargosa Elementary School

In 2009, the entire campus was evaluated for compliance with the Americans with Disabilities Act (ADA), and several deficiencies were identified. The full scope of deficiencies is outlined in the report provided by PSWC Architects. Remediation of these deficiencies should be prioritized once funding is available.

The school is situated on an approximately 10-acre site with minimal slope for drainage. A large, fully paved parking and driveway area provides access to the southern main building entrance. In 2023, the parking lot underwent a complete replacement to address previous deterioration and drainage concerns. As part of this project, the grading and drainage systems were improved to prevent water buildup. The newly paved lot now provides ample parking capacity and meets ADA accessibility standards, ensuring safe and convenient access for all visitors, staff, and students.

- The building's wide communication is original, and parts are limited. This system will be scheduled for replacement after Mount Charleston is complete. The new system will ensure that all areas can be alerted to an emergency, and emergencies may be reported from multiple areas of the campus.

- The roofing systems over several classrooms are starting to show their age and require multiple repairs. It is scheduled to be recoated in the 2027- 2028 fiscal year.

- The Amargosa kitchen is all original, and multiple pieces of equipment are outdated, and procurement of replacement parts is not possible. Equipment to be replaced in the duration of this 5-year plan are the kettle, double oven, warming cabinet, and serving table.

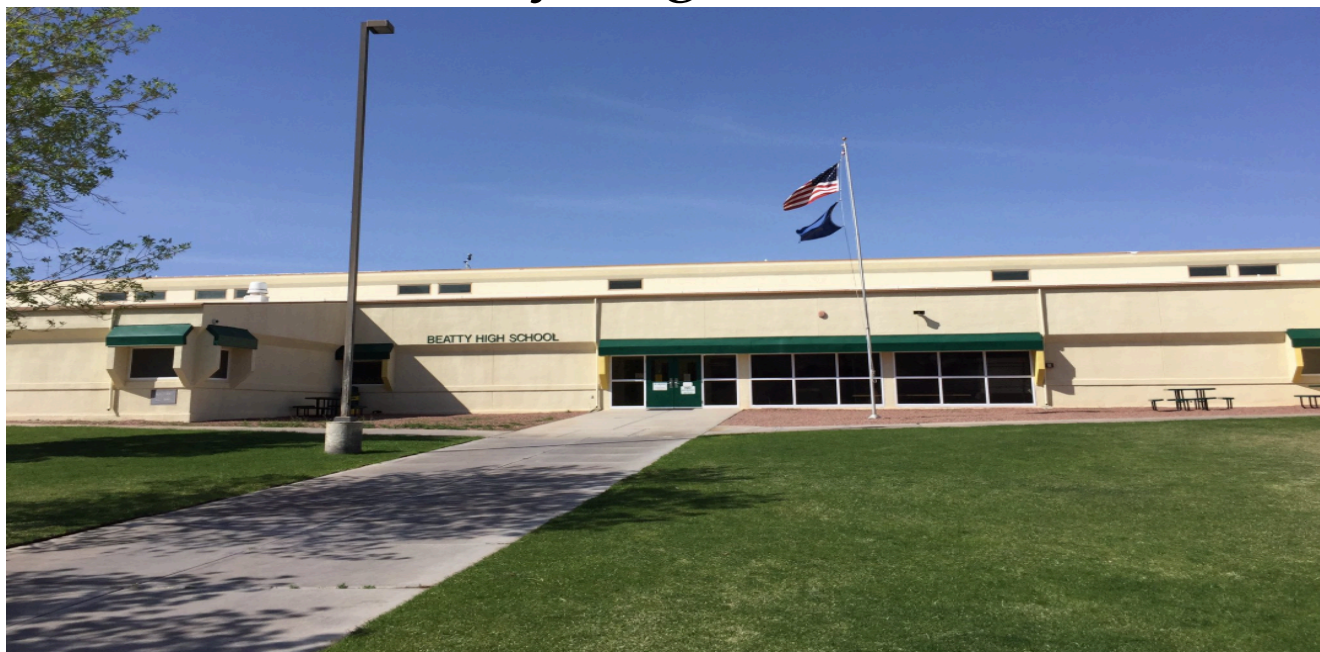
# Beatty High School

All buildings on campus, including the main high school building, the shop buildings, and the multi-purpose building, are pre-engineered metal structures with steel panel exterior wall siding. In 2009, the entire campus was evaluated for compliance with the Americans with Disabilities Act (ADA), revealing multiple deficiencies. A report provided by PSWC Architects outlines the full scope of these issues. Most deficiencies remain unresolved, and remediation should be prioritized as soon as funding becomes available.

- The Technology Department is set to implement a comprehensive computer refresh across the campus in the summer of 2025.
- The school currently utilizes several HVAC units containing R-22 refrigerant and is scheduled to be upgraded in the summer of 2025 by Emcor Service Nevada.
- Paint around the trim area near the floor is starting to peel due to rust and should be repaired and painted as well as the awnings to match when funds are available.
- The serving tables are original and require heat lights and will be replaced with the district standard tables to improve safety when the funds are available.
- The addition of home and away dugouts for baseball should be considered if funds are available as the current dugouts are deteriorating and do not offer any shelter from the weather.

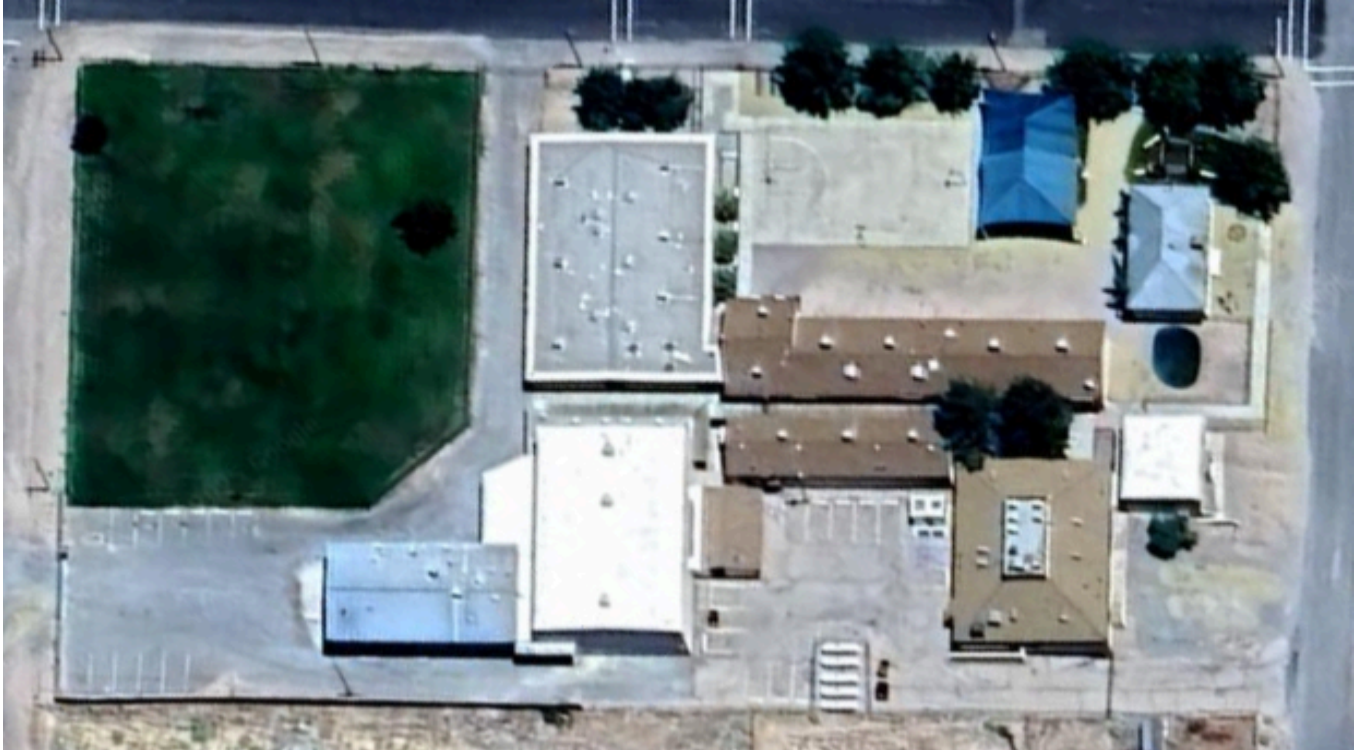
# Beatty Elementary & Middle Schools

In 2009, the entire campus was evaluated for compliance with the Americans with Disabilities Act (ADA), revealing multiple deficiencies. A report provided by PSWC Architects outlines the full scope of these issues. It is assumed that most deficiencies remain unresolved, and remediation work should be prioritized as soon as funding becomes available.

- Roofing systems vary and include asphalt composition mineral-surfaced shingles. It is starting to show its age with recurring problems. The gym and middle school roof replacement project has been approved and will be completed in 2025.
- The Technology Department is set to implement a comprehensive computer refresh across the campus in the summer of 2025.
- The fire alarm infrastructure is original and does not allow for individual classroom notification. This system is slotted for replacement in 2025.
- The serving table is original and has failed. It will be replaced with the district standard table to improve safety when the funds are available.

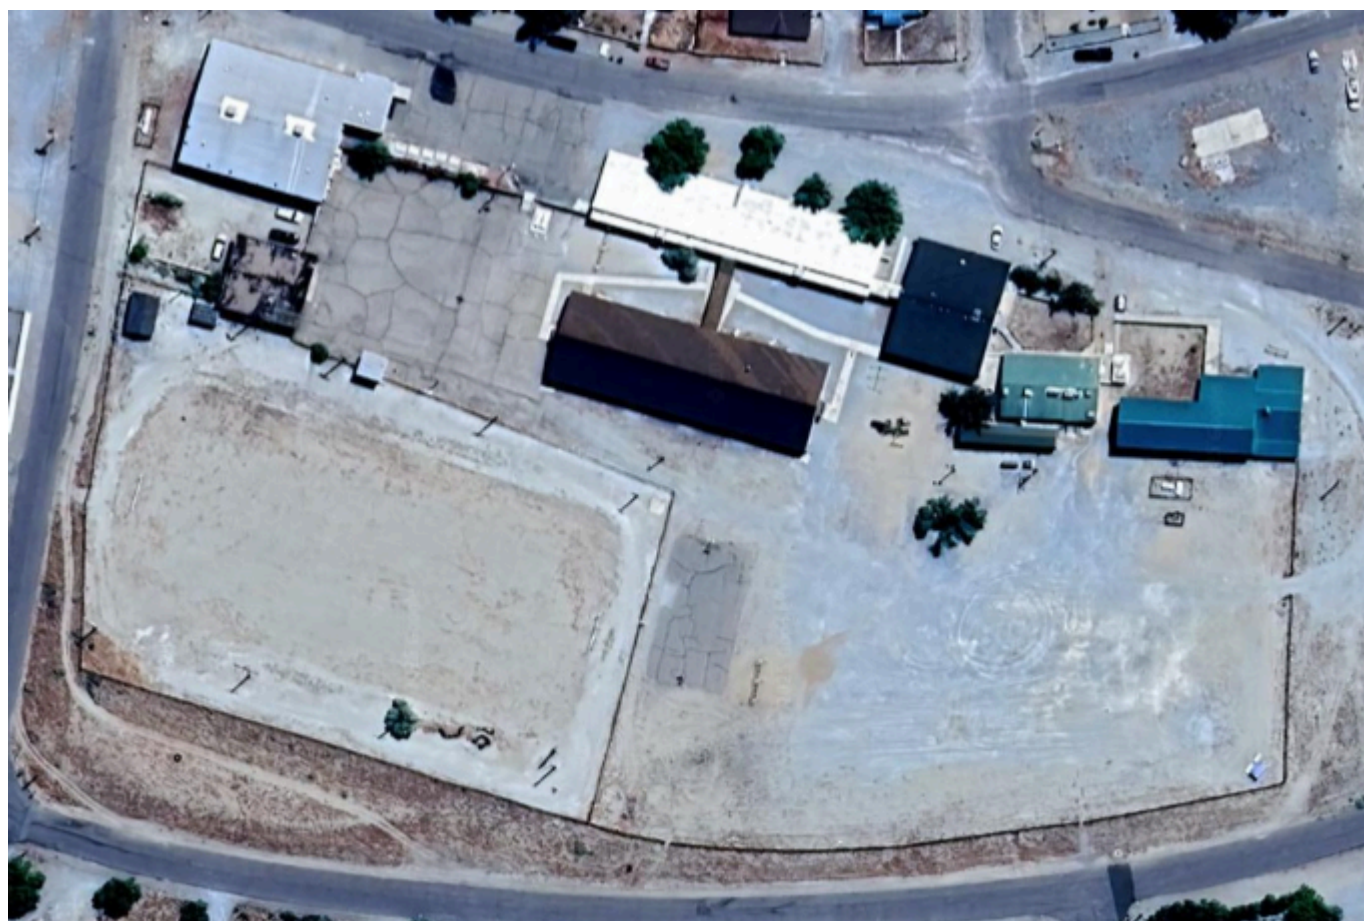
# Gabbs School

Gabbs School is a campus-style facility consisting of seven separate buildings totaling 42,725 square feet. The school originated in the 1940s, with the masonry elementary school built in 1942, followed by the high school in 1955. In 1975, additional construction expanded the facility to include a gymnasium, a home economics room, and three new classrooms. Since then, several modernization projects have been completed, including the installation of a new wood gymnasium floor, air conditioning systems, and a walk-in refrigeration unit for the cafeteria. The school serves students from Gabbs, the Reese River Valley, the Yomba Indian Reservation, and surrounding ranches. At this time, there are no plans to expand the facility or increase student capacity within the next five years.

In 2009, the school underwent an ADA compliance evaluation conducted by PSWC Architects, which identified multiple deficiencies. It is assumed that most of these issues remain unresolved, and remediation efforts should be prioritized as funding becomes available. In 2021, a separate evaluation was conducted to assess the feasibility of demolishing certain buildings. However, it was determined that refurbishment and exterior painting would be more cost-effective than demolition and disposal, given the high costs associated with tearing down the structures.

Several facility improvements are planned, including the demolition of the sports field house and abandoned HVAC equipment, as well as the removal of deteriorated asphalt in the play area. The asphalt will be replaced with compacted chat or decomposed granite sourced from the local mine, with the possibility of repaving with asphalt if funding allows. The existing playground also requires refurbishment or complete replacement, depending on available funds, to ensure compliance with modern safety codes.

- The A.C. paving surfaces will undergo maintenance, including crack repairs, a slurry coating, and restriping, scheduled for the 2029/ 2030 fiscal year.
- The Technology Department is set to implement a comprehensive computer refresh across the campus in the summer of 2027.
- The gym building needs to be repainted to help with longevity and mitigate the peeling paint around the building and is scheduled for 2025/2026.
- The serving table and milk cooler require replacement due to their age and the availability of replacement parts.

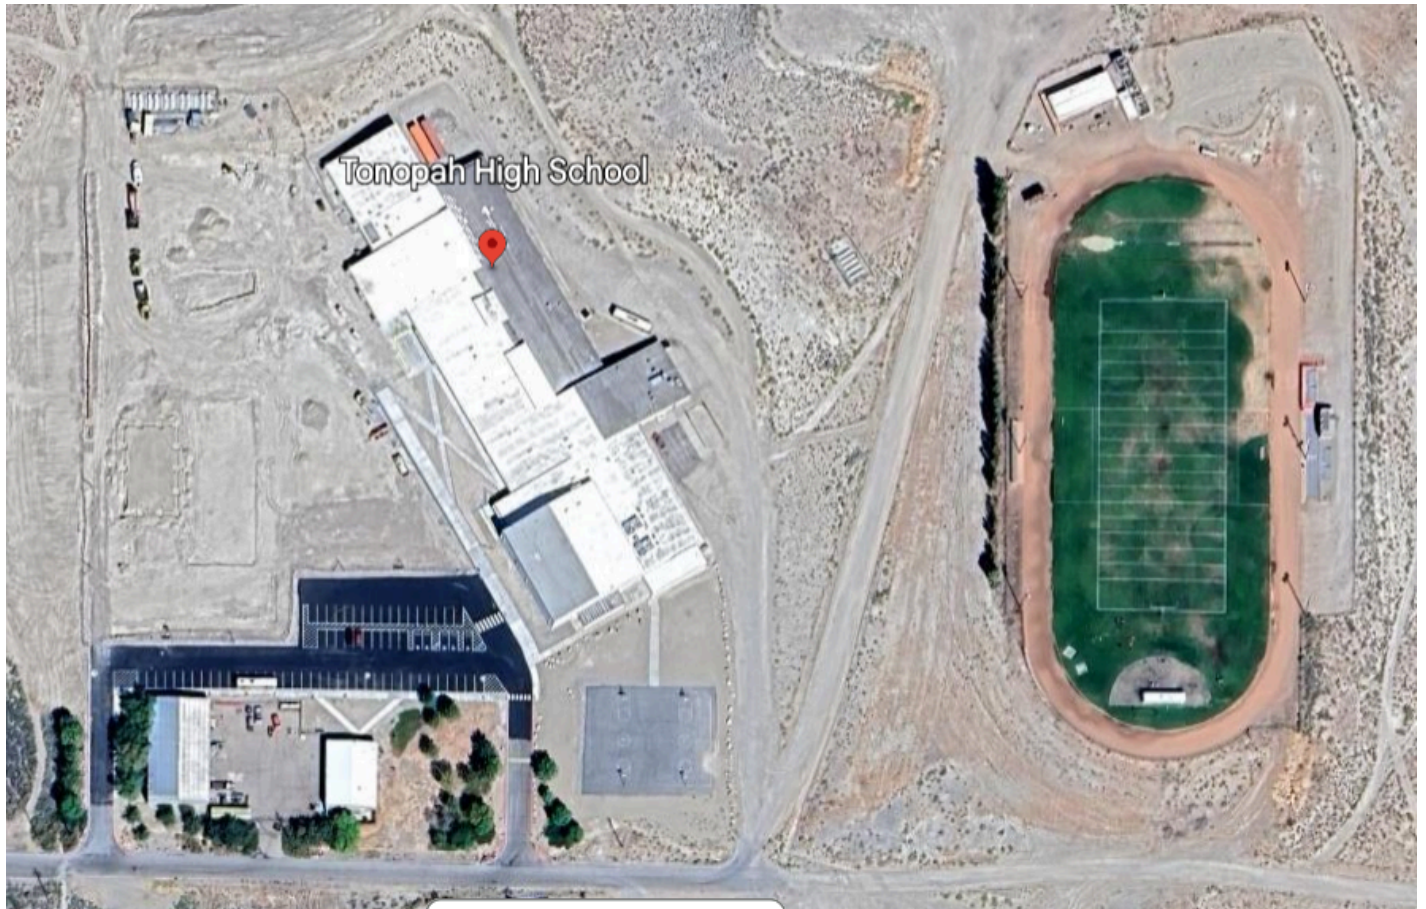
# Tonopah Middle/High School

In 2009, the entire campus underwent an evaluation for compliance with the Americans with Disabilities Act (ADA), which revealed multiple deficiencies. A report provided by PSWC Architects details the full scope of these issues. It is assumed that most of these deficiencies remain unaddressed, and remediation work should be prioritized as soon as funding becomes available. The school's HVAC systems were upgraded to R-410a refrigerant in 2024 to comply with modern standards. In addition, the heat exchanger plates were replaced at the same time to ensure maximum efficiency.

- The Technology Department is set to implement a comprehensive computer refresh across the campus in the summer of 2026.
- The District is moving forward with a new sports complex currently under design with KNIT. Its completion date is scheduled for 2027, pending available funds.

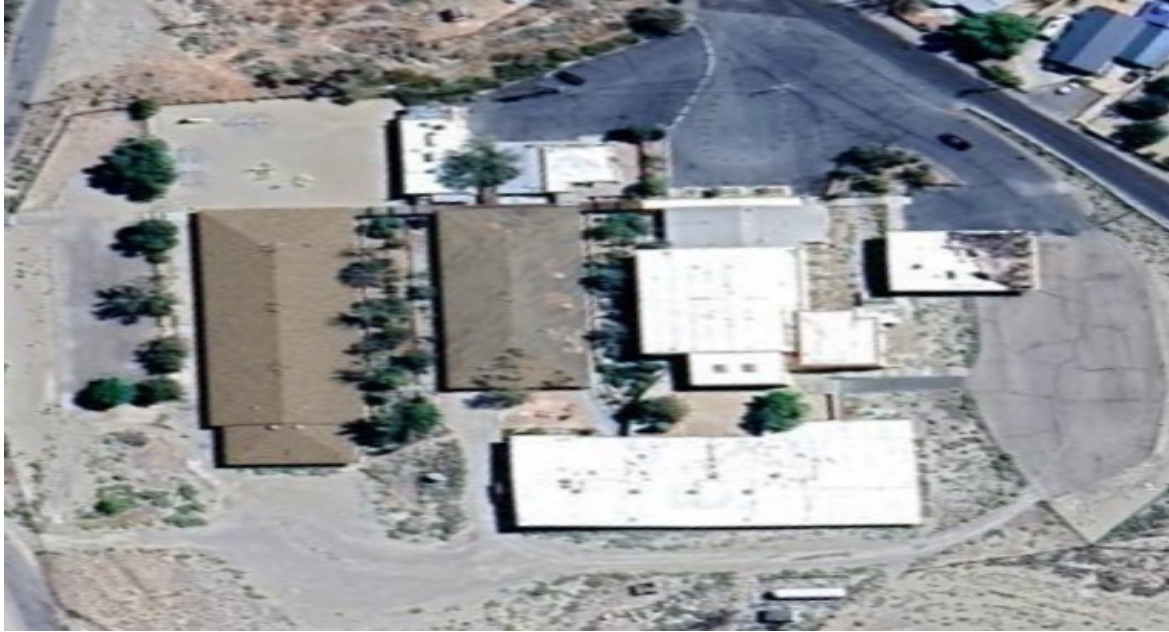
# Tonopah Elementary School

Tonopah Elementary School developed over time through a series of additions and modifications to existing structures, eventually expanding into a 74,531-square-foot complex consisting of multiple individual buildings. In 2009, the entire campus was evaluated for compliance with the Americans with Disabilities Act (ADA), revealing multiple deficiencies. A report provided by PSWC Architects details the full scope of these issues.

- The Technology Department is set to implement a comprehensive computer refresh across the campus in the summer of 2026.
- A new Tonopah elementary facility is currently under construction in the old parking lot of Tonopah High School. We are on schedule to start school when students return from winter break in January 2026.

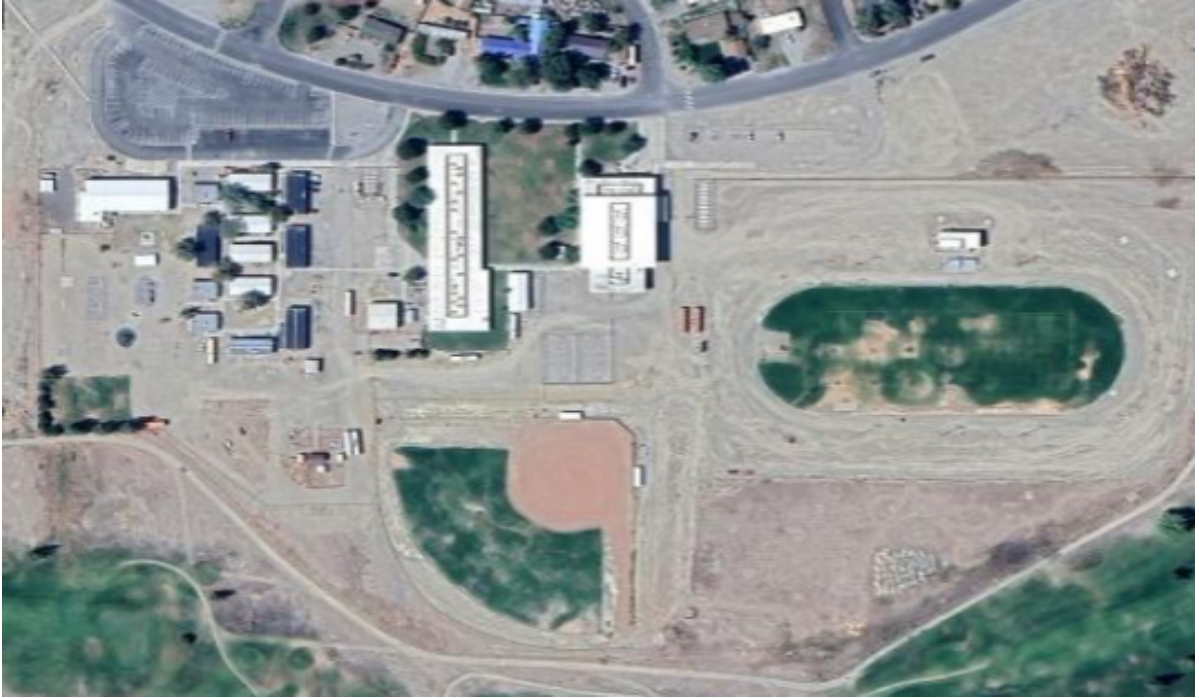
# Round Mountain Schools

Round Mountain Junior/Senior High School reveals that the facility consists of pre-engineered metal structures. In 2009, both the building and the immediate surrounding site were evaluated for compliance with the Americans with Disabilities Act (ADA), and multiple deficiencies were discovered. It is assumed that these deficiencies have not been addressed, and it is recommended that remediation work begin as soon as funding becomes available.

The elementary school also showed several ADA-related deficiencies during the 2009 evaluation. These site deficiencies are assumed to remain unaddressed, and remediation is recommended as soon as financial resources are available.

The Junior/Senior High School, the surrounding site was also evaluated for ADA compliance in 2009, with multiple deficiencies identified. Like the building, it is assumed that these deficiencies remain unremediated, and corrective action should be prioritized as funds become available.

\*Both the Junior/Senior High School and the Elementary School share a cafeteria/multi-purpose building, which was also evaluated for ADA compliance in 2009. Multiple deficiencies were discovered within the cafeteria, and it is assumed these issues have not been remediated. As with the other buildings and site areas, it is recommended that these deficiencies be addressed once funding permits.

- Sidewalks are deteriorating due to the use of ice melt and should be replaced as funds are available.
- Roofing is original; the Jr./ Sr. High and gym have been approved for replacement in 2025

- The rooftop HVAC units on the High School contain R-22 refrigerant and must be replaced with updated units as mechanical parts and freon are unavailable. This is tentatively scheduled for the 2026- 2027 school year based on the available budget.

- The kettle is starting to show its age and was installed in 1990 and will be replaced in the next 5 years.
- The serving table was installed in 2000 and is used daily and should be replaced if funds are available as it is an essential part of serving lunch and breakfast.
