# NYE COUNTY SCHOOL DISTRICT

# **Debt Management Policy**

**Fiscal Year 2027**

# July 2025 thru June 2030 MASTER PLAN UPDATE FOR THE

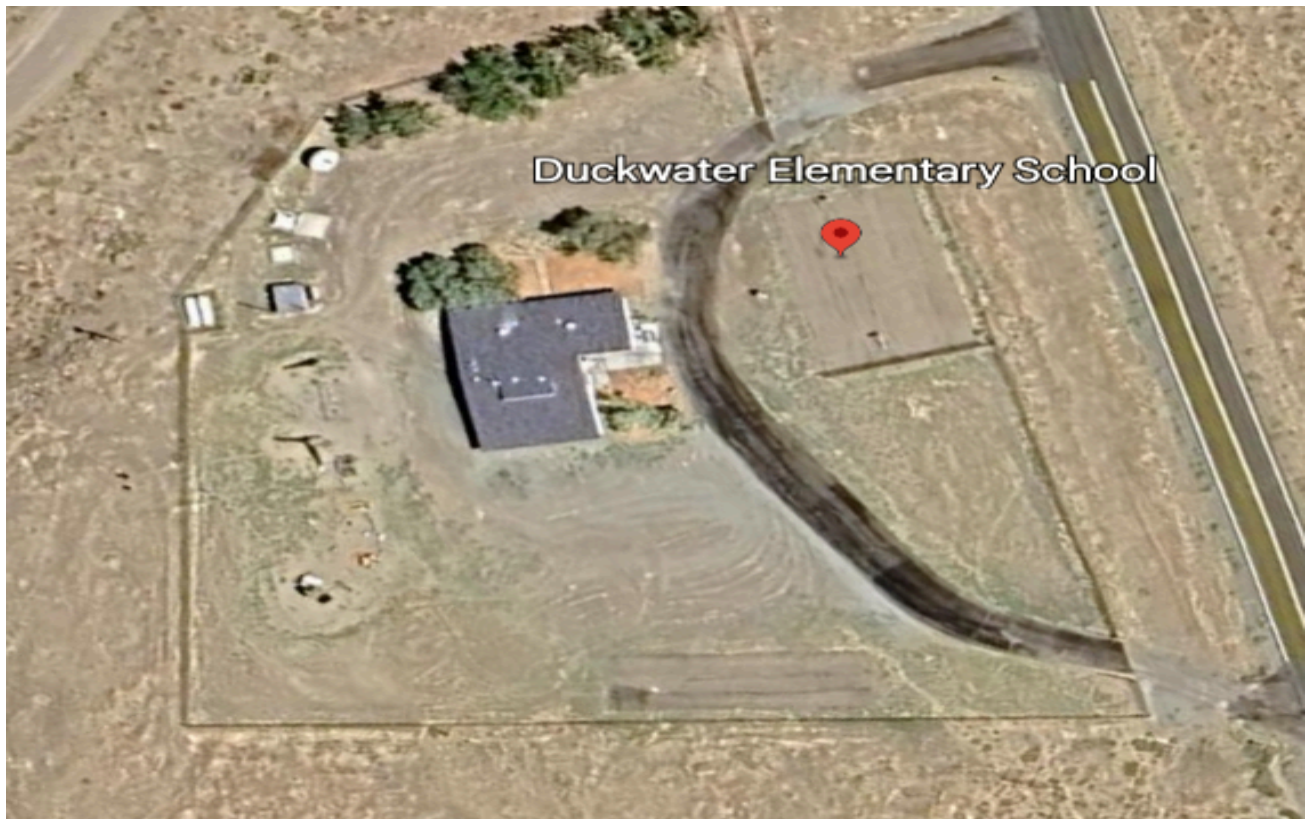
# Duckwater School

The Duckwater School, originally built in 1954, is made up of multiple buildings with varying construction types. These include wood frame, metal frame, and masonry structures, with roofing systems that also vary. Over the years, the school has seen new additions and modernizations, but there is no adherence to a consistent architectural theme. The school's building(s) and immediate site were evaluated in 2009 for compliance with the Americans with Disabilities Act (ADA), uncovering multiple deficiencies. It is assumed that most of these deficiencies remain unremediated. The recommendation is that remediation work should begin as soon as funding becomes available to address these issues and ensure the building meets ADA standards.

- Continue to keep the property maintained as the school is closed.

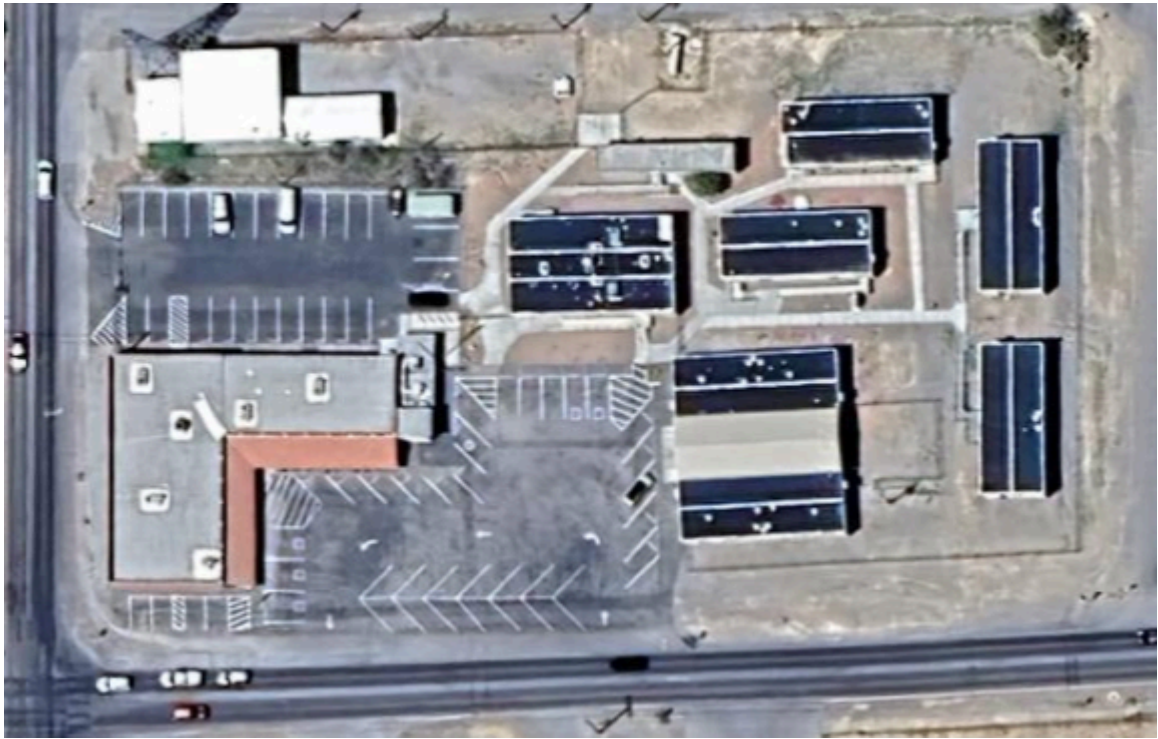
# Southern District Office

- A rekey of the property should be scheduled when funds are available so that the property is under the district's master key program.
- The A.C. paving surfaces will undergo maintenance, including crack repairs, a slurry coating, and restriping scheduled for the 2029/ 2030 fiscal year.

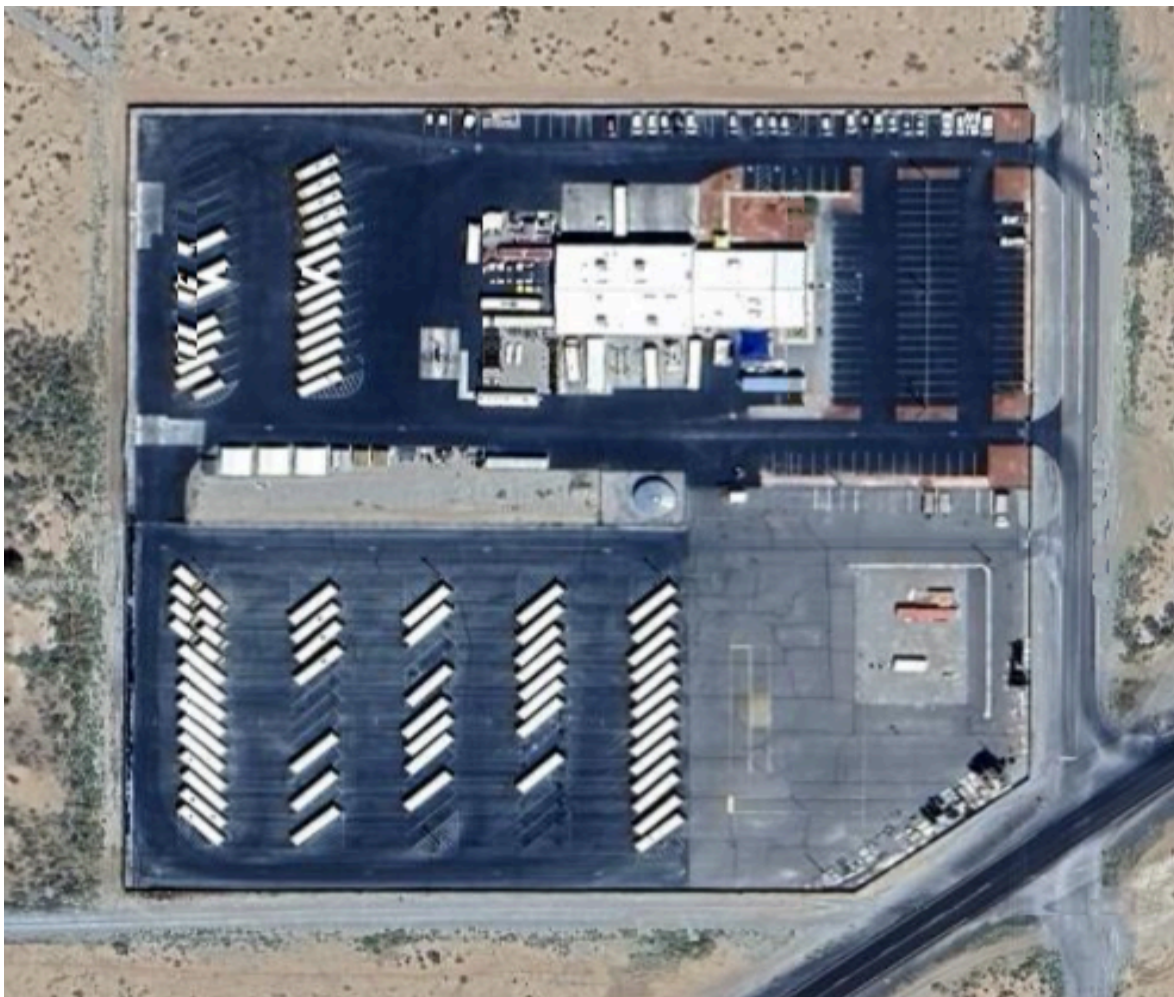
# Transportation Building

The Transportation Building was originally constructed in 2001, with a major addition built in 2008. The main structure of the building is a pre-engineered metal construction, which includes a 3,200-square-foot administration area and a 5,075-square-foot full-service shop area. The building is in generally good condition, though there were two areas on the westerly boundary where the paving has failed at the end of a drain swale. These areas have been repaired to prevent further damage. The facility was designed to comply with the Americans with Disabilities Act (ADA).

- The A.C. paving surfaces will undergo maintenance, including crack repairs, a slurry coating, and restriping, scheduled for the 2027/ 2028 fiscal year.
