Property Committee Meeting

Monday, November 9, 2026 4:00 PM
Virtual Meeting

Facility Condition Assessment – Transportation Building

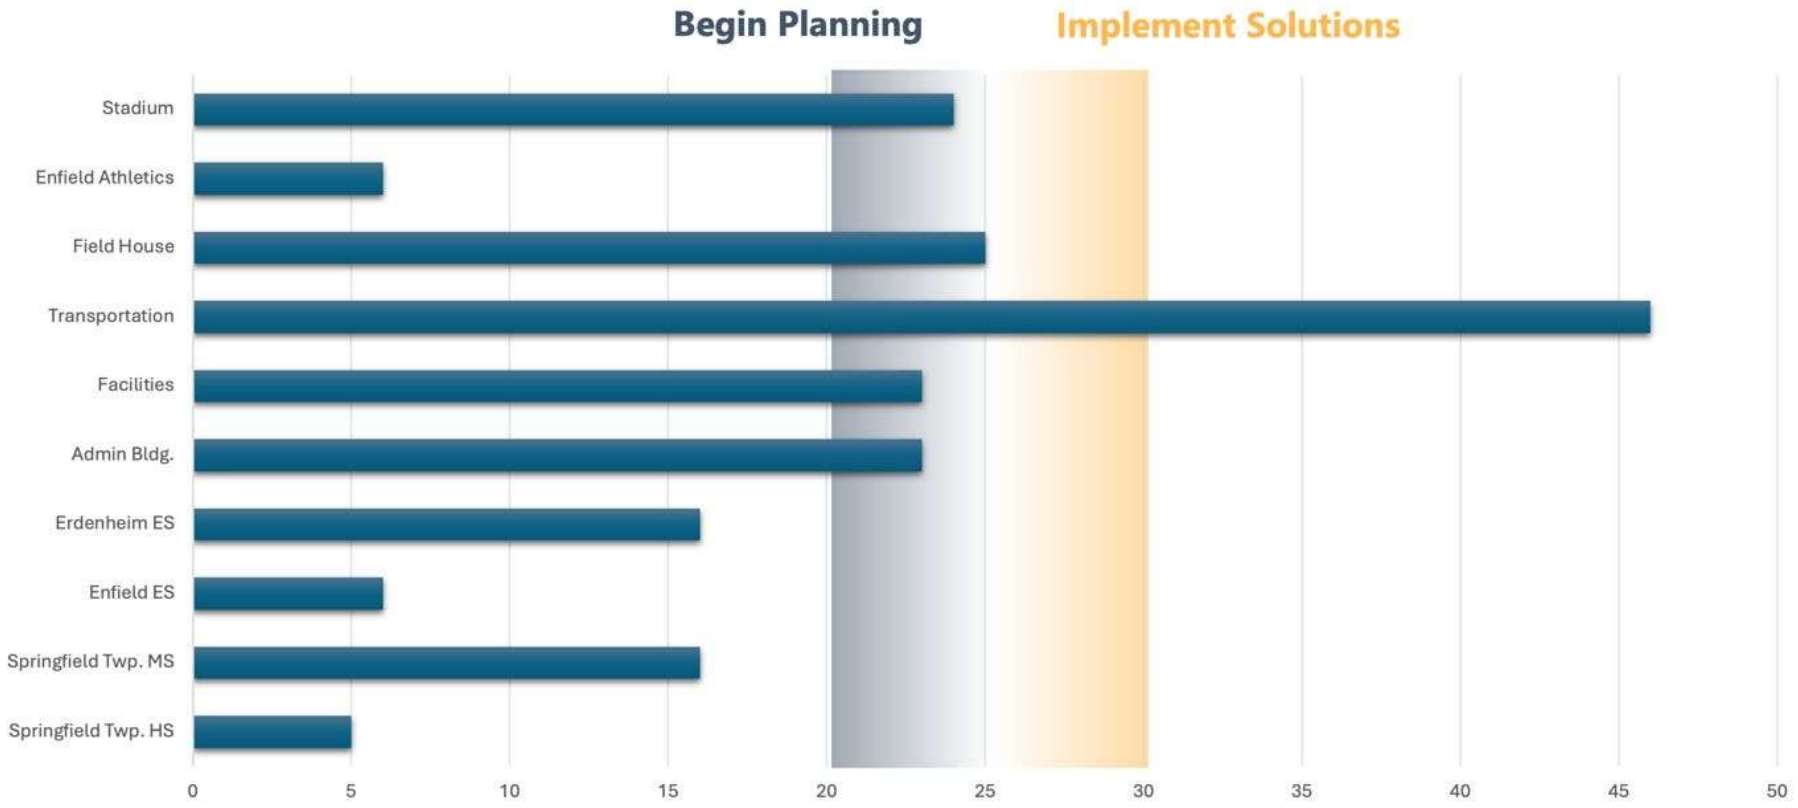
Facility needs are major at the Transportation Building. The district is in the process of engaging ICS to perform a feasibility study for options and considerations.

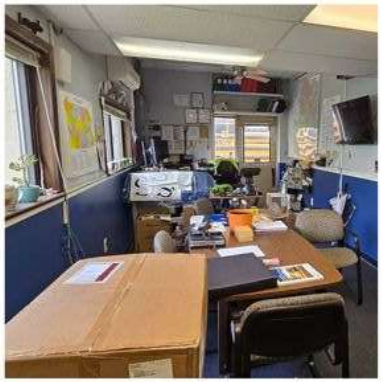
- The natural gas fired furnace was installed in 2016 and is in good condition. Replace at the end of its useful life which is around 2034
- 3 mini-split systems are past their useful life expectancy and in need of replacement
- Upgrade garage area ventilation system including CO and CO2 sensors and alarms
- The domestic water piping should be fully insulated/reinsulated properly
- Test existing water quality and determine if water softener would be beneficial
- Provide mixing valves at each electric water heater
- No sprinkler system present
- All seven (7) rooftop exhaust fan are past their useful life expectancy and need to be replaced
- Determine the age of the generator. Consider replacement if it's past useful life
