June Facilities, Finance & Operations Committee Meeting

**Subject:** 5 Year IAQ Report

**HVAC Ventilation Review**  
**Weston School District**  
**Intermediate School**

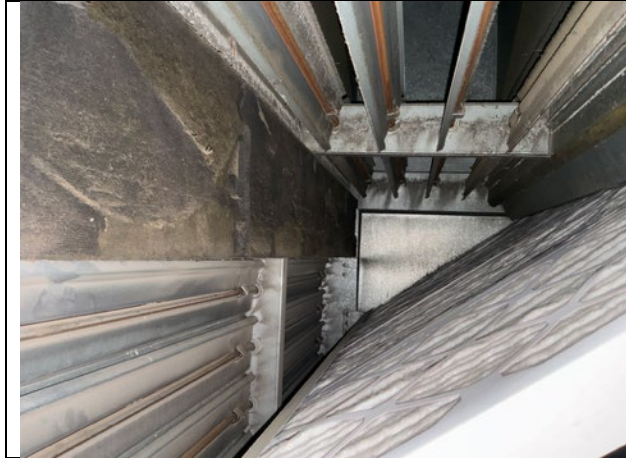
Outdoor air damper (top) is open  
Return air damper (left) is closed

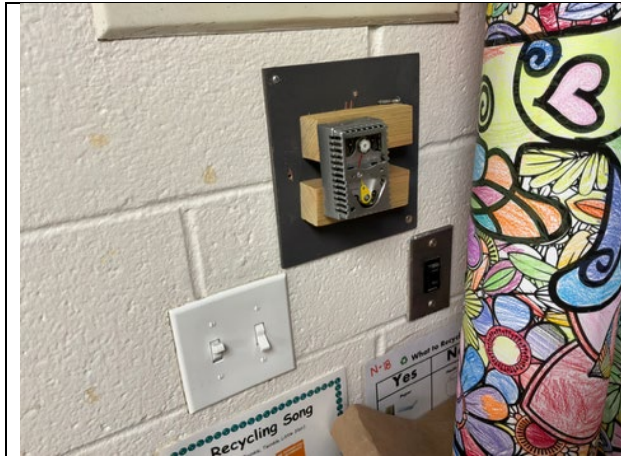
Pneumatic control of heating valve in unit
