Work Session with Vote on Consent
Agenda
Tuesday, November 18, 2025 6:00 PM

Building Assessment Report

PPS One North Commercial Building Inspection
2025-1106

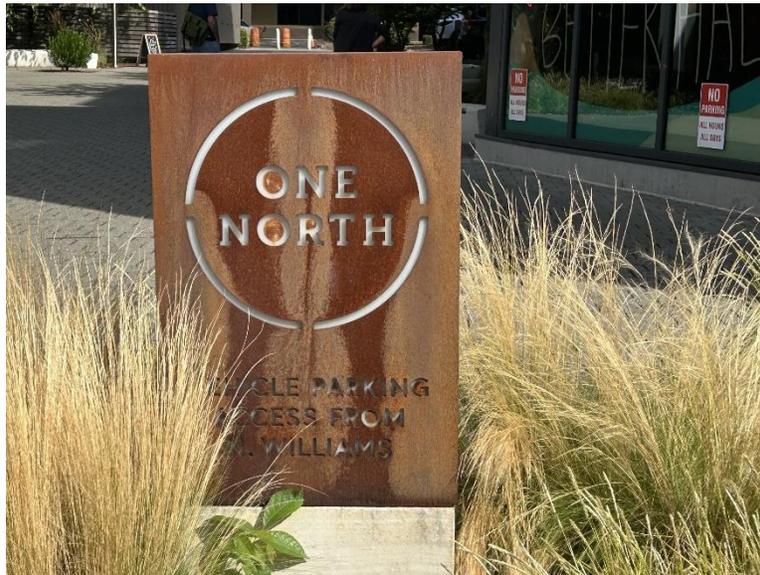
Figure A-3 One North - Directional sign for vehicular parking

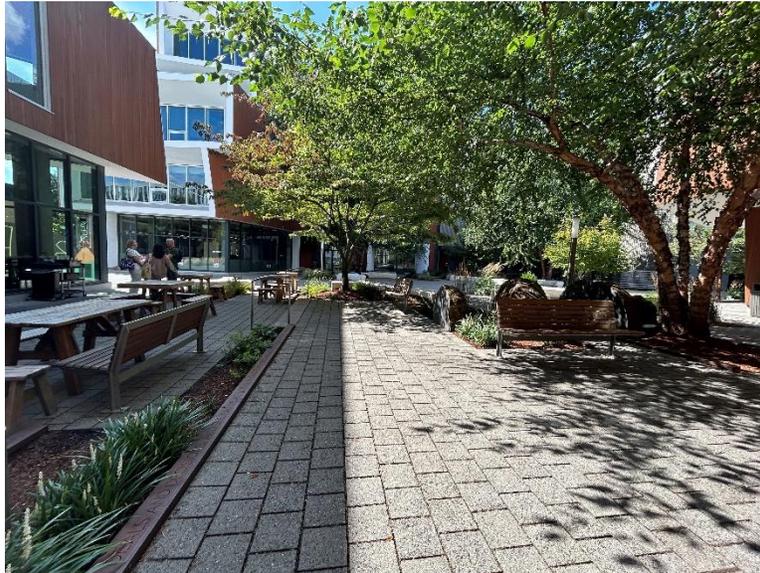
Figure A-4 Karuna II East Courtyard view to west

Plant and paving materials are consistent across the site. They appear well established and well maintained with areas in need of plant renewal. Low steel rails stamped with artful comments line planter edges at several locations. The color contrast and height are low, presenting tripping hazards where paths intersect.

The site slopes down from northeast to southwest. Connective walking paths are low slope and appear to be accessible routes. Planters and low concrete faced retaining walls provide structured height transitions – notably at the Karuna II East building courtyard. Steel punched plates at planters' edge and large organic shaped benches mark the boundaries for pedestrians and vehicles to navigate within the courtyard. Removable bollards at the north end of fire lane limit traffic from driving through. Other fixtures on site include bicycle racks near building entry doors, benches, and bollard lighting. Irrigation heads were visible within courtyard planting beds.

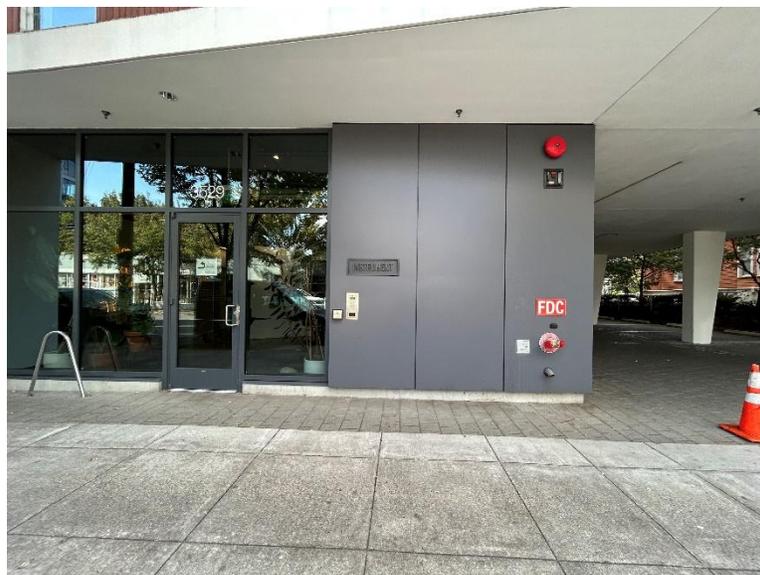
Figure A-7 Karuna II East Parking and Main Accessible Lobby Entry

- Recommend a detailed evaluation and develop conformance schedule for the buildings and site accessible signage.
- Karuna II East building accessible parking: Van Accessible sign (R7-8P) and Access Aisle pavement markings required per Oregon Revised Statute (ORS) 447.233 and Oregon Structural Specialty Code Chapter 11 were missing.
- Karuna II East and West buildings: Elevator landing and interior tenant signage indicating accessible exits.

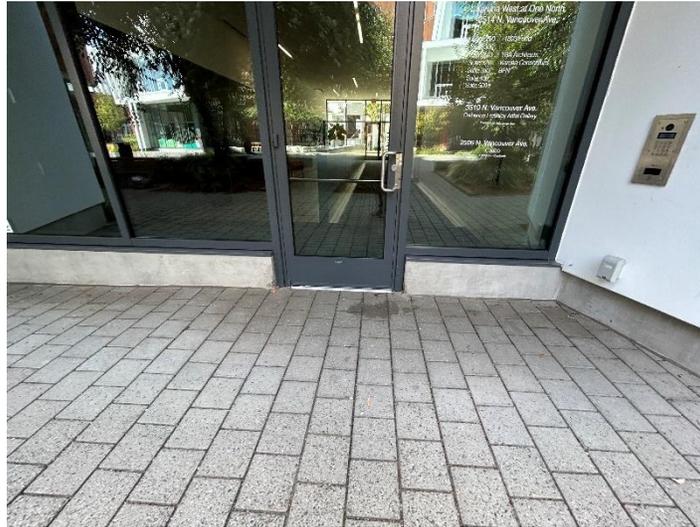
*Figure A-12 Karuna II West courtyard main lobby entry door.
Prefinished storefront window and door system.
Door bottom rail height is less than 10 inches.*

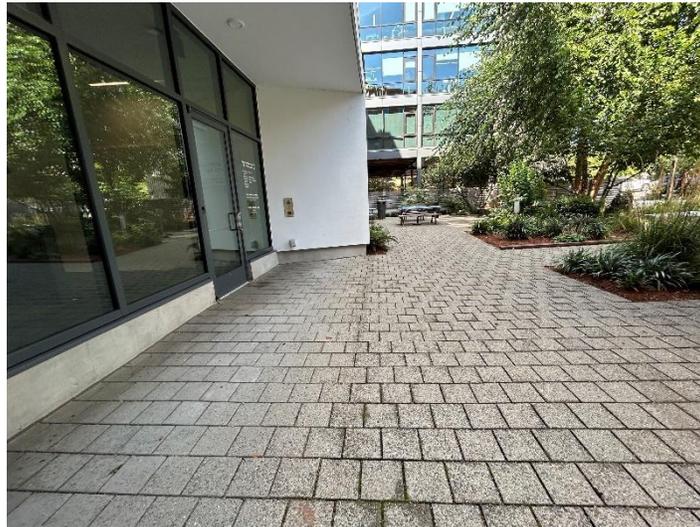
*Figure A-13 Karuna II West courtyard entry door approach with access call box.
Overhead downlights at soffit above.*

- Observed uneven surfaces and varying joint widths near the West building exterior exit passage and the north entry lobby call box. Other areas may exist, and further review is recommended to repair paver and material transitions resulting in smooth and level surface with well-anchored materials.
- Evaluate exterior lighting levels for conformance with exit path illumination code. include building courtyard exits and connecting paths within the courtyard to the fire lane.
- Coordinate waste collection pick up location and days with tenants and adjacent building owners. Plan for Facilities operational staff to maneuver carts to and from locations on service days.
- An evaluation of bicycle parking provided versus required for the building site is recommended to maintain conformance with city zoning codes as building improvements occur in time.

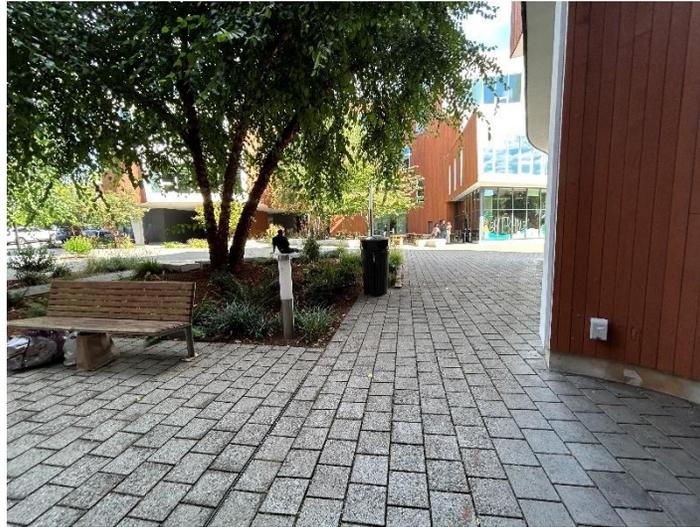
Figure A-14 Karuna II West courtyard view from exit passage to fire lane beyond. Common courtyard fixtures include lighting, waste receptacles, and benches.

- Measure exit illumination levels along path from exit to fire lane.
- Maintenance to remove discoloration on concrete stem wall.
- Maintenance to secure paver system smooth and well anchored. Paver joint with metal insert extends to building from planter.
- Paver wear varies at building wall and beyond drip line.
- Existing exterior furnishings and fixtures—including exterior lighting, waste receptacles, and benches in the courtyard—present safety and fire risks. Recommend evaluating these fixtures are

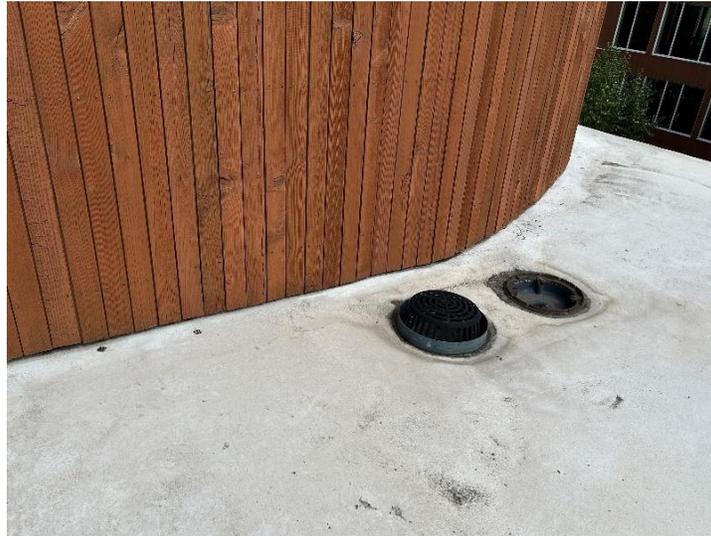
*Figure A-16 Karuna II roof to exterior wall and roof drain.
Install roof drain screen and anchor into flange.*

- Secure roof drain screen baskets to trim ring.

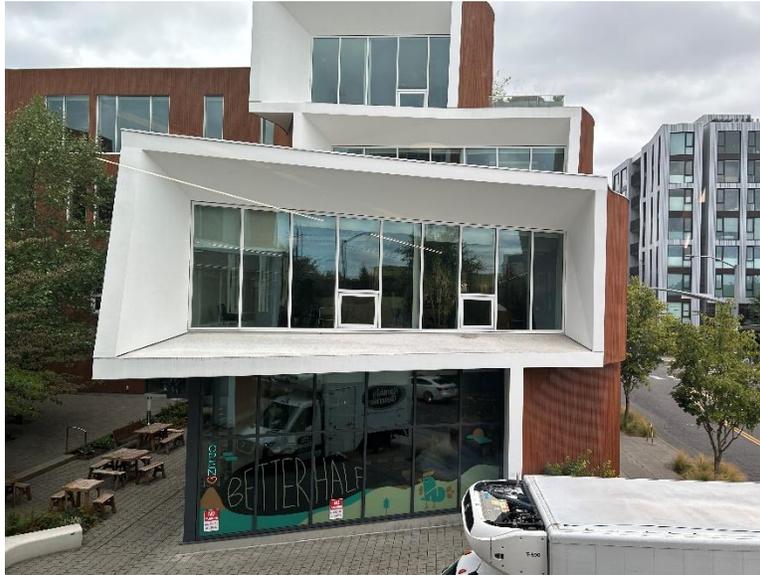
Roof finishes are white with roof membranes adhered to low profile coping. Dirt and debris on the white membranes are visible through tenant windows from the interior and adjacent buildings. Frequent maintenance will be necessary to keep the area clean and avoid deterioration. The only way to clean these areas would be via vertical lift from the street and courtyard.

Figure A-17 Karuna II East building white apertures surrounding upper-level windows.

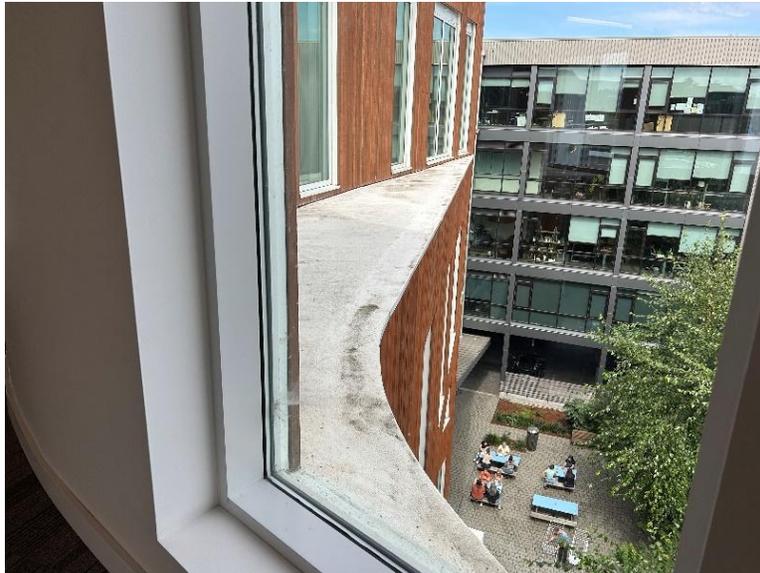
*Figure A-18 Karuna II West unique roof shapes.
View north from tenant space level 4.*

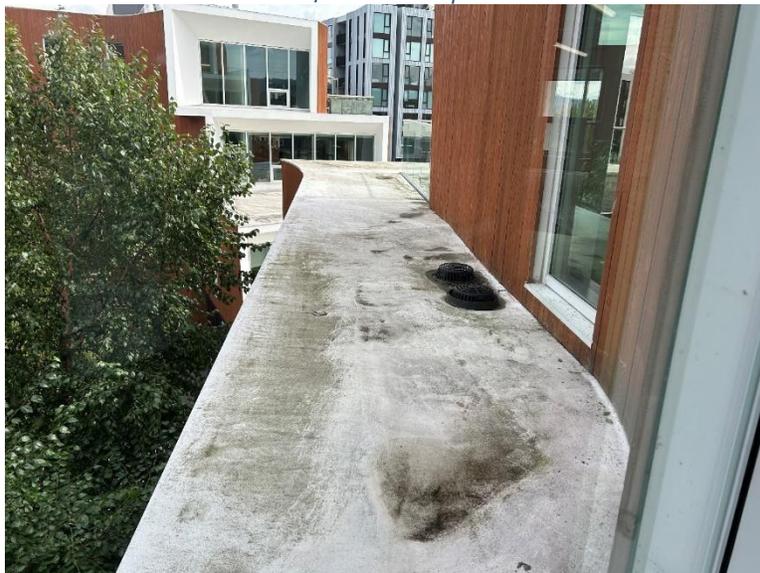
*Figure A-19 Karuna II West. Roof drain at exterior wall.
View east from level 4 tenant space.*

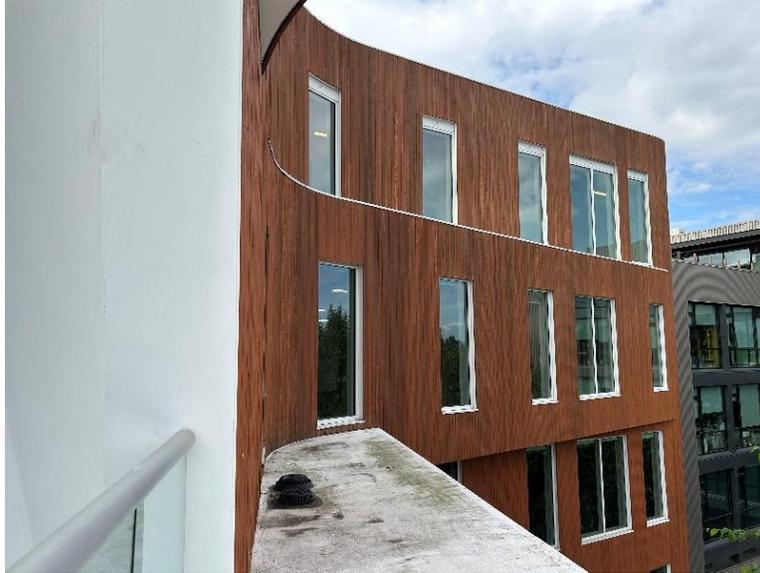
*Figure A-20 Karuna II West. Roof drain at exterior wall.
View west from level 4 tenant space.*

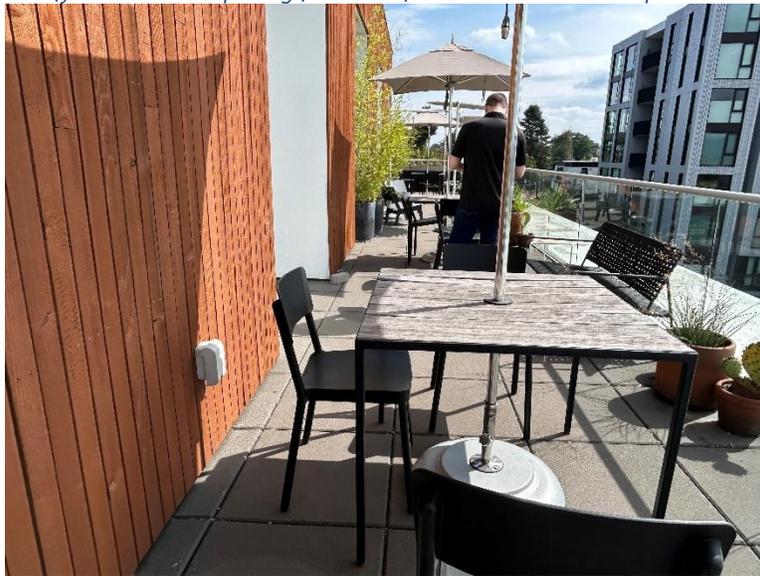
Figure A-23 Karuna II West south terrace view east. Concrete paver finish over roof with drains below. Glass guard rail height at perimeter conforms with code minimum.

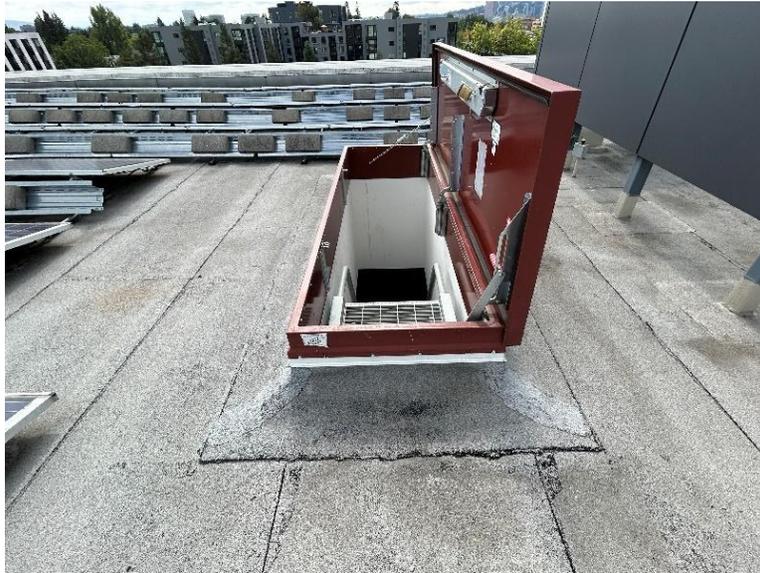
Figure A-24 Figure 48 Karuna II West Roof Access hatch.

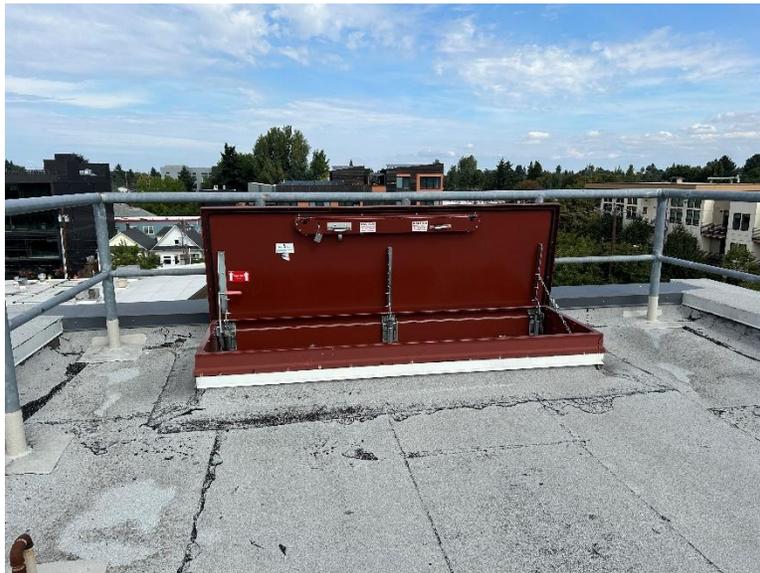
The building's primary roof is access by ships ladder through large roof hatch. The ships ladder and hatch provide ease of access from stair below. The hatch lid when open on Karuna II East building provides a barrier at the north building roof edge. A short section of raise parapet provides a tall guard when stepping onto the roof. The roof hatch on Karuna II West building is centrally located within a few steps of the main mechanical equipment enclosure.

Figure A-25 Karuna II East Roof Access hatch and perimeter guard at north building wall.

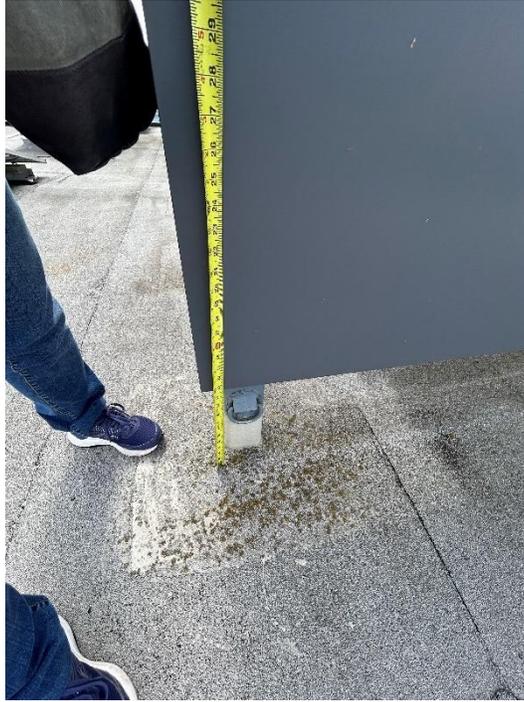
Fall protection exists with a single tie off near the roof center and additional D-rings welded to the screen tube steel posts of the mechanical screen enclosure. Exterior lighting was not observed on the roof level.

Figure A-26 Karuna II West 'D ring' anchor on mechanical screen enclosure post.

- Adjust mechanical screen enclosure gates to remove sag and result in ability to open and close without force.
- Adjust solar panel racks to provide walkways at roof perimeter to conform with code.
- Evaluate installation of additional fall arrest anchors for worker safety tie off.
- Engage PPS Risk to evaluate roof terraces for student and public use areas. The guard rail to roof ledge configurations and access control after hours.

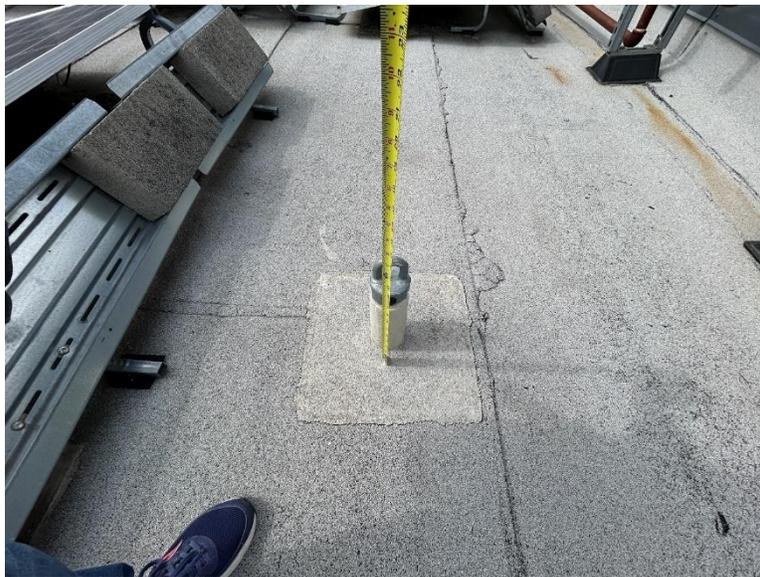
Figure A-27 Karuna II West fall restraint anchor at main building roof.

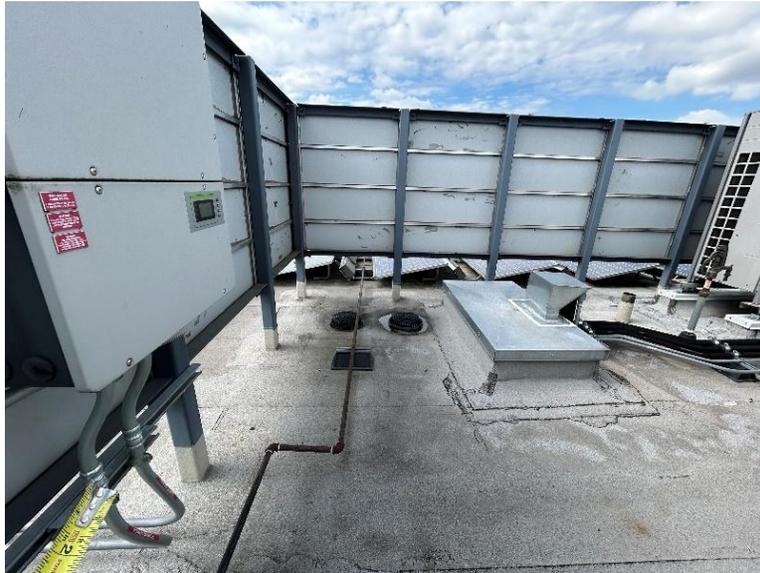
Painted steel mechanical screens surround roof top mechanical equipment near the roof centers. Roof top equipment on raised curbs, surface conduits, and pipes on blocks, and control panels mounted to the screen frame can be found within the enclosure. Doors on the enclosure are heavy steel with lever hardware and latches. The doors have sagged over time and require effort for them to close.

Figure A-28 Karuna II West view inside main building roof top mechanical screen enclosure.

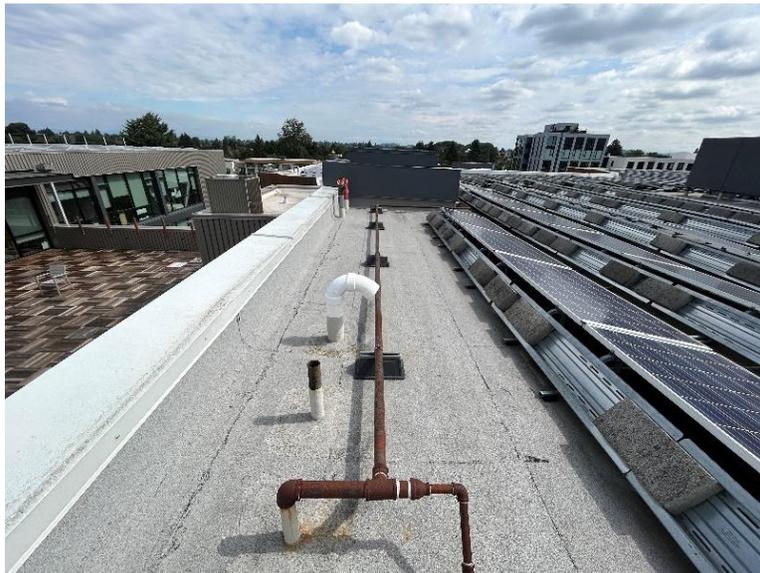
*Figure A-29 Karuna II West main building roof parapet coping at north wall.
Gas line on surface blocks.
Standpipe and elevator roof view beyond.*

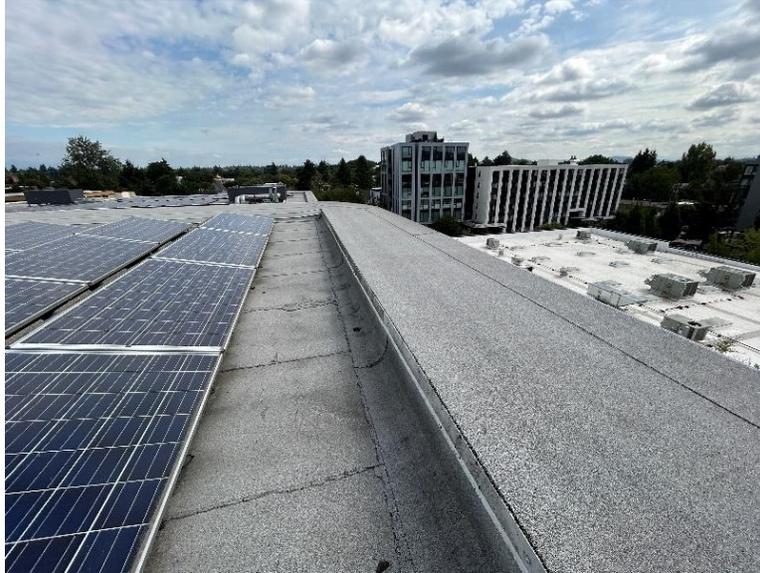
Figure A-30 Karuna II West building roof step at south wall.

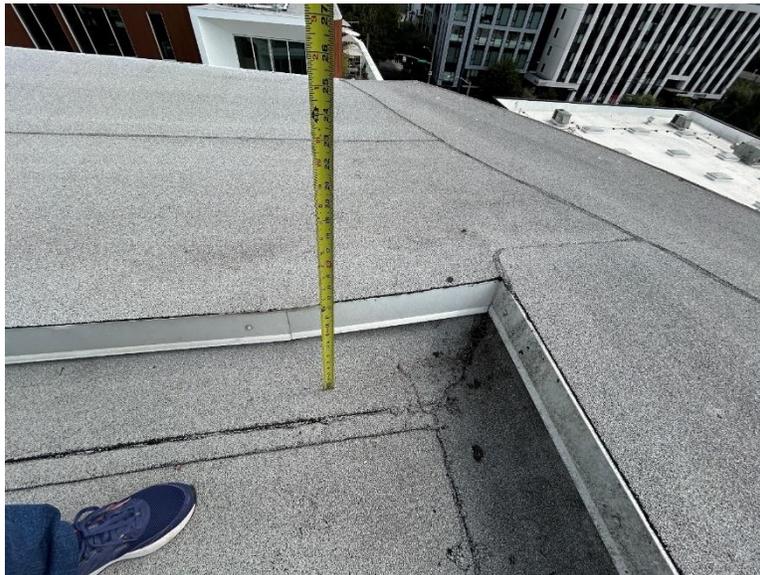
Figure A-31 Karuna II West building roof step at northeast corner.

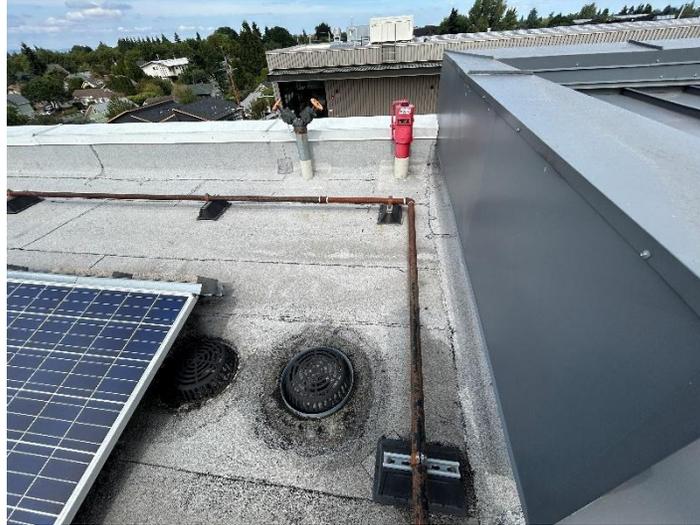
*Figure A-32 Karuna II West roof at elevator roof and north property line.
Metal joint cover transitions from building roof to elevator roof clad in metal roof panel.
Fire standpipe onto roof from stair below.*

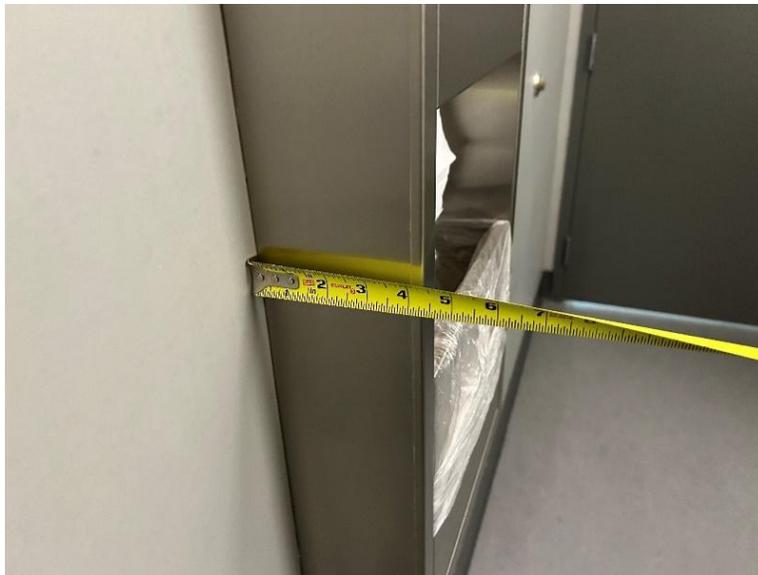
Figure A-41 Surface mounted Paper towel dispensers protrude more than four inches from wall on the route to accessible toilet compartment.

- Mounting of accessories below grab bar interferes with grab bar operations and is recommended to be relocated per ADA standards.
- Wall-mounted paper towel dispensers on site measured more than four inches and where they are located along the accessible route from toilet room door to accessible stall are considered protruding objects. Installing a maximum 4-inch-deep dispenser is recommended at these locations.

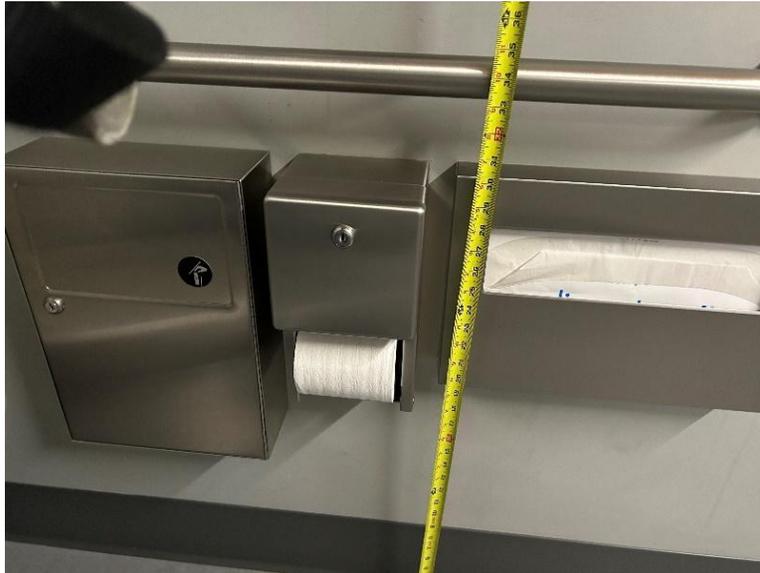
*Figure A-44 Grab bar and Toilet Accessories surface mounted.
Projection and location of accessories conflict with accessible clearances for grab bar.*

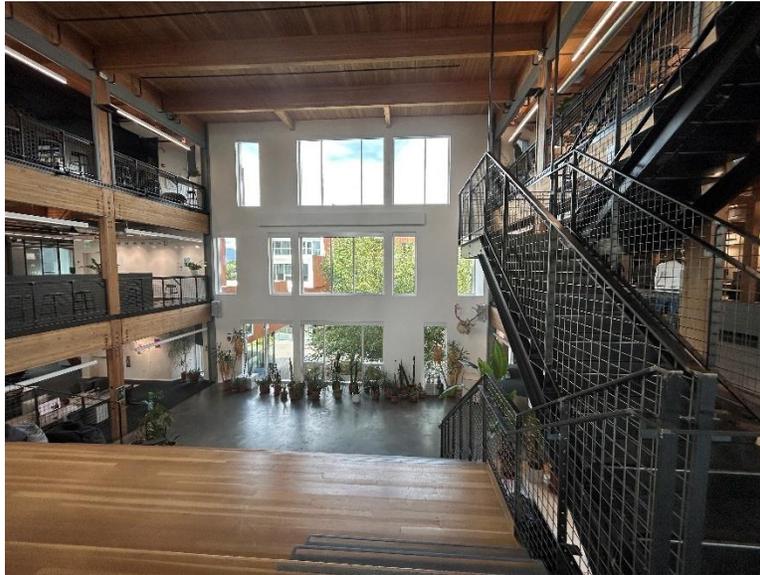
*Figure A-54 Karuna II East stadium seating and open stair in tenant space.
Open space connecting 3 floors with fire shutters at level top level.
Steel stair with guard and continues rail.
View west to courtyard beyond.*

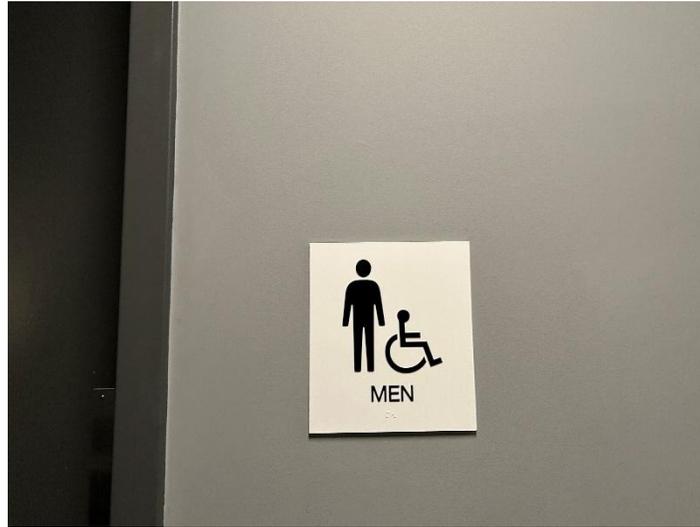
Typical signage for toilet rooms, interior exit stairs conforms with code for mounting height, symbols, raised characters and braille. Conformance varies inside tenant spaces.

Figure A-61 Karuna II West - Typical gendered toilet room signage

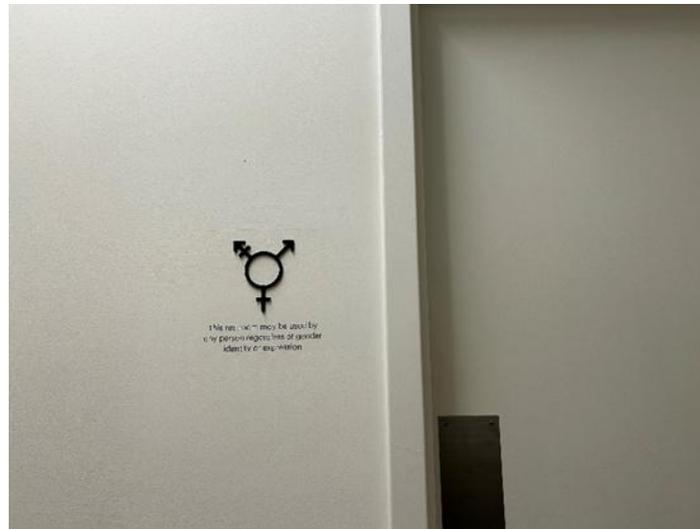
*Figure A-62 Karuna II West - Tenant space toilet room signage.
Lettering applied to wall surface is not raised and does not conform to code for accessible toilet room wayfinding.*

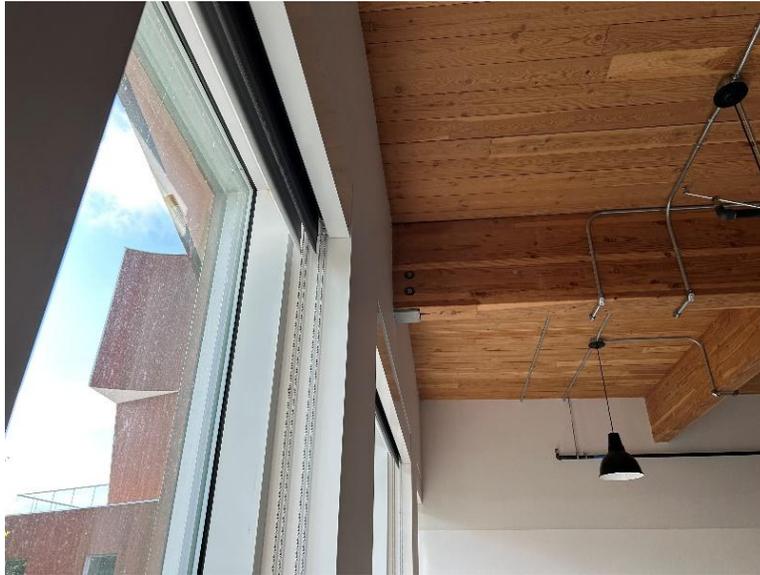
In the West building the full floor tenant Level 3, private offices and other rooms are fitted with access control swipe pads to secure the rooms. The suite also has motorized black out shades with switch controls near the room entry doors.

Figure A-68 Karuna II West and East building roller shade window treatments

- For O and M purposes, recommend an evaluation locations where motorized and manual shades occur.

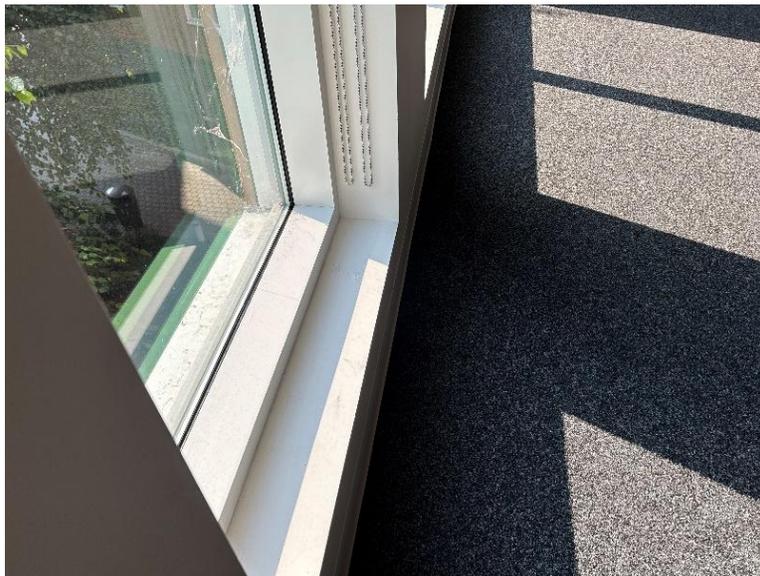
Figure A-69 Karuna II West and East building windowsill finish

- Recommend consideration of more durable material such as solid surface at windowsills in areas of student use areas.
- Recommend evaluation and consideration to install durable, heavy impact finishes in areas where student use is planned.

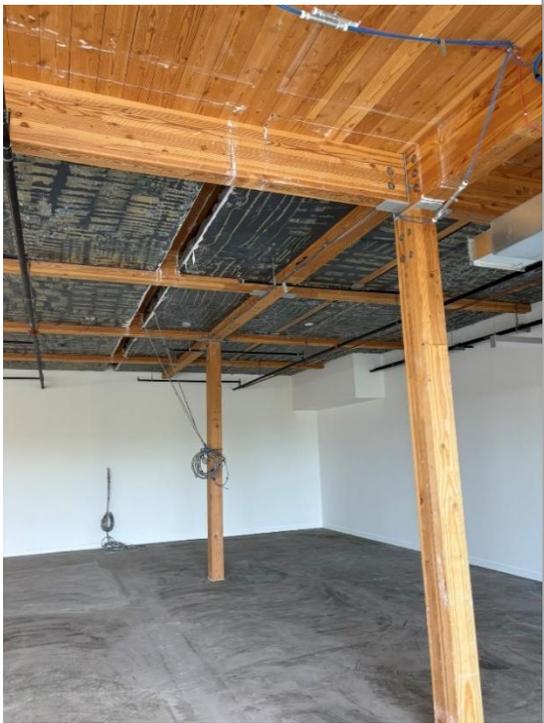
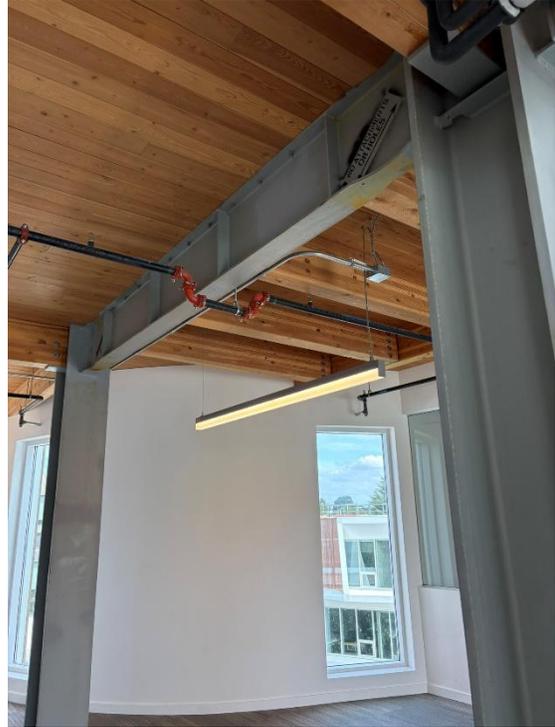
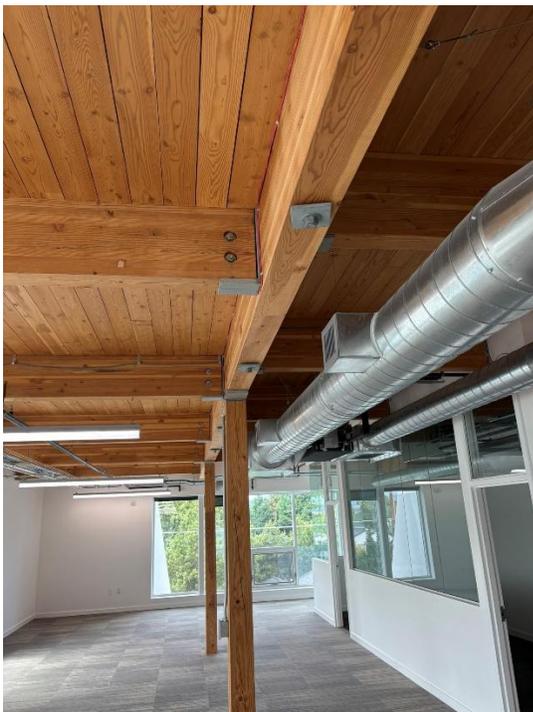
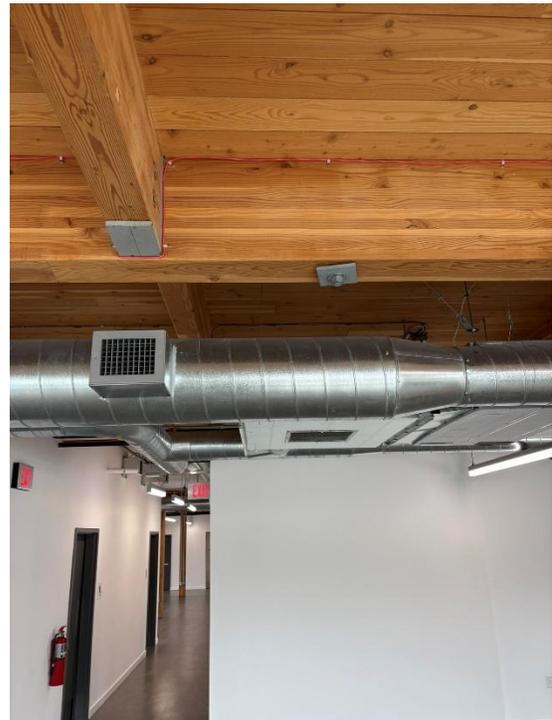
Structural Observation Photos Karuna II West

Karuna II West has been in service for approximately eight years and, as a relatively new structure, appears to be performing as expected. The mass timber framing did not exhibit significant checking or splitting; while some minor checking was observed, it is consistent with the natural behavior of timber and considered typical for this type of construction. Minor drywall cracking was noted in isolated locations, particularly at re-entrant corners, which is also common in buildings of this age and structural system. A few timber connections exhibited visible gaps due to shrinkage over time.

In reviewing the structural drawings, we noted that the post-tensioned slab at Level 2 was not detailed to accommodate shrinkage in the manner typically expected. Standard practice often includes a pour joint near the mid-span of the slab or a slip joint at the slab-to-wall interface, which allows the slab to shrink before a pourback is placed. Without this detailing, slab shrinkage can impart additional stress on the concrete shear walls as they resist the slab’s shortening. The shear walls were not exposed to view during our site visit, and no shrinkage-related cracking or distress was observed in the accessible areas. This is a condition to be aware of if cracks are discovered hidden under finishes.

- As with many mass timber structures, some shrinkage has occurred over time, resulting in localized gaps at connections where bolts or screws have loosened. This shrinkage should be substantially complete at this stage, and it is recommended that any loose bolts and lag screws, exposed to view be tightened to maintain proper bearing at connections.
- Overall, no conditions were observed that would indicate a reduction in the structural integrity of the building.

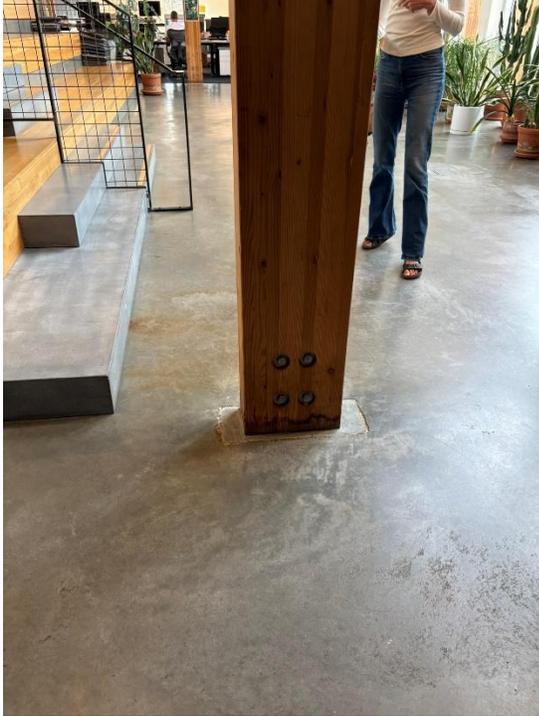
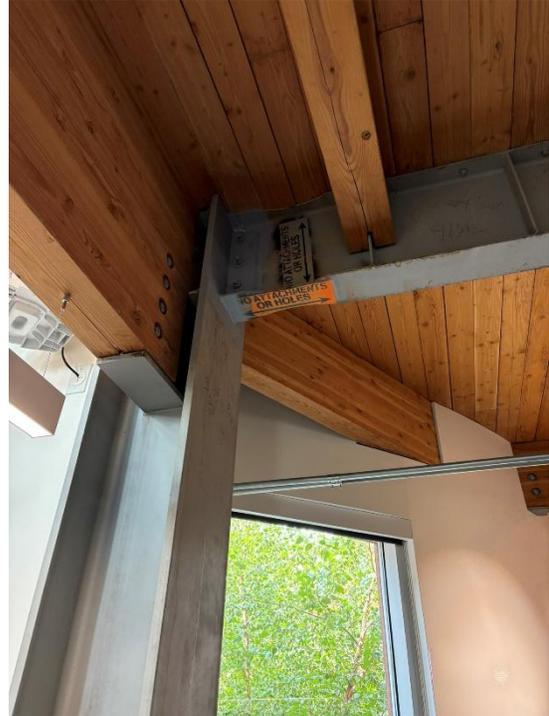
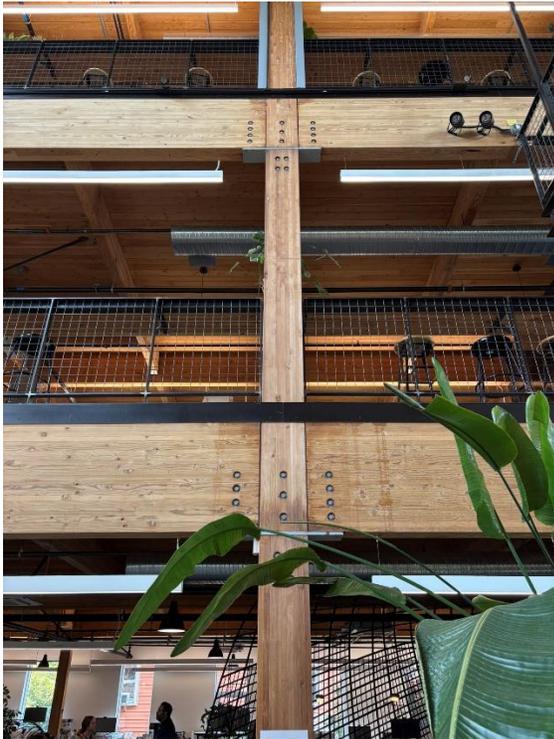
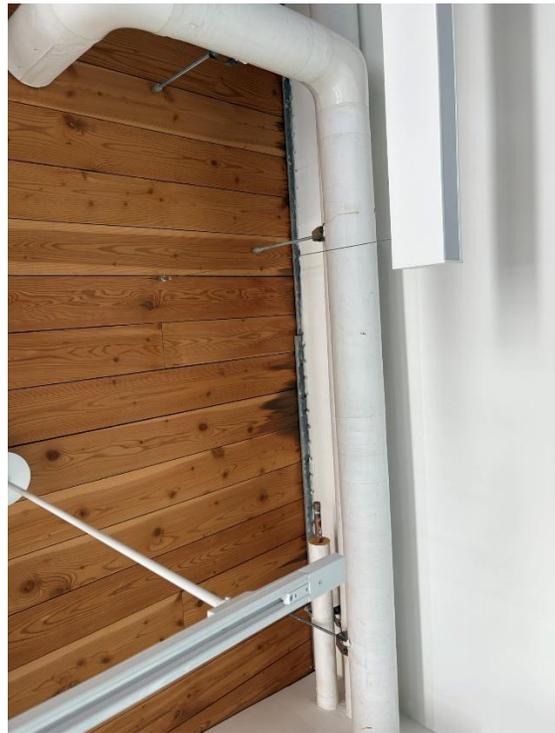
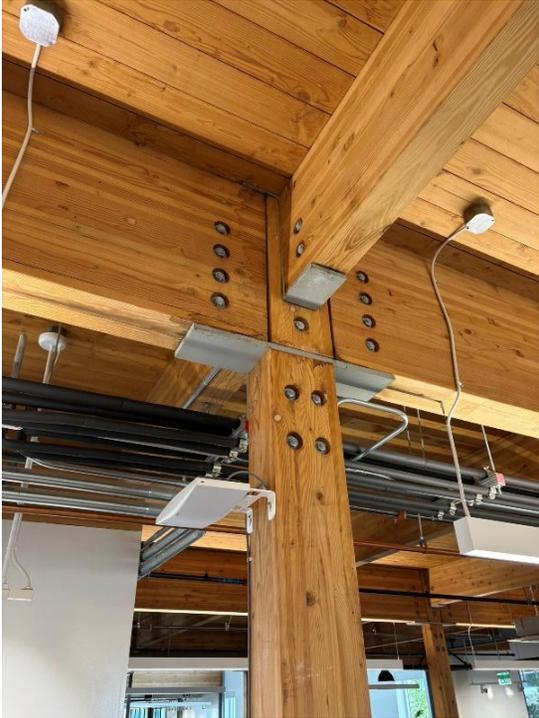
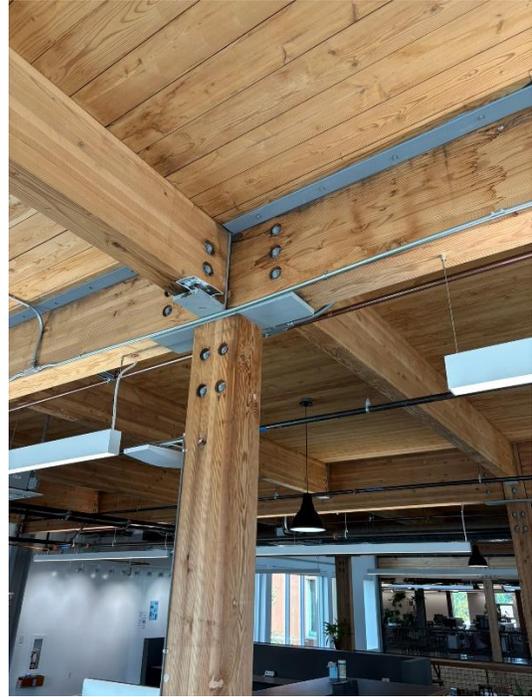
Structural Observation Photos Karuna II East

Karuna II East has also been in service for approximately eight years and is generally in good condition for a building of its age and construction type. The mass timber elements showed only minor checking and splitting, which is typical and not considered structurally significant. Some water staining was observed on glulam columns and beams, most notably near column-to-floor joints. Based on the staining patterns, this appears to result from routine floor cleaning, where water has seeped through small joints at the floor/column interface and run down the face of the columns. The staining is considered an aesthetic issue and does not affect the structural performance of the timber. Similar to the West building, small drywall cracks were observed in locations with re-entrant corners, and a few timber connections exhibited visible gaps due to shrinkage over time.

As with Karuna II West, our review of the structural drawings indicated that the post-tensioned slab at Level 2 was not detailed with a shrinkage joint or slip joint at the slab-to-wall connection. This type of detailing is often used to reduce stresses on shear walls by allowing slab shrinkage to occur prior to placement of a pourback. In the absence of this detail, shrinkage of the slab can increase stresses at the wall/slab interface. During our observations, the concrete shear walls were not exposed, and no visible shrinkage-related cracking or distress was noted. This condition should be monitored in the future, particularly if cracking develops at shear walls or at slab-to-wall connections.

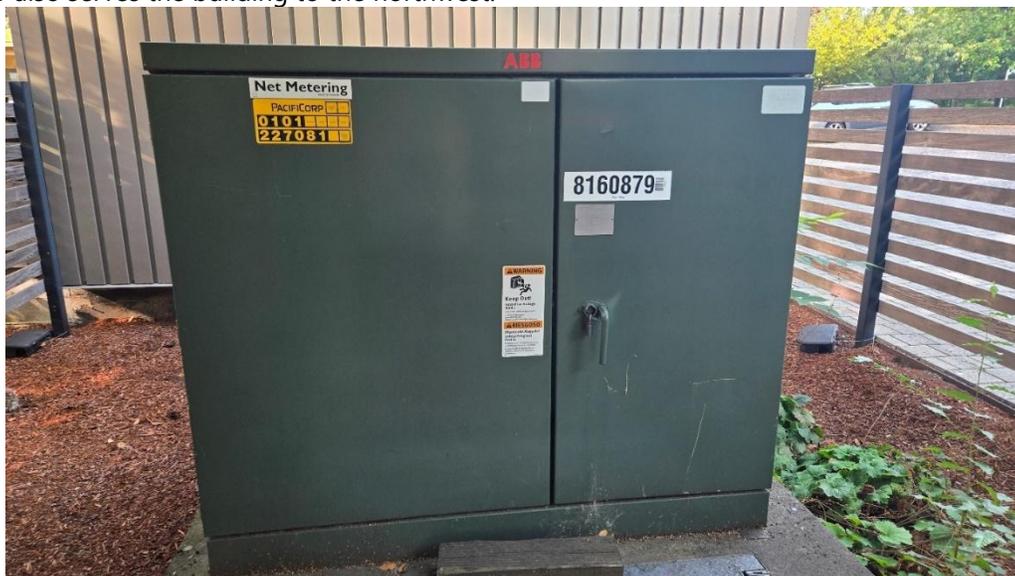
Power to both buildings is provided by a 500 kVA, 12470Y/7200-480Y/277V pad-mounted transformer served by Pacific Power. The transformer is in a gated enclosure and appears to be in good condition. The transformer also serves the building to the northwest.

Figure E-70 - Pacific Power Transformer

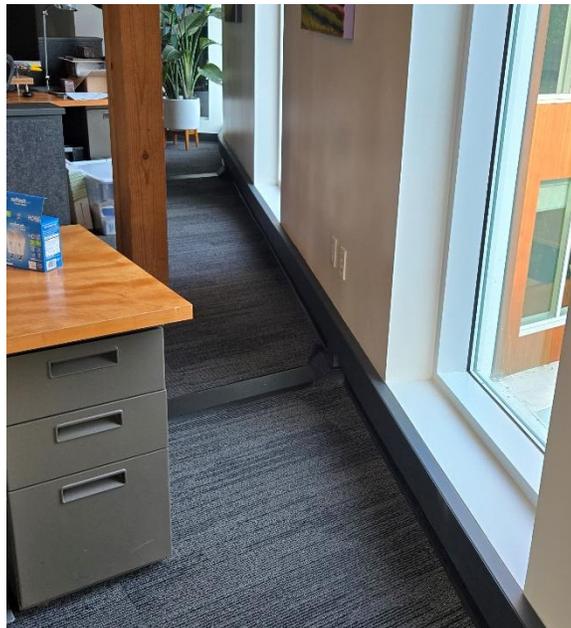
There is a baseboard raceway and above-ground raceway to provide power to desks in Suite 310 (Figure E-73). Consider removing this if space is to be reused.

Figure E-73 - Suite 310 Floor Raceway
