## **Board of Education Study Session**

School District of Seward

# Condition Summary

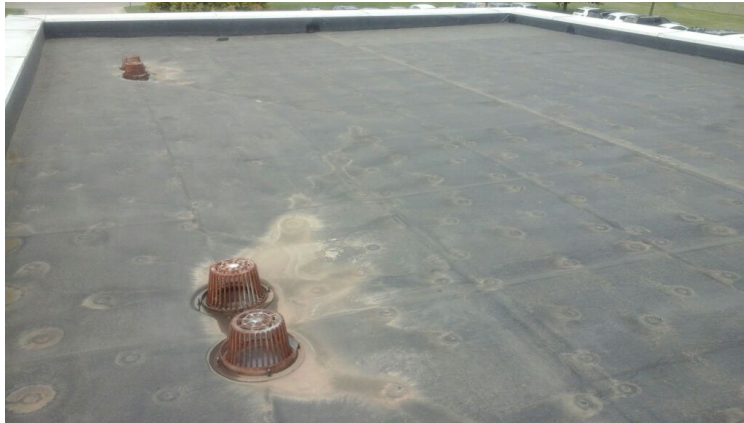
This roof is in good condition and appears to be performing well.

Photo showing overview of Area 01 Roof.

I recommend continued inspections and maintenance.

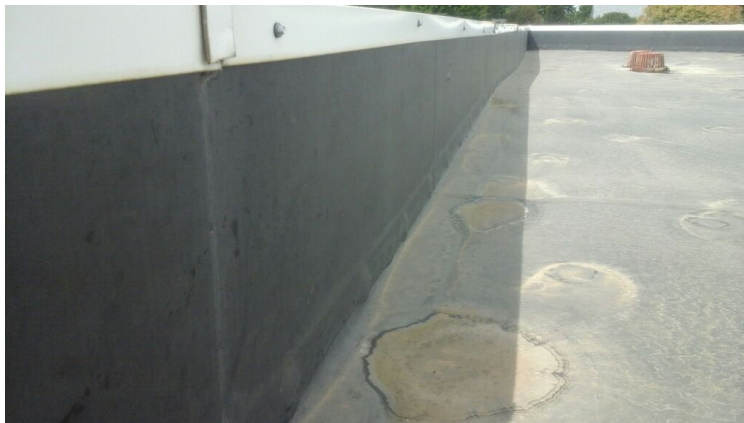
Photo showing condition of the perimeter flashings.

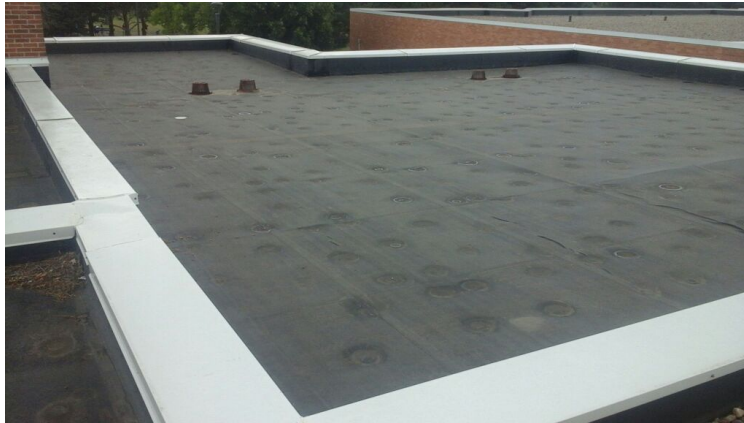
Photo showing overview of Area 04 Roof.

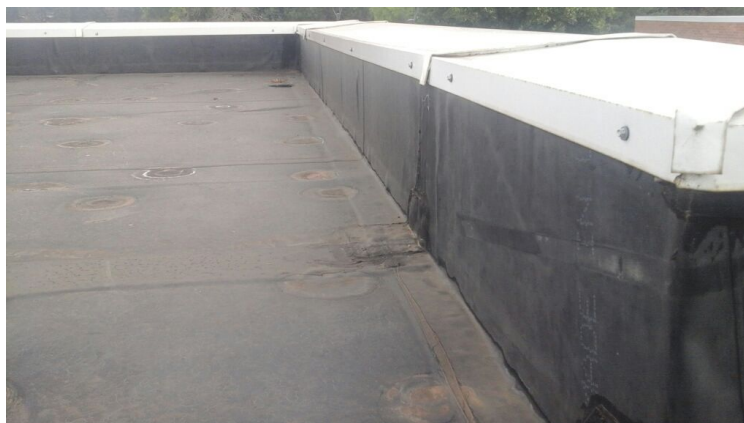
Photo showing condition of the perimeter flashings.

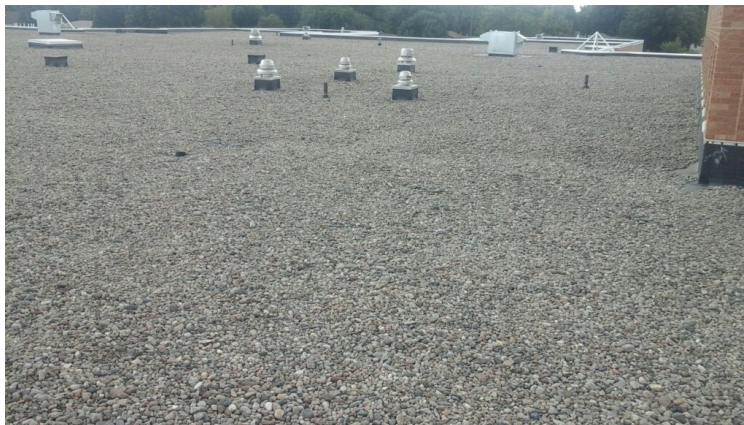
This roof is in fair condition and appears to be performing well. There are several areas where the membrane is being lifted up by extruding insulation.

Photo showing additional overview of Area 05 Roof.

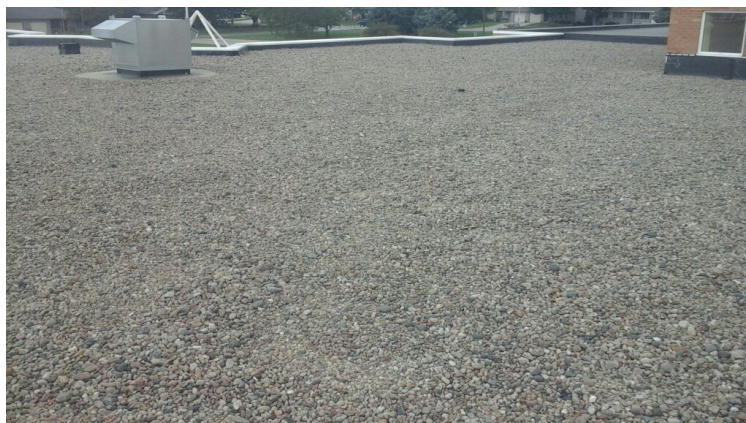
Photo showing additional overview of Area 05 Roof.

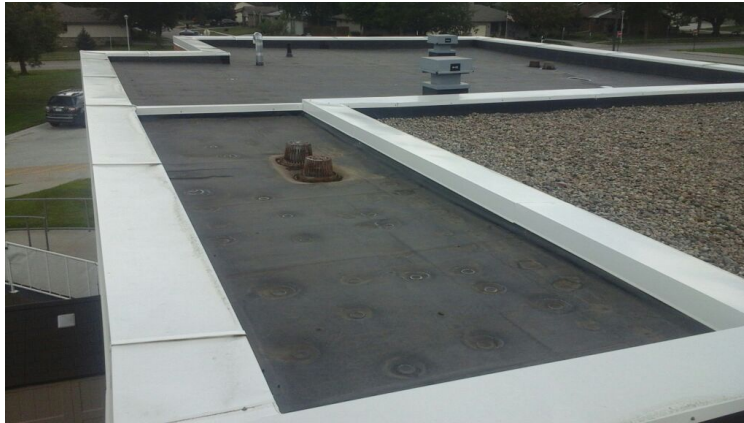
Photo showing overview of Area 06 Roof.

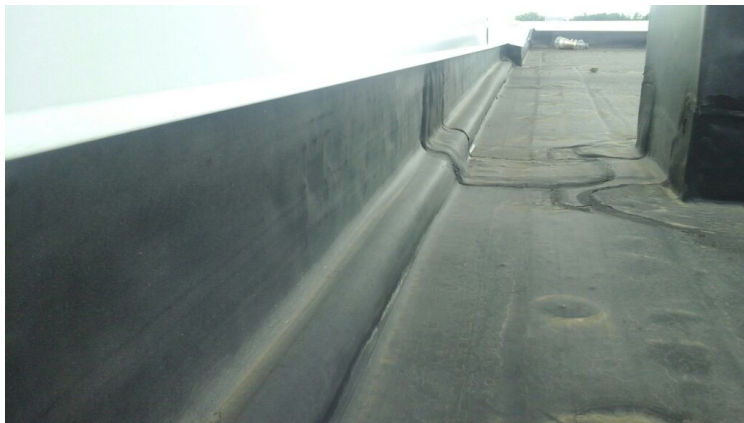
Photo showing condition of the perimeter flashings.

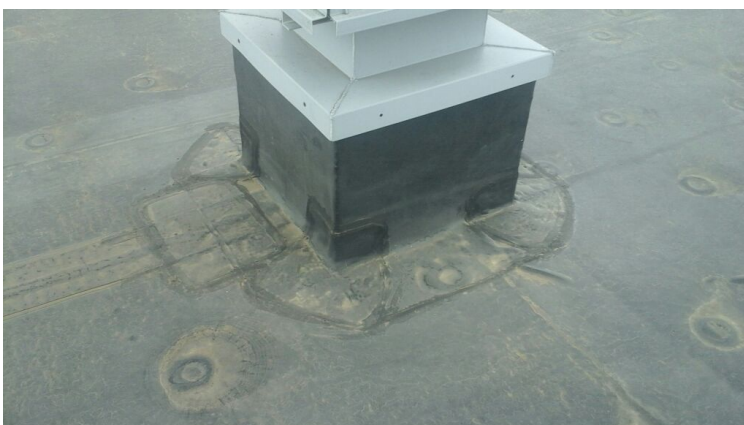
Photo showing condition of projection flashings.

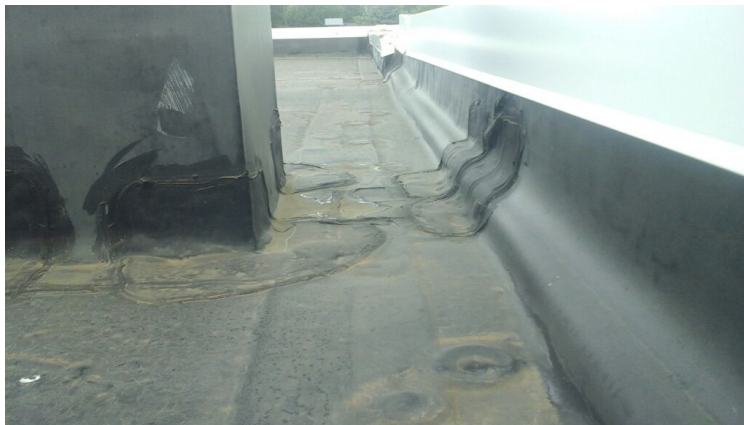
Photo showing condition of the perimeter flashings.

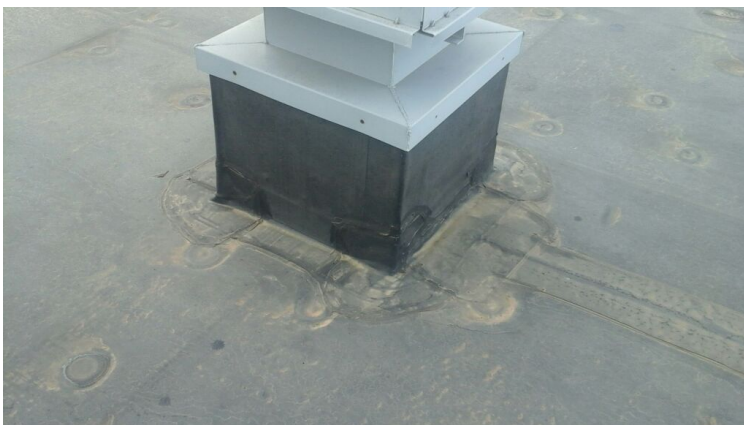
Photo showing condition of projection flashings.

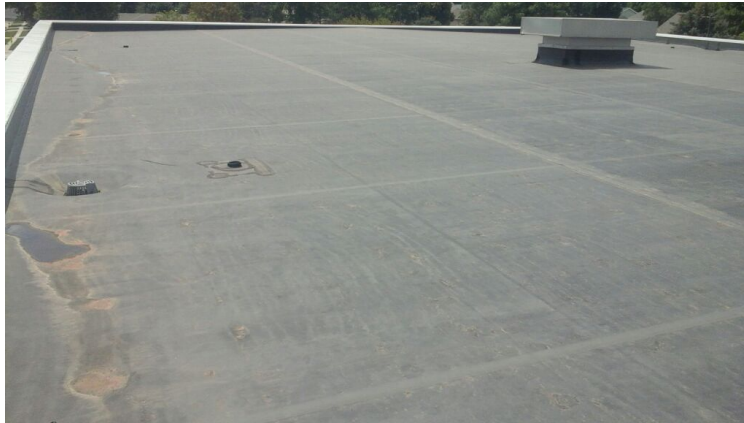
Photo showing overview of Area 10 Roof.

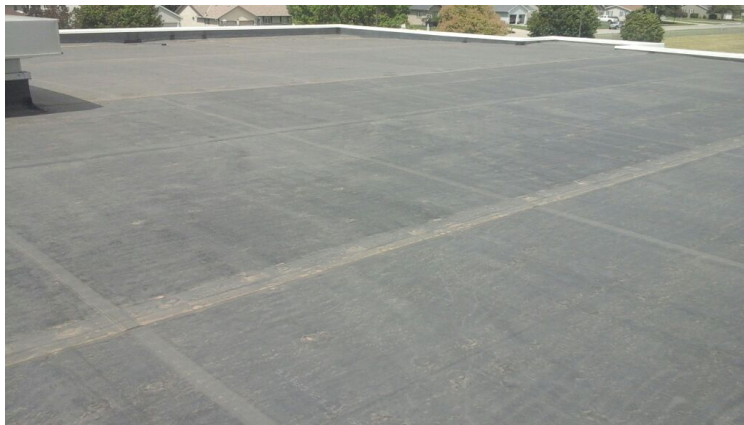
Photo showing additional overview of Area 10 Roof.

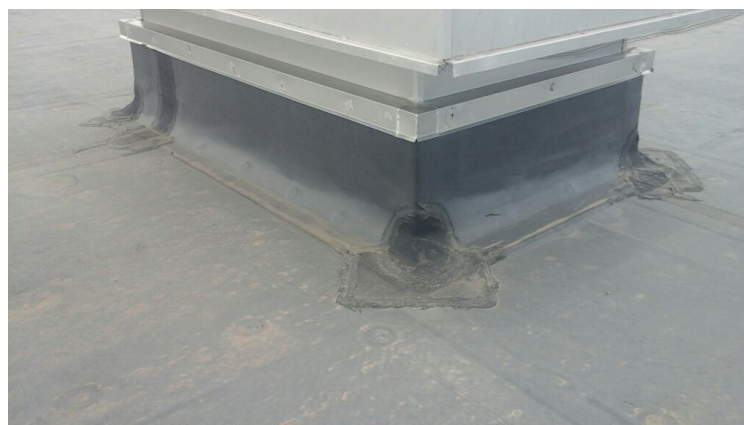
Photo showing condition of projection flashings.

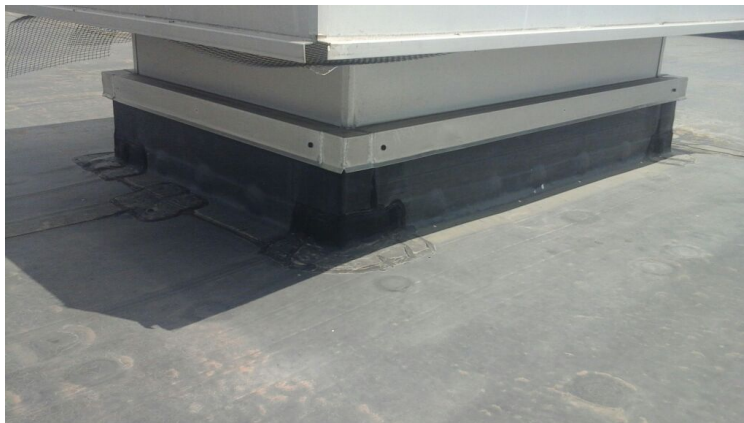
Photo showing condition of projection flashings.

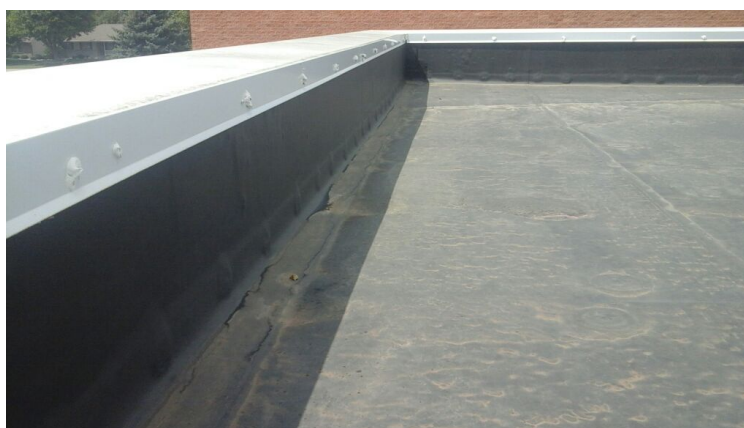
Photo showing condition of the perimeter flashings.

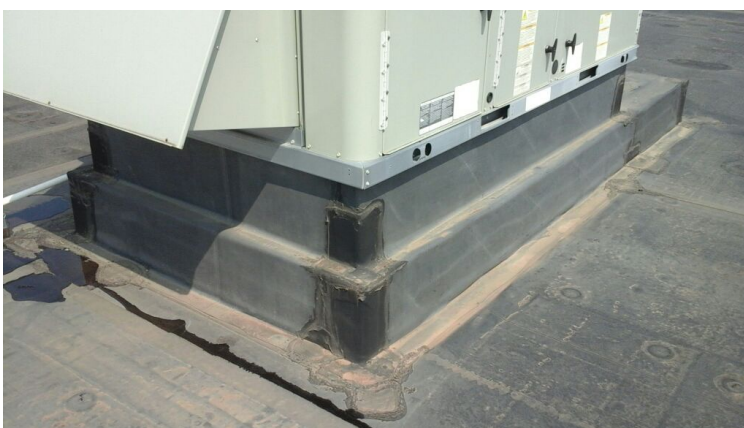
Photo showing condition of projection flashings.

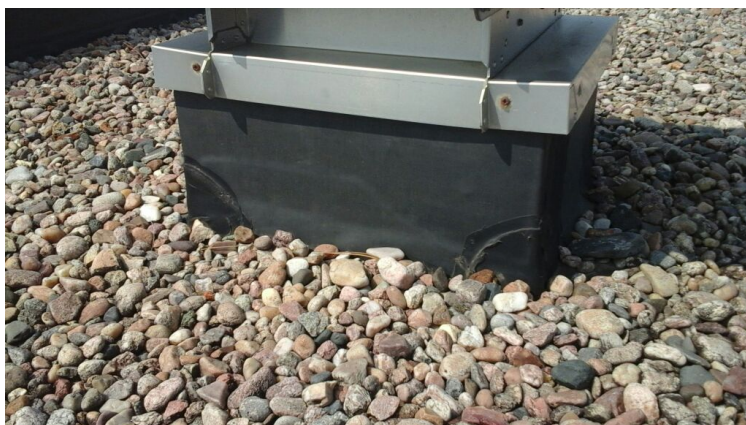
Photo showing condition of projection flashings.

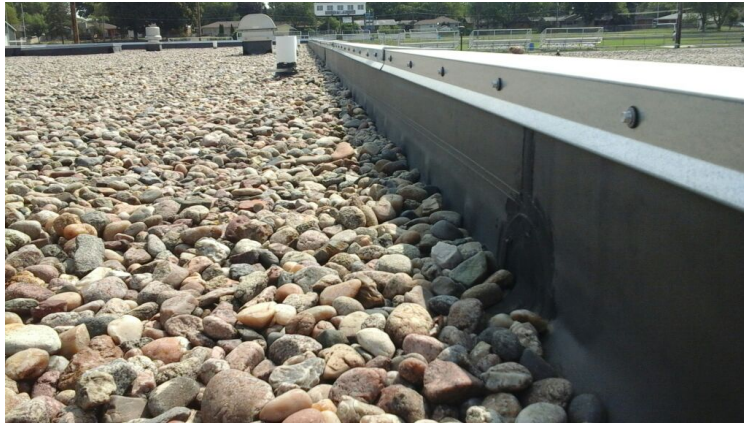
Photo showing condition of the perimeter flashings.

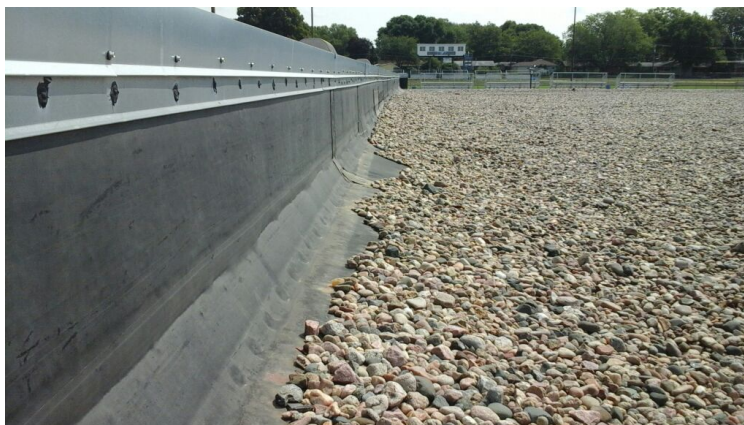
Photo showing additional blowout patch pulling loose.

This roof is in fair condition but has several areas where blowout patches are beginning to pull loose. There was also a hole found in the perimeter flashing that was open down to deckin.

I recommend restoring the problem areas in the flashings and continued inspections and maintenance to extend the life of this roof. The estimated budget number for restoring this roof is \$30,000.

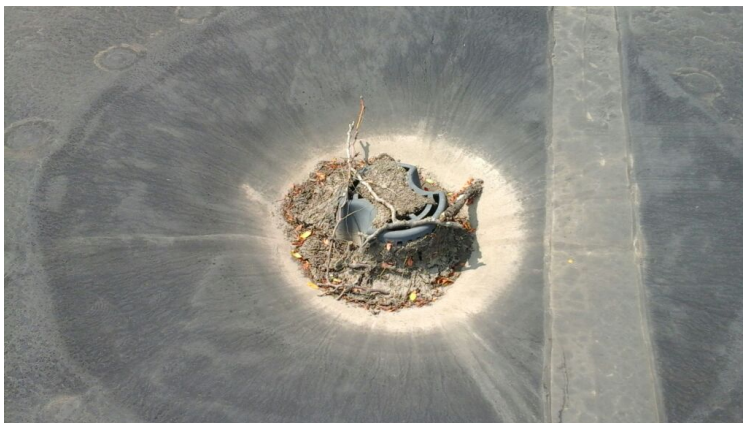
Photo showing clogged drain.

I recommend continued inspections and maintenance which would include clearing drains.

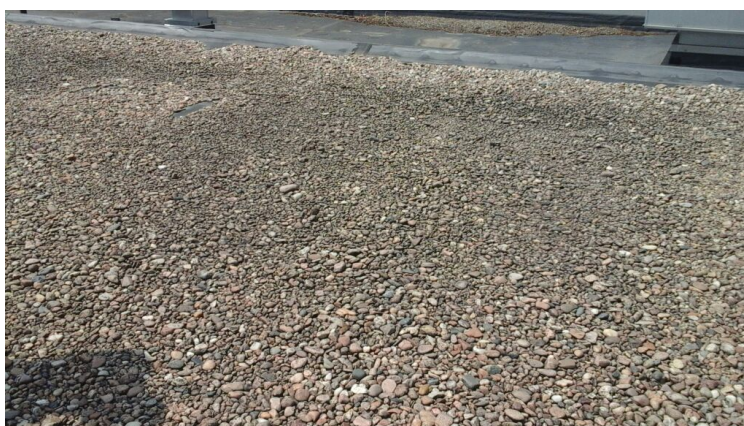
Photo showing evidence of ponding water.

I recommend scheduling a restoration on the problem areas of this roof as budgets allow. I also recommend continued inspections and maintenance. The estimated budget number for restoring this roof is \$50,000.

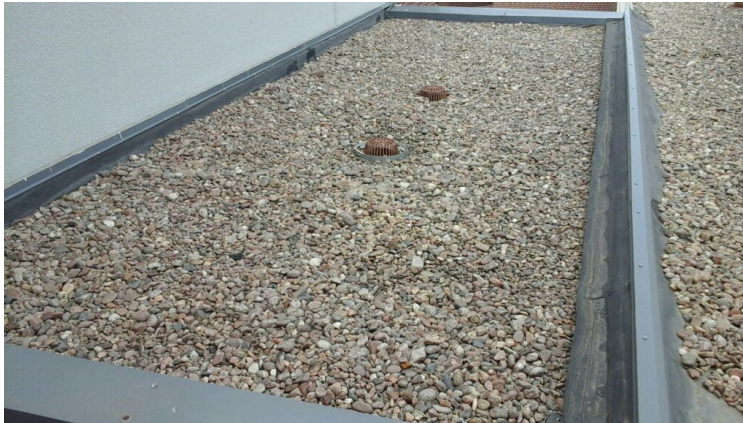
Photo showing overview of Area 12 Roof.

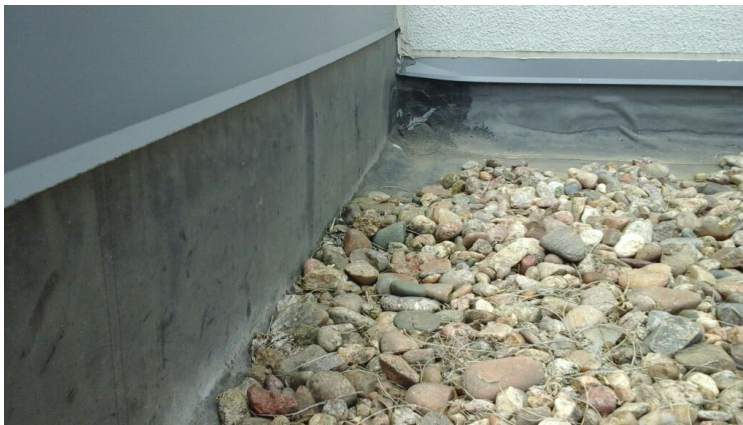
Photo showing condition of the perimeter flashings.

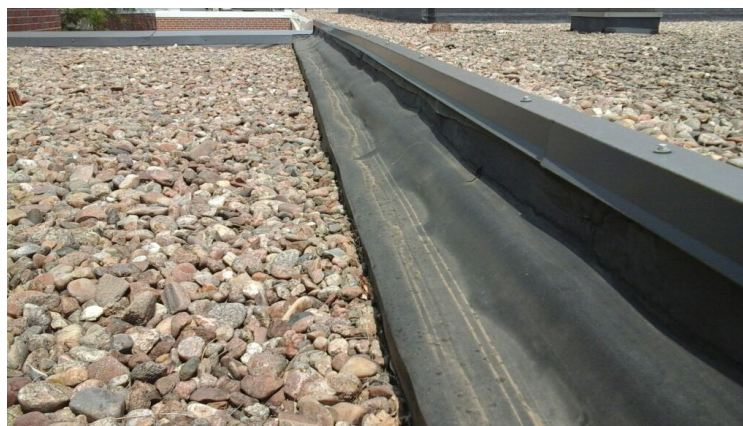
Photo showing condition of the expansion joint.

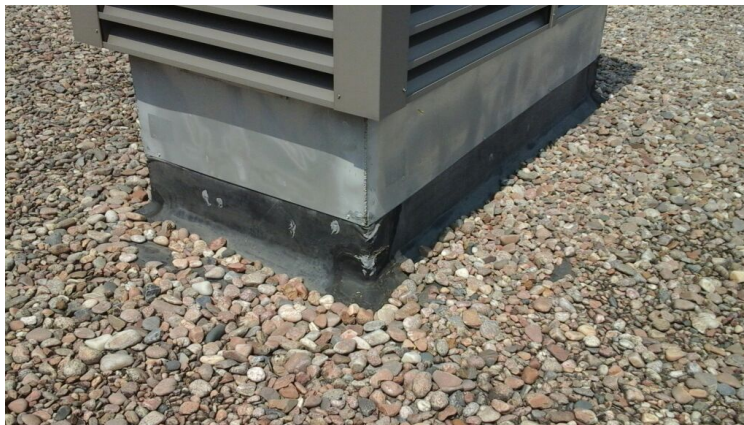
Photo showing condition of projection flashings.

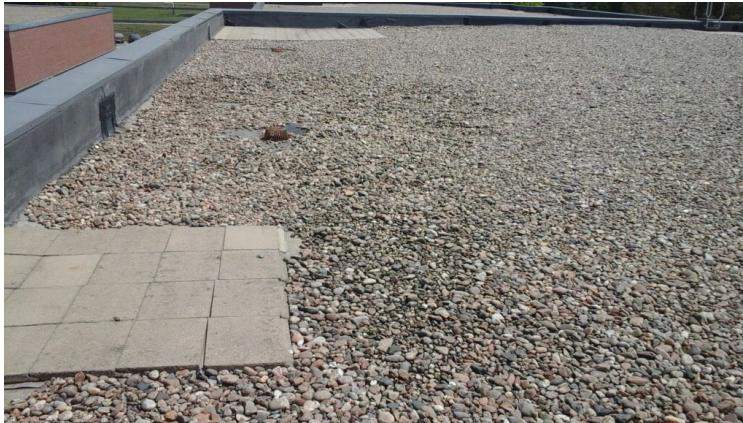
Photo showing overview of Area 15 Roof.

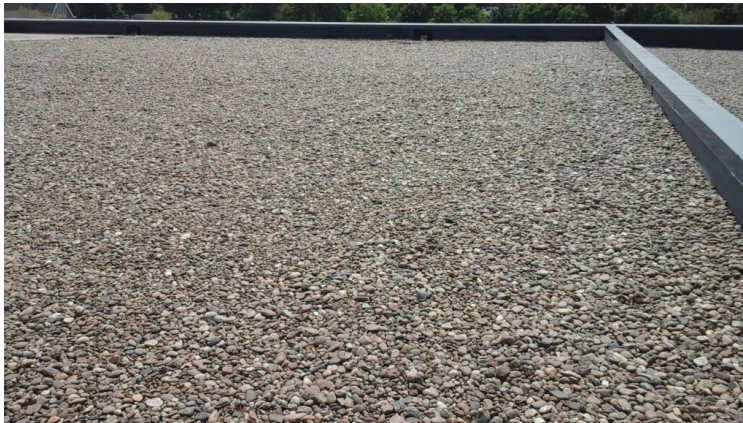
Photo showing additional overview of Area 15 Roof.

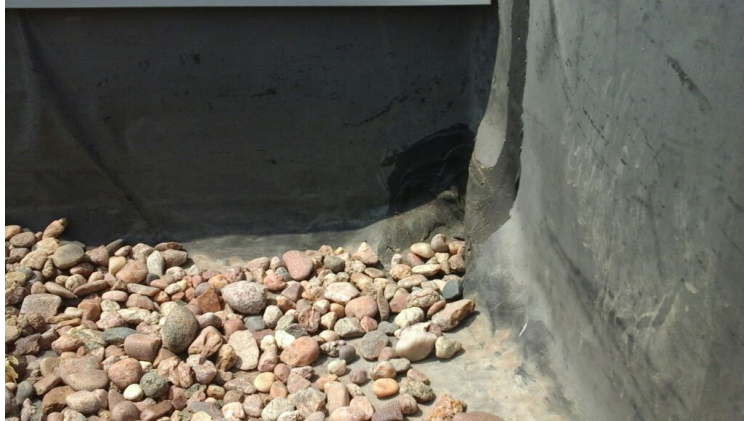
Photo showing tenting occuring in the corner of the perimeter flashings.

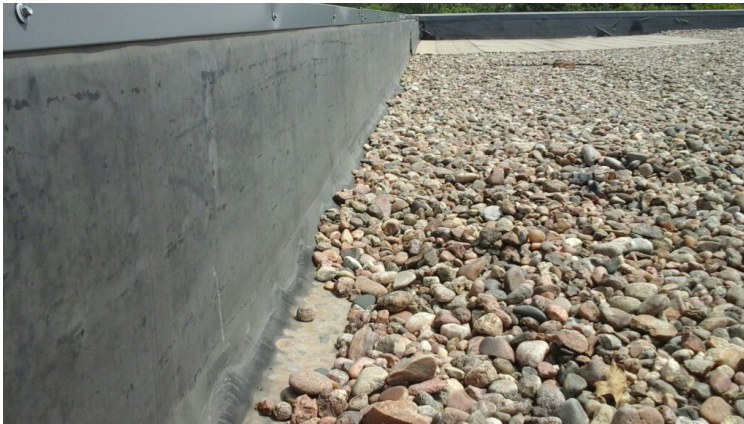
Photo showing condition of the perimeter flashings.

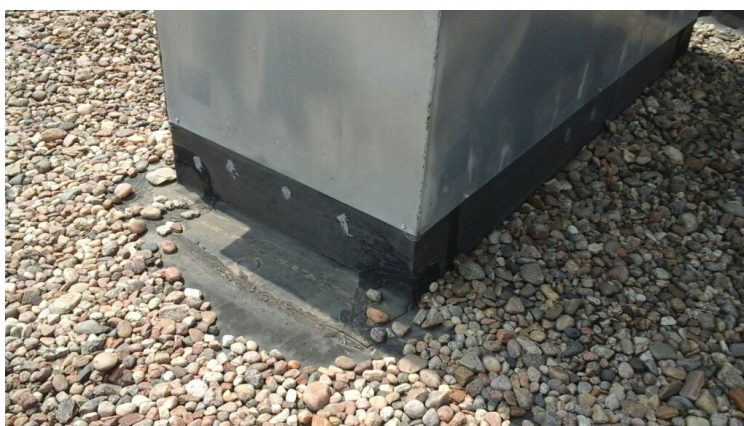
Photo showing condition of projection flashings.

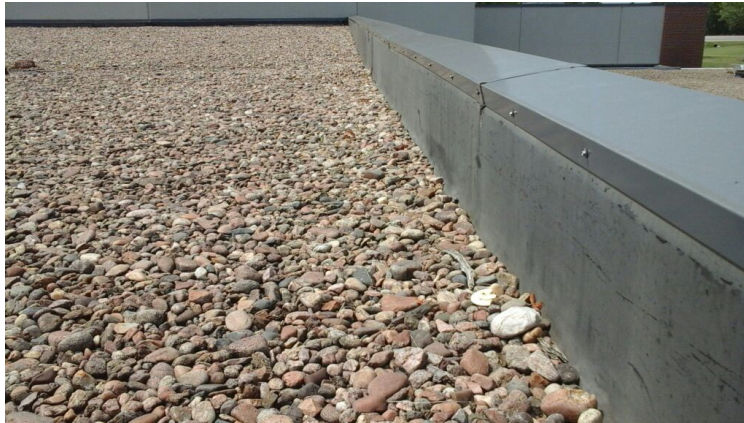
Photo showing condition of the perimeter flashings.

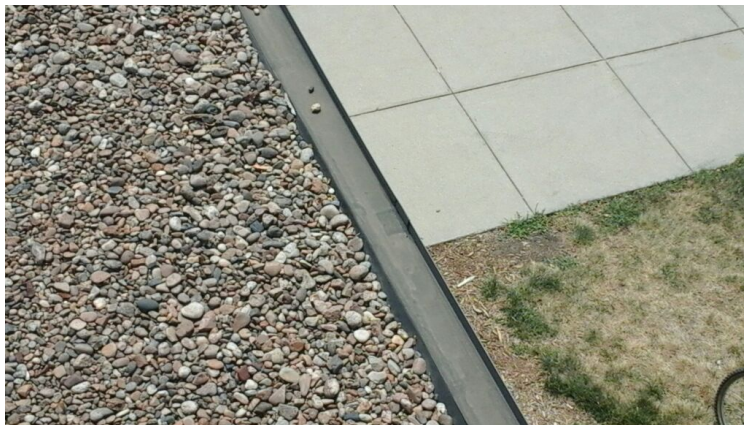
Photo showing condition of the form flashings.

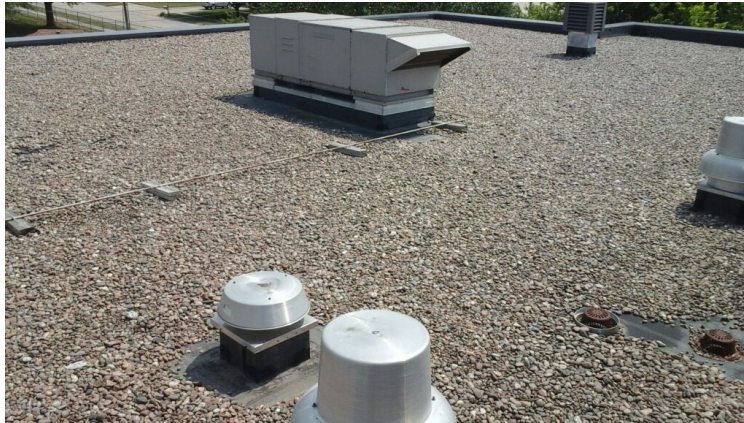
Photo showing overview of Area 21 Roof.

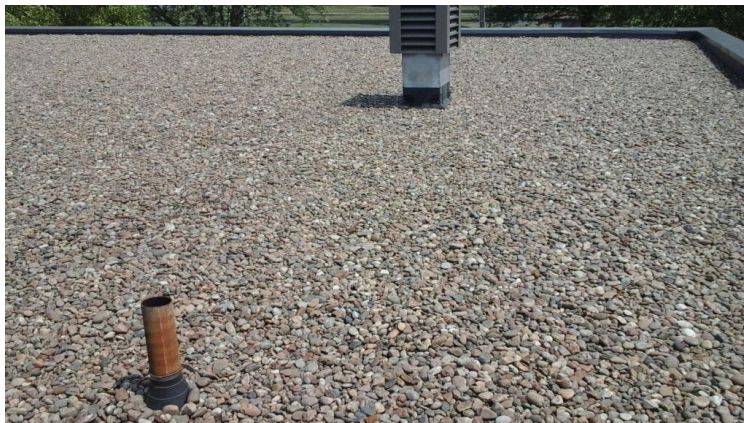
Photo showing additional overview of Area 21 Roof.

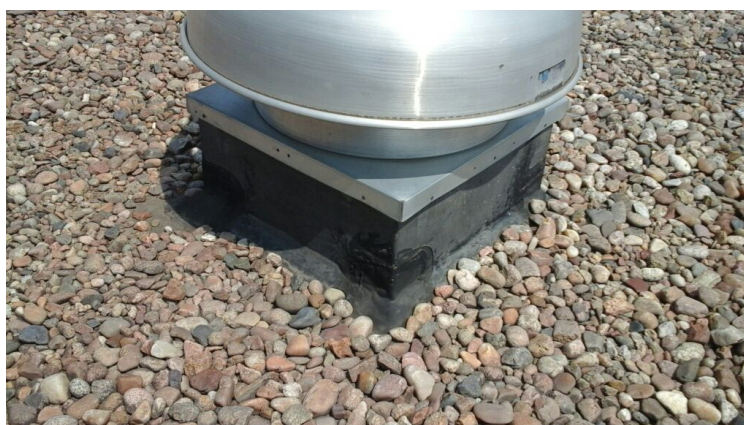
Photo showing condition of projection flashings.

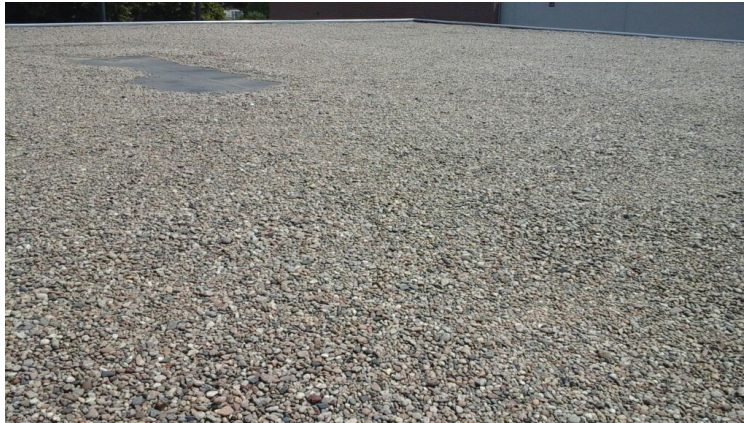
Photo showing overview of Area 24 roof.
