June Facilities, Finance & Operations Committee Meeting

**Subject:** 5 Year IAQ Report

**HVAC Ventilation Review**  
**Weston School District**  
**Intermediate School**

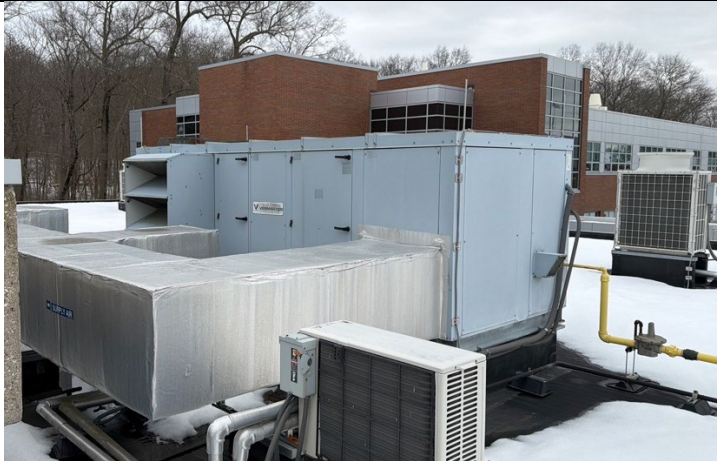
- The W-wing dedicated outdoor air system is missing filters on both the outdoor air intake and exhaust intake to the heat exchanger wheel that tempers the air. This unit supplies outdoor air directly to each classroom in the E wing. Currently the air is unfiltered.

| | Dedicated outdoor air energy recovery unit |

| | | | | | Action Priority | | |
|---|---|---|---|---|---|---|---|
| | Install missing filters in dedicated outdoor air unit | | | | | | |

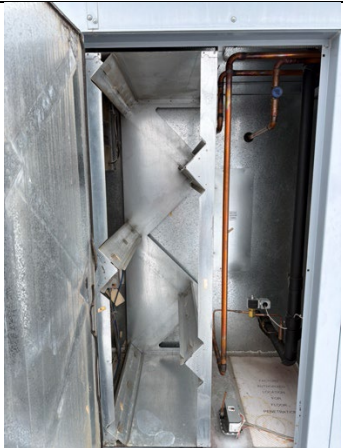
The DOAS unit is missing filters in both the outdoor air stream and the exhaust stream. It is supplying unfiltered outdoor air to the classrooms. The exhaust filters are meant to be installed upstream of the desiccant wheel heat exchanger to protect it from fouling and losing heat transfer effectiveness. The supply filters do the same with the added task of filtering the outdoor air supplied to the classroom. Without filters the wheel has some self-cleaning capability as supply air enters in one direction through half of the wheel as exhaust air passes through the other half of the wheel in the other direction.

| Filters | None installed on return or supply side of wheel. |
| | Return air empty filter rack |

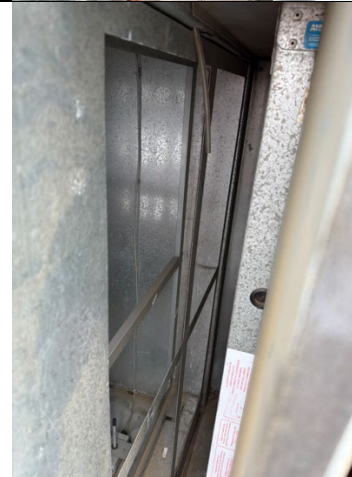
| A photograph showing outdoor supply empty filter racks. The racks are made of metal and are located in a mechanical room. A white label is visible on the rack. | | <p>Outdoor supply empty filter racks</p> |

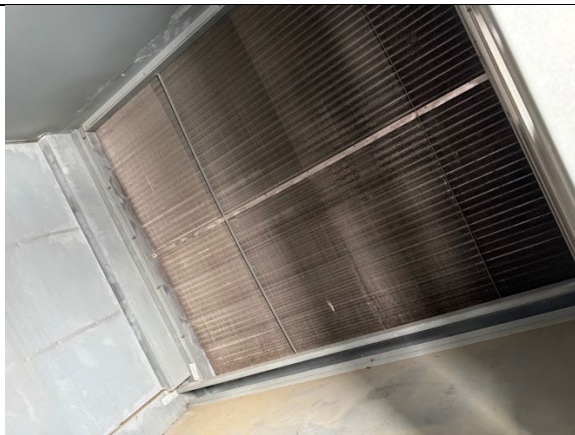
Coil inlet face. Some debris building up especially at bottom

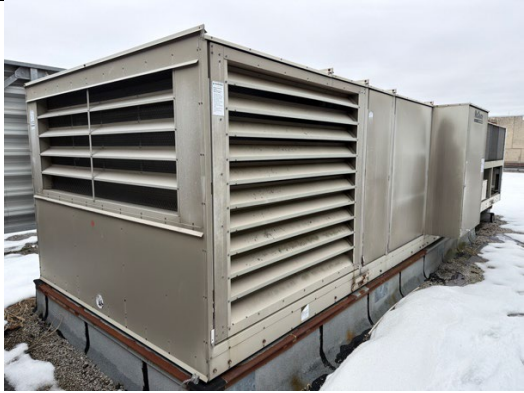
| | Unit Overview |

| Filters | 2 inch MERV-8. Filter blown out of rack. |

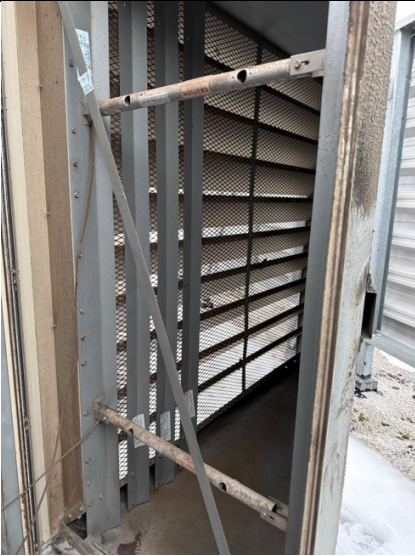
| | <p>Outdoor air flow measuring station (AFMS) in door with intake louvers</p> |

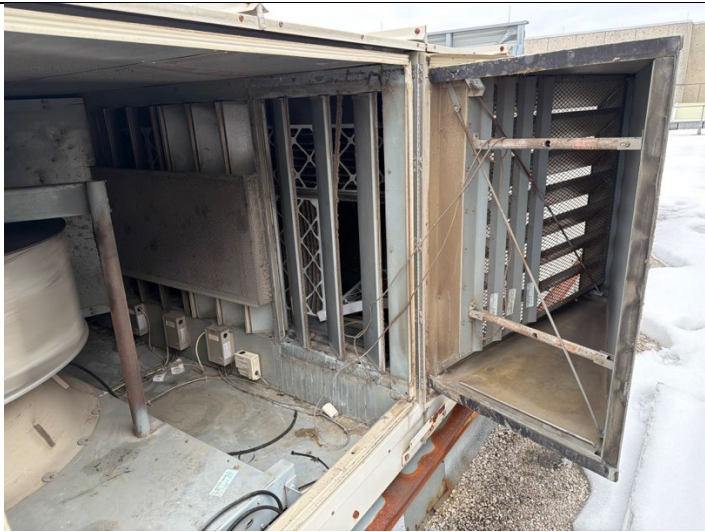
| Filters | 2 inch MERV-8. Two filters blown out of rack. |
| | Outdoor air flow measurement station in door with intake louvers. OA dampers right. Return air dampers left. |

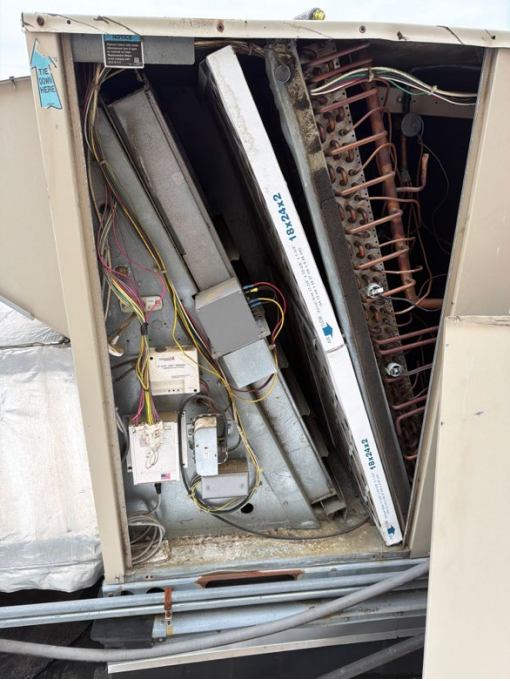
| | Outdoor damper on slant at top. Return air damper on slant at bottom |

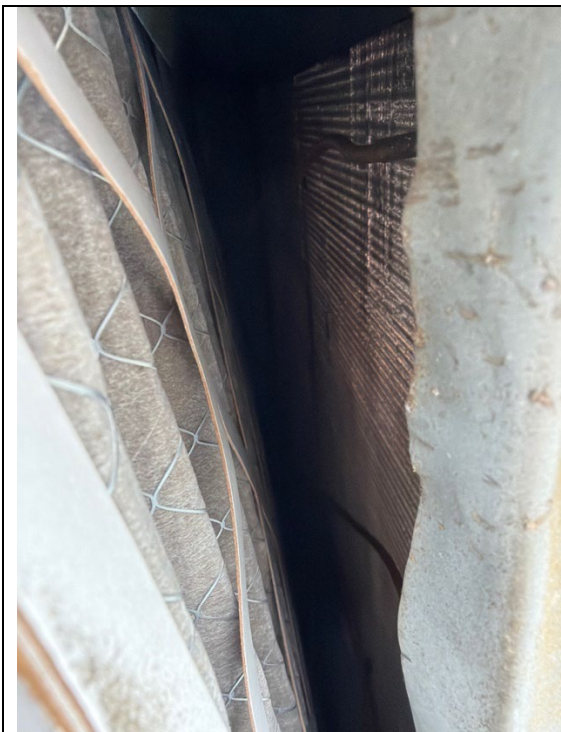
Mixed air temperature sensor in gap between filters and coil

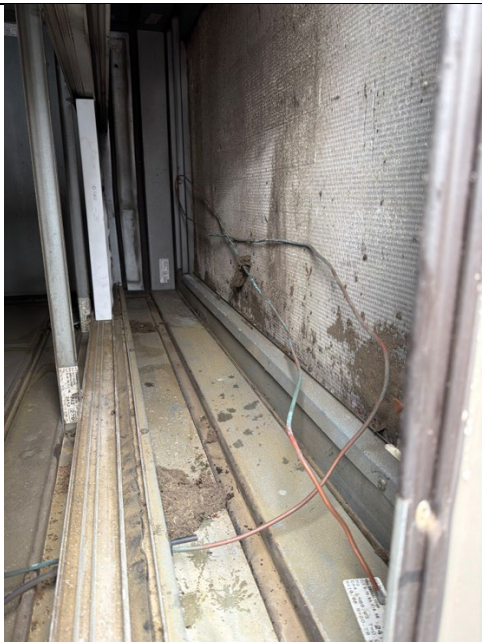
| | Dirty coil inlet face. Mixed air temperature across bottom of coil. |

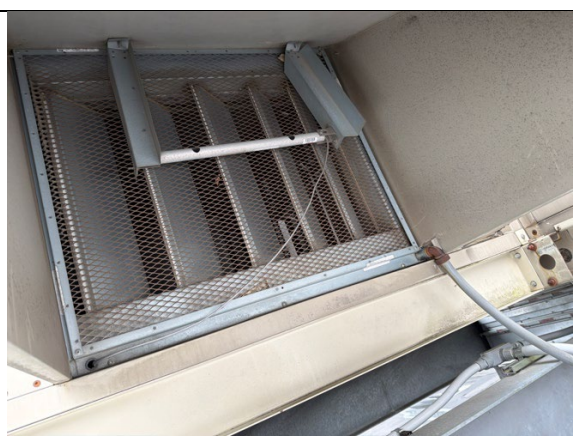
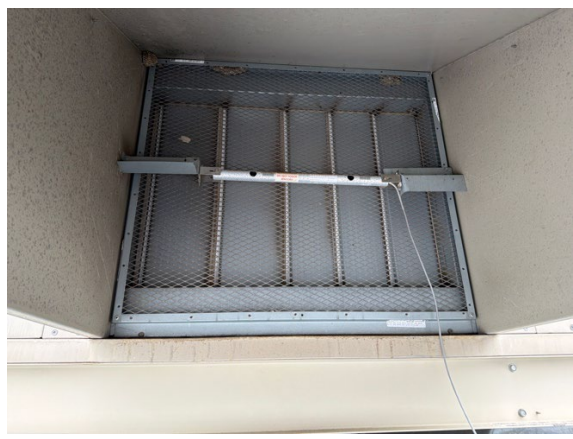
| <br> | | <p>AFMS outside under shroud.<br/>Damper did not close when unit was off,</p> |

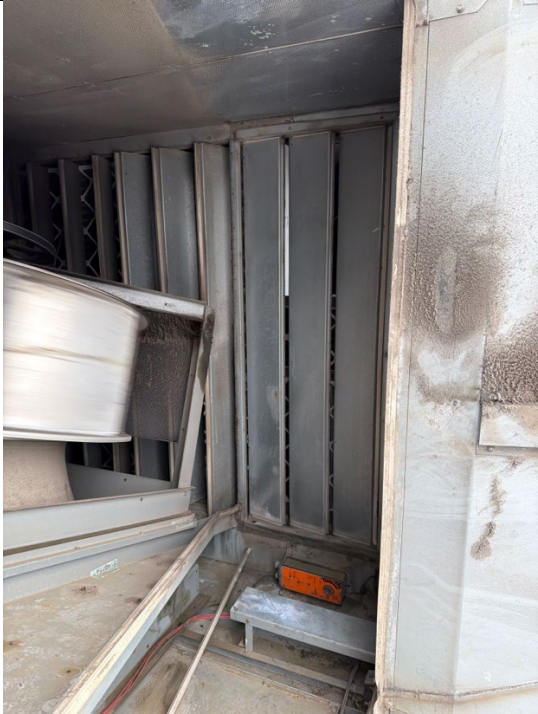
| | Outdoor air damper – right<br>Return air damper - left |

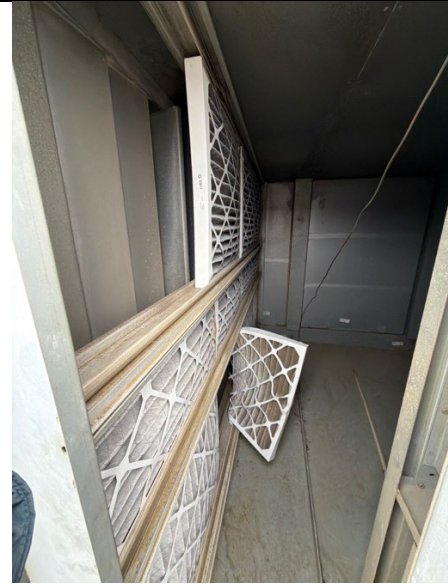
| Filters | 2 inch Merv-8. One found blown out |

| | | <p>Lower center filter blown out</p> |

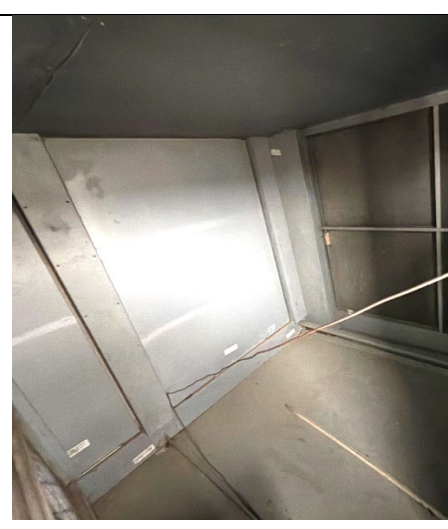
| | | <p>Mixed air temperature sensor and dirty coil inlet face</p> |

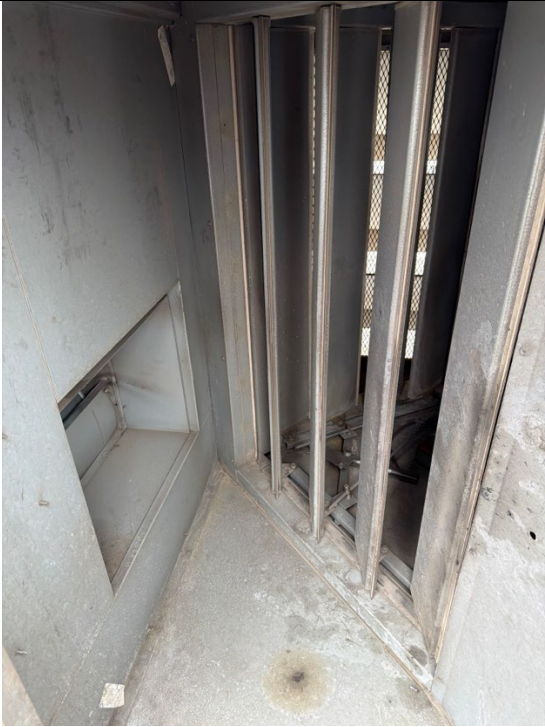
| | Return damper - near.<br>Outdoor damper far through RA damper. |

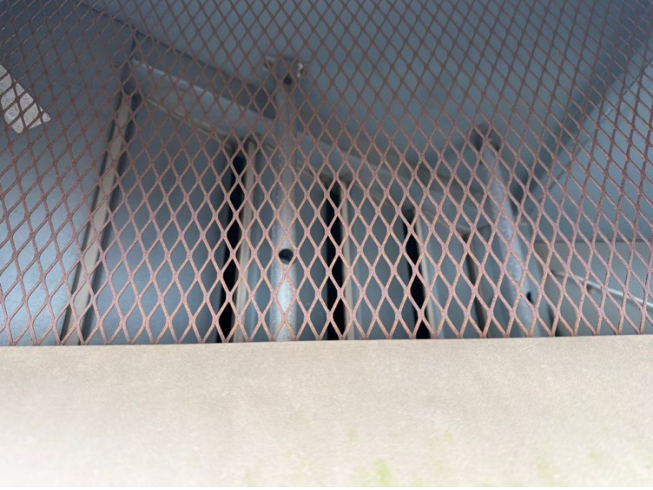
| | <p>Outdoor air flow measurement station behind bird screen in front of damper</p> |

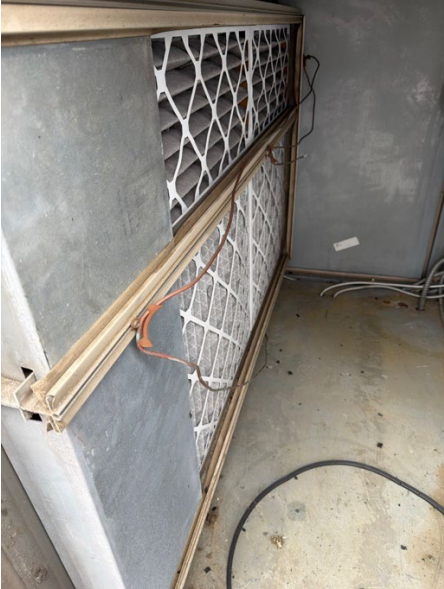
| | <p>Mixed air temperature sensor at filter outlet.</p> |

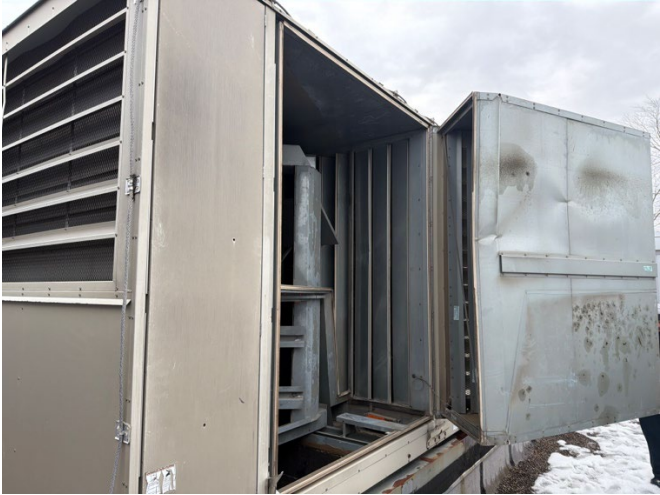
- RTU damper actuation should be verified. Observations noted some dampers open when the units are off or not closing completely. A relief damper that is erroneously open could contribute to the observed reduction in system air flow by exhausting excess return air.

| | Return air section with outdoor air dampers – right<br>AFMS in door with intake louver<br>OA dampers do not close completely with unit off |

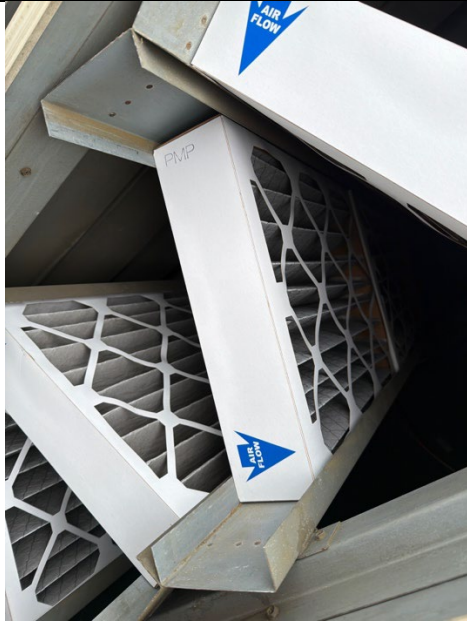
Filters lack blank off panels at end allowing dirty air to bypass filters

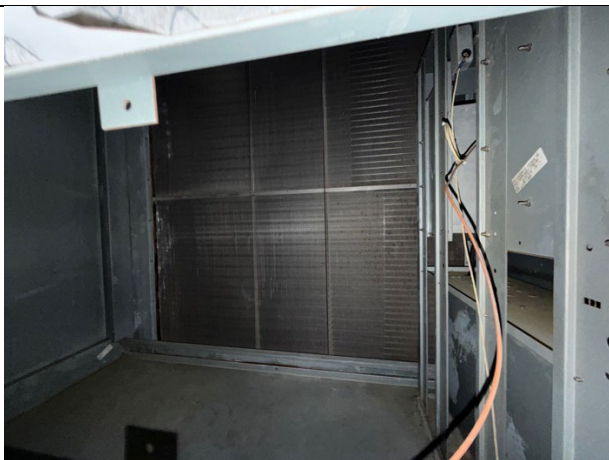
Coil inlet face

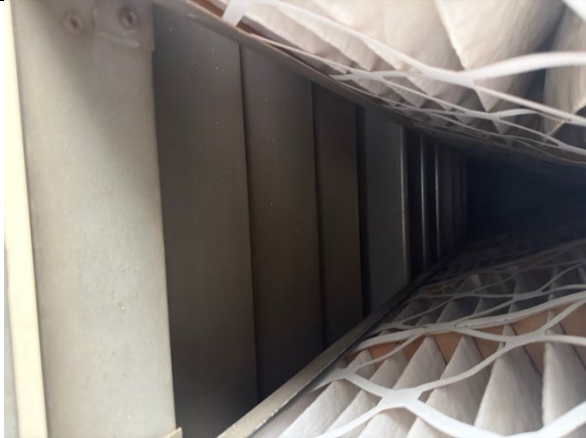
| | Outdoor air damper near (closed)<br>Return air damper far (open) |

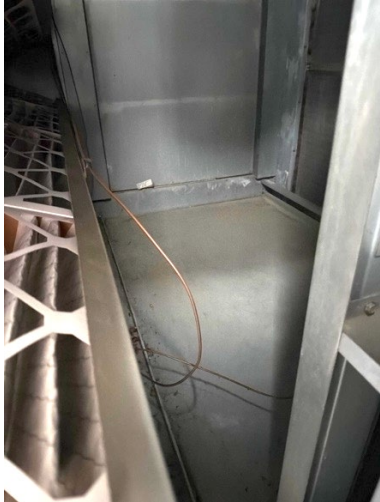
| | Mixed air temperature sensor |

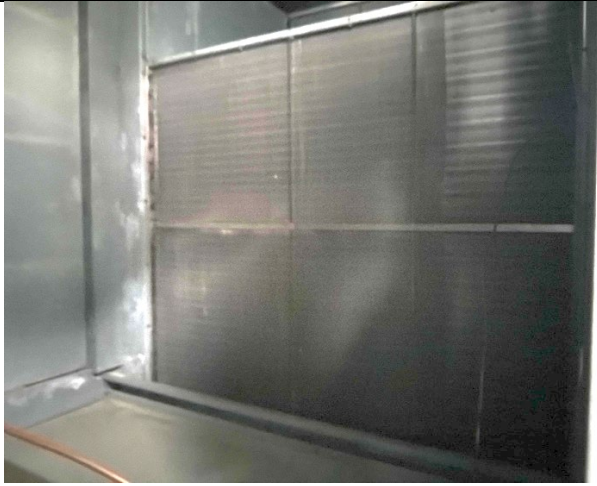
| | Coil inlet face |

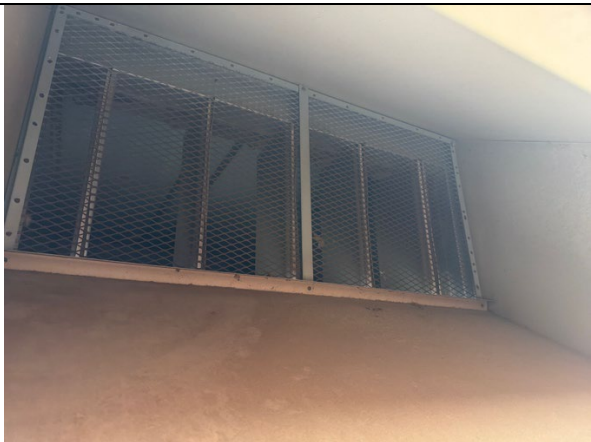
| | Relief damper is open when unit is off |

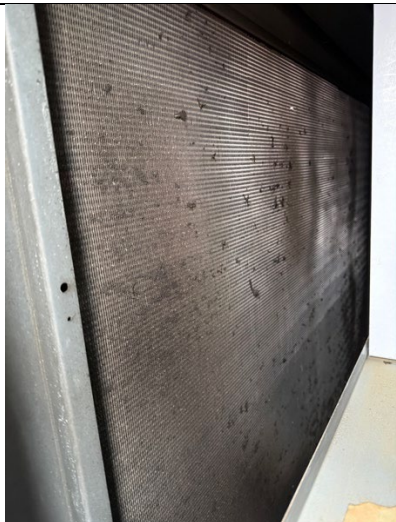
| | Coil inlet face |

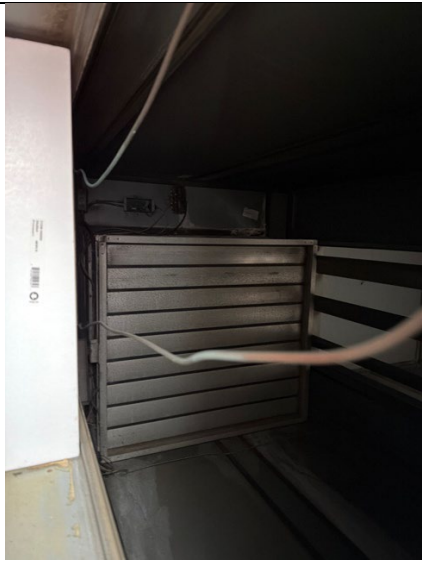
| | <p>Mixed air temperature sensor at filter inlet.<br/>Part of sensor is close to outdoor air intake.</p> |

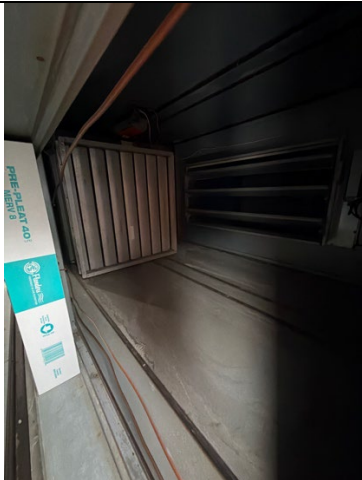
| | Mixed air temperature sensor across filter inlet. Part of sensor is near outdoor air intake, |

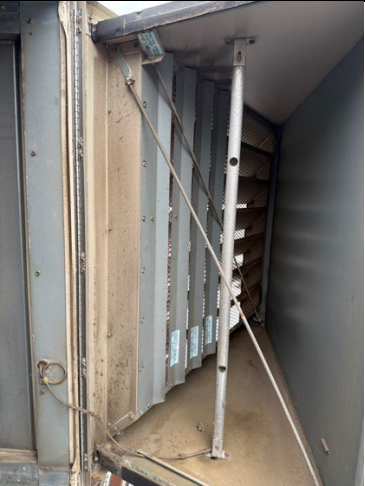
| | Outdoor air flow monitoring station (AFMS) in door with intake louver |

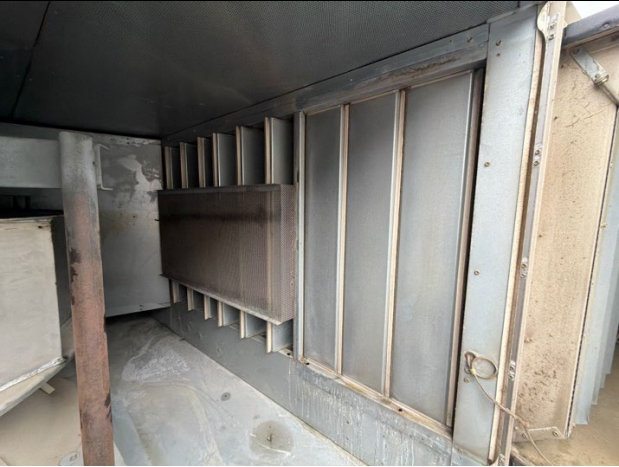
| | Outdoor air dampers right<br>Return air dampers left |

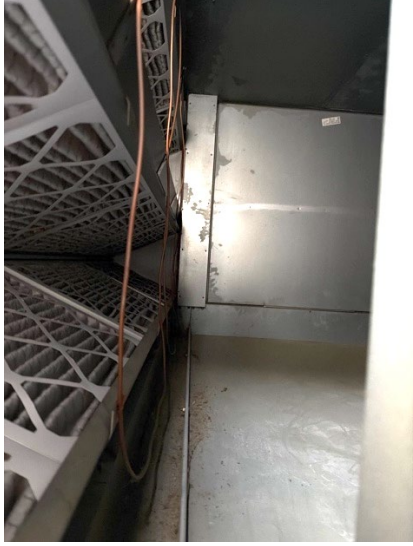
| | <p>Mixed air temperature sensor at filter outlet</p> |

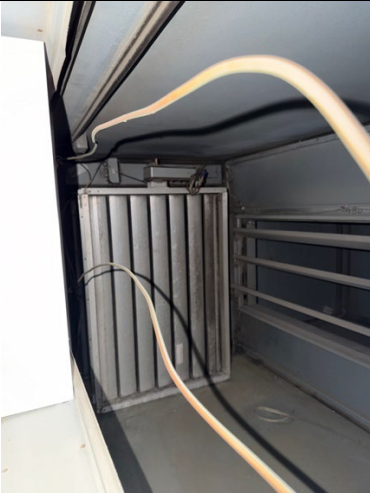
| | Mixed air temperature sensor at filter inlet.<br>Part of sensor is near outdoor air intake. |

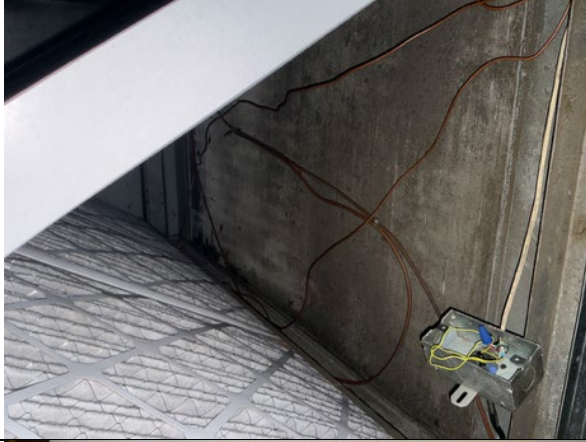
Part of the coil downstream of the filters section are covered in dust due to air blowing by the filter. The filter section has a gap between the end of the filter and the door. A blank-off section is missing allowing dusty air to bypass the filter.

Coil face near the door is covered in dust. Air is bypassing filter in gap between filter and door.

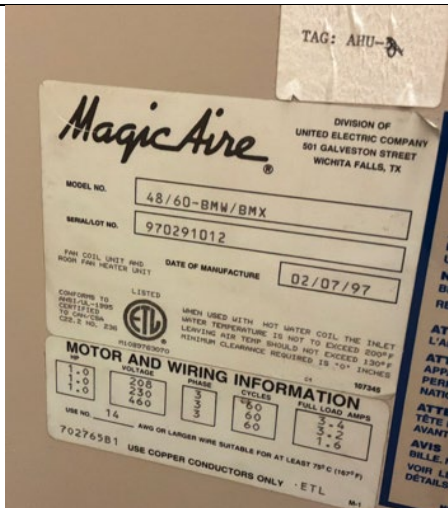
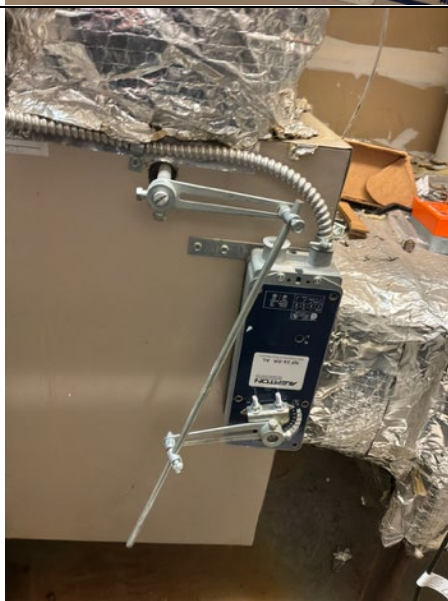
| | Outdoor and return air damper linkage is tightly secured to the control actuator |

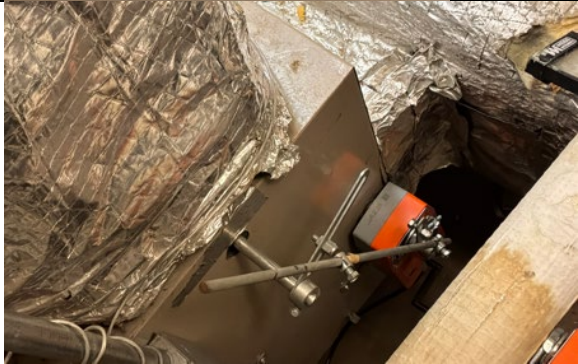
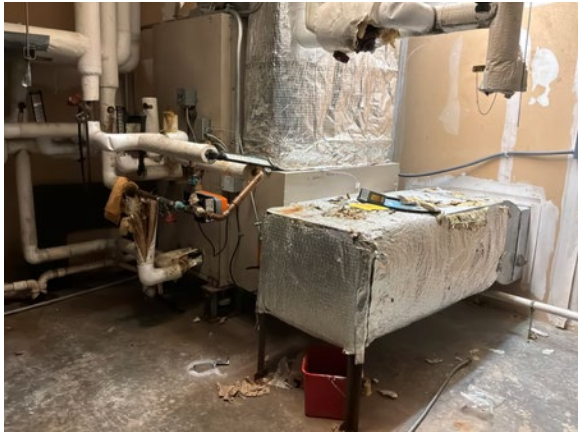
| Outdoor and return air damper linkage is tightly secured to the control actuator | |

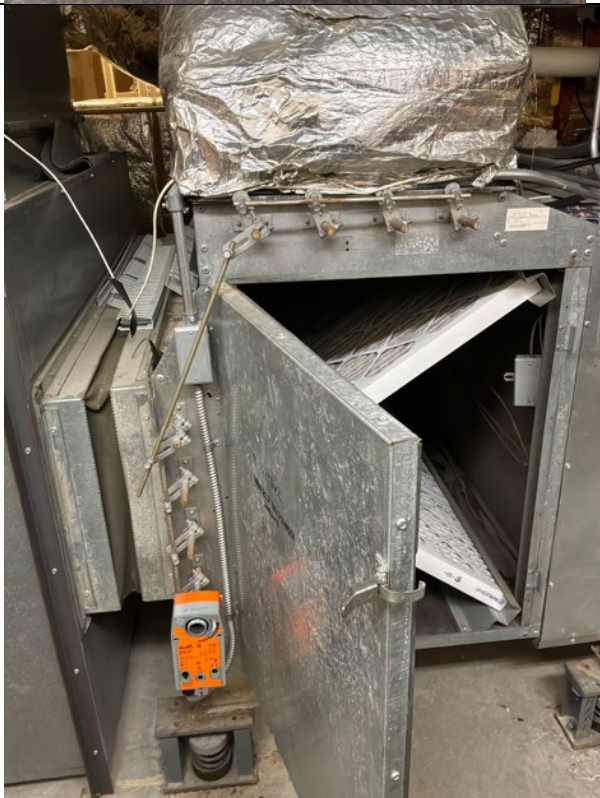
| | Control actuator is connected tightly to damper linkages |

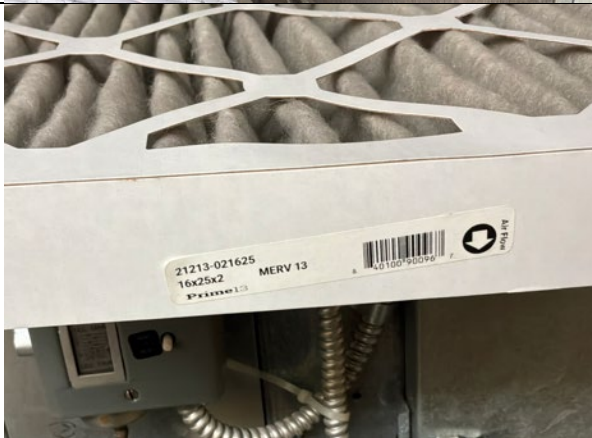
Example filter  
MERV 13 rating

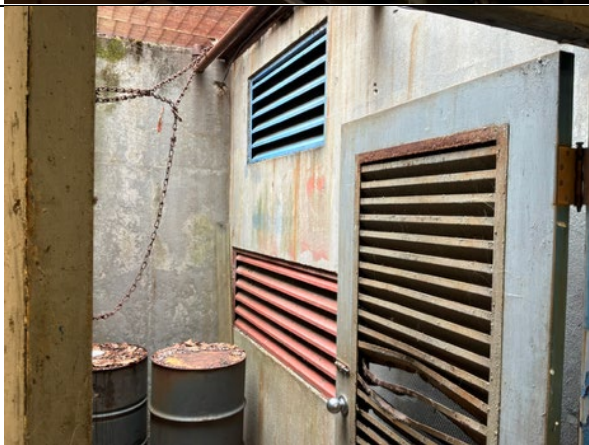
| | Outdoor air louver (lower) |

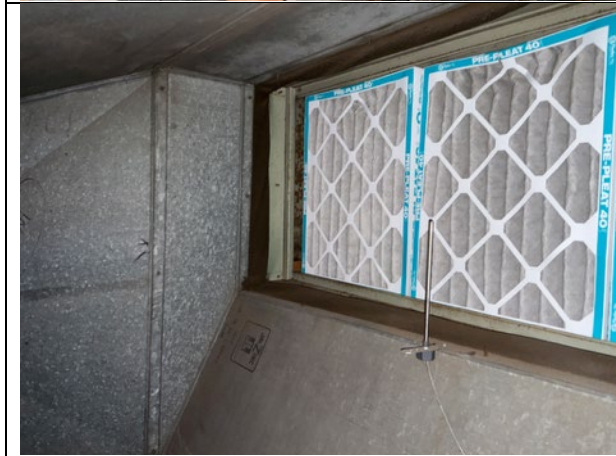
Filter section with single point mixed air temperature sensor in front of filter

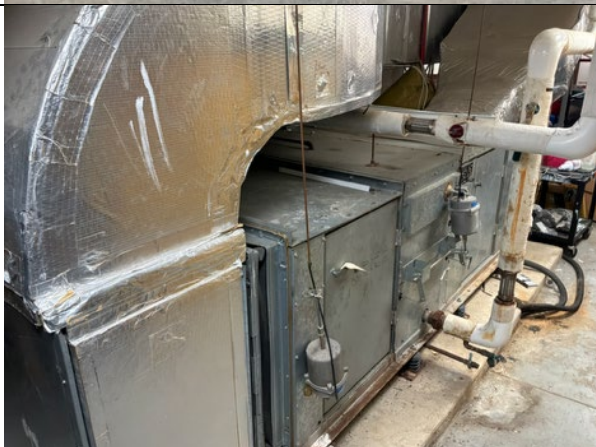
| | Unit overview<br>Pneumatic damper actuator |

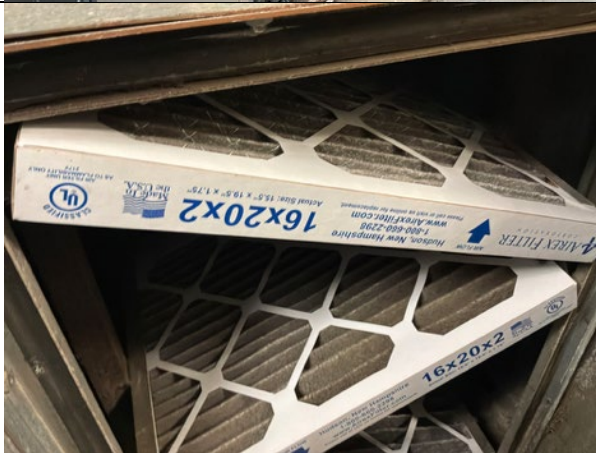
| | Example filter<br>MERV-8 rating |

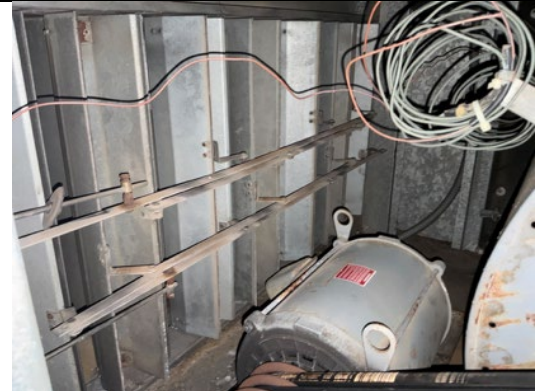
| | <p>Downstream of heating coil. Clam shell damper blocks view of coil.</p> |

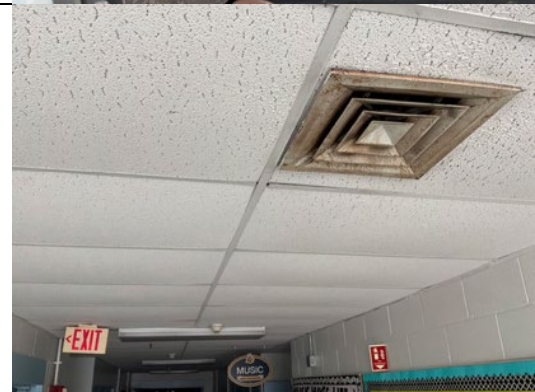
| | <p>Example supply register in corridor</p> |

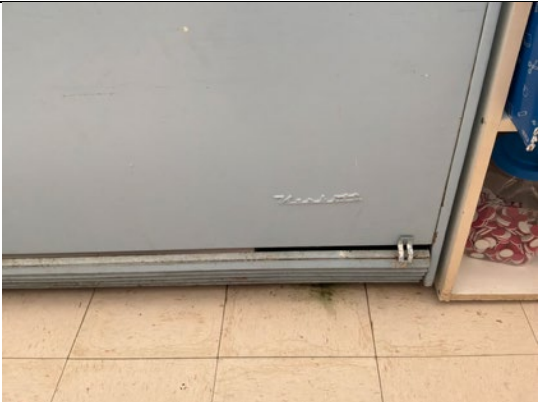
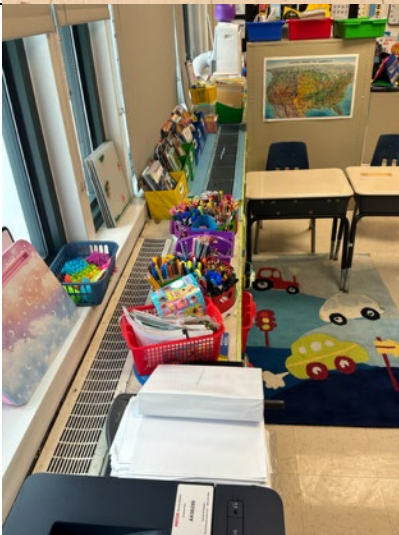
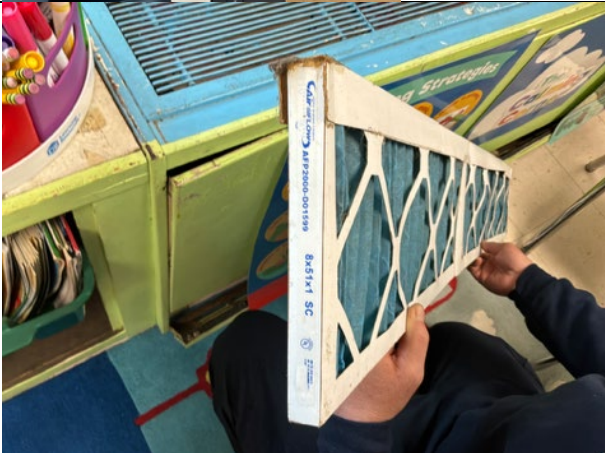
| <p>Unit heater (blue background)<br/>Baseboard heat (foreground)</p> <p>Example filter at inlet at base of unit</p> | |

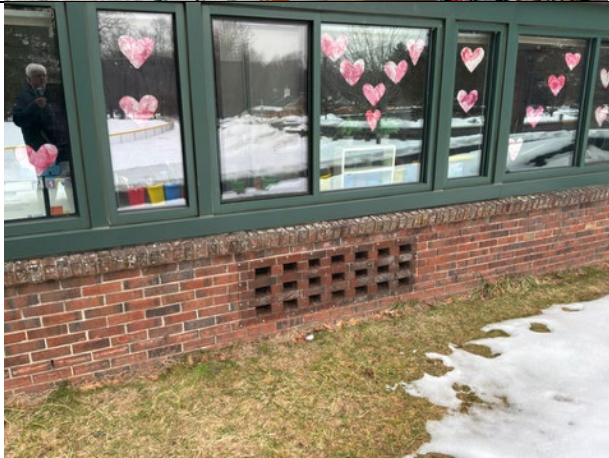
Outdoor air inlet
