## **Board of Education Study Session**

School District of Seward

# Condition Summary

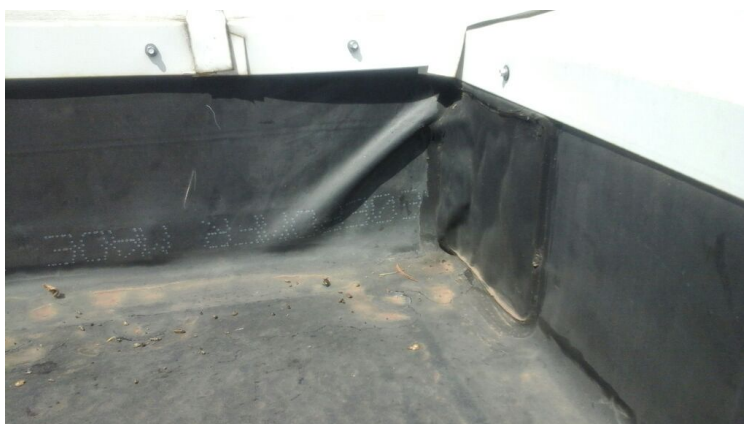
Photo showing condition of the perimeter flashings in the corner.

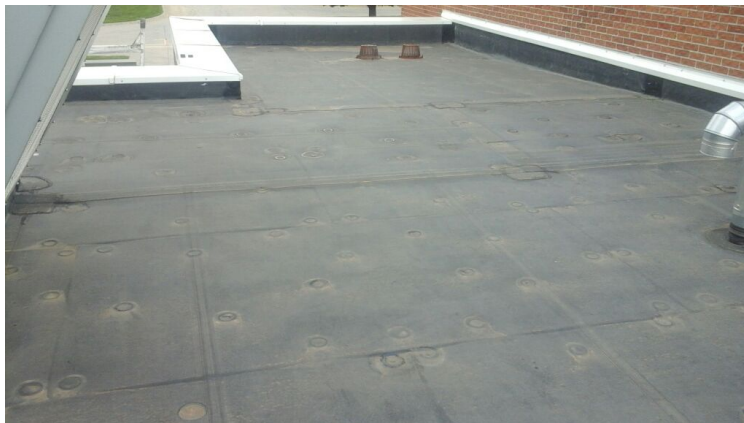
This roof is in good condition and appears to be performing well.

Photo showing additional overview of Area 02 Roof.

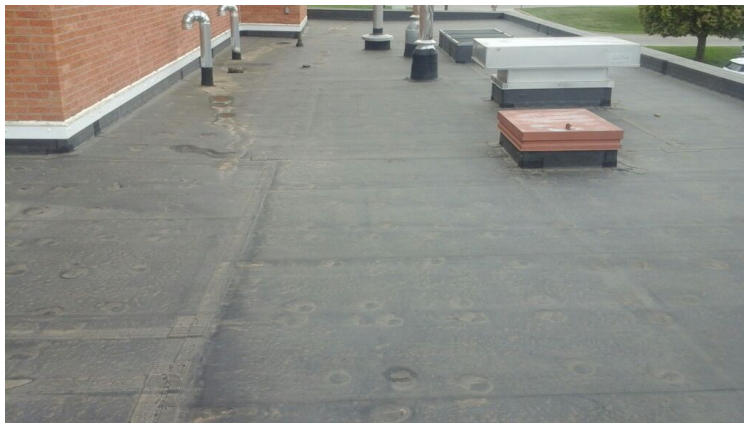
Photo showing additional overview of Area 03 Roof.

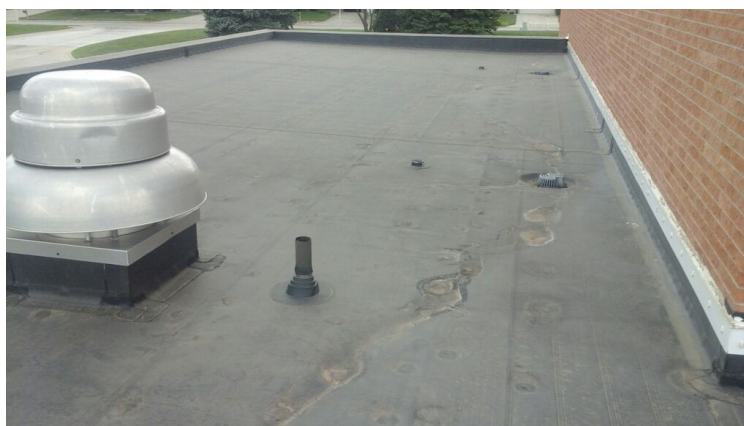
Photo showing additional overview of Area 03 Roof.

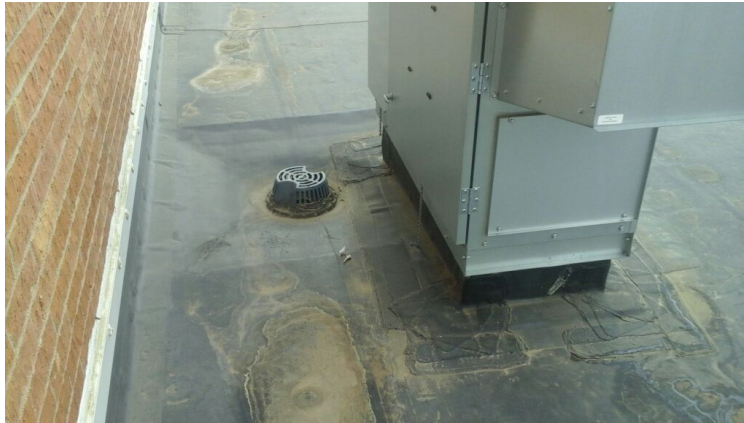
This roof is in good condition and appears to be performing well. There is one projection located in a drain sump that could become a problem in the future.

Photo showing HVAC unit located in drain sump.

I recommend continued inspections and maintenance.

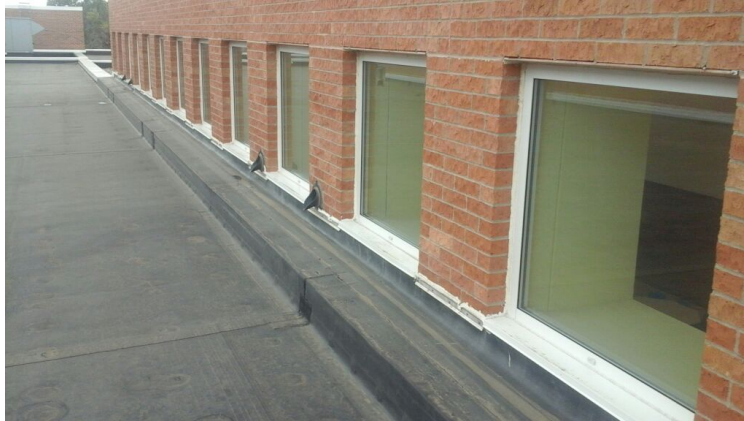
Photo showing condition of the perimeter flashings along window wall.

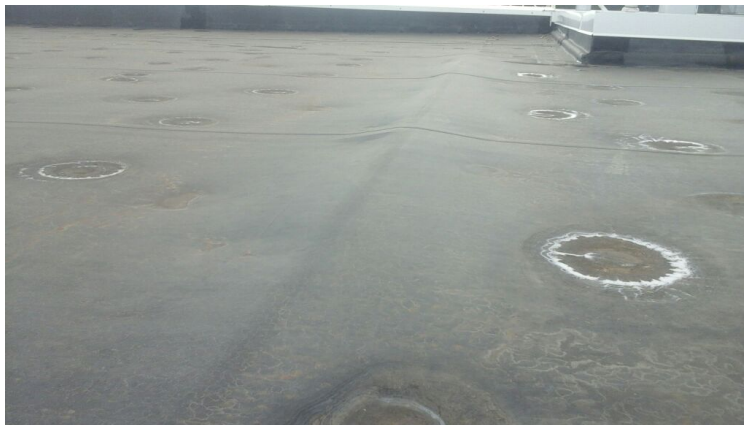
This roof is in good condition and appears to be performing well. There is an area where the cover board was not staggered and is pressing up against the field membrane that should be monitored.

Photo showing coverboard extruding under field membrane due to joints not being staggered on install.

I recommend continued inspections and maintenance.

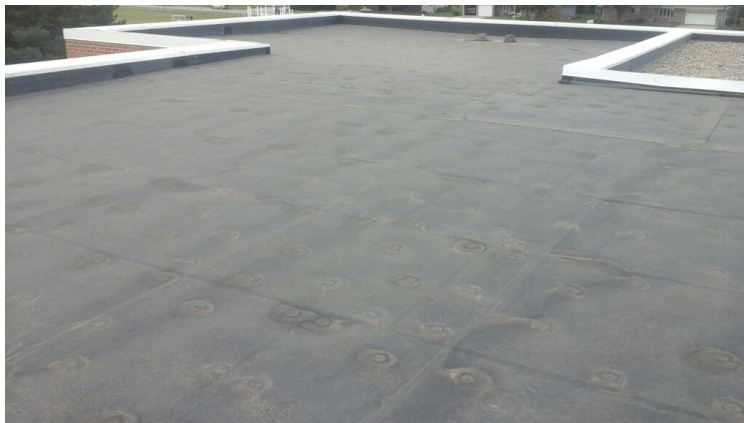
This roof is in good condition. There is some ponding water around the central drain do to missed taper design. There was one hole found in the field membrane.

Photo showing additional overview of Area 08 Roof.

I recommend patching hole and continued inspections and maintenance.

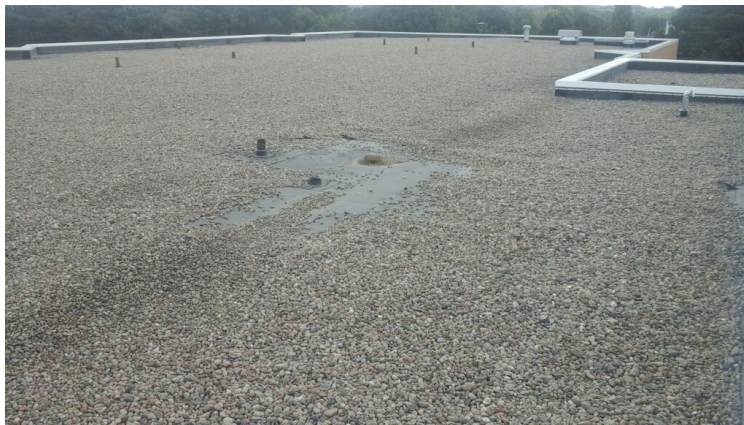
This roof is in fair condition due to the aging and tenting perimeter flashings. There were several areas where flashing patches were pulling loose.

Photo showing additional overview of Area 09 Roof.

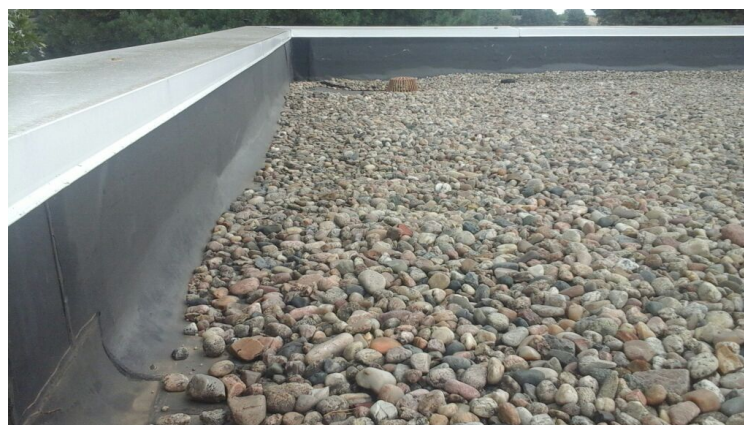
Photo showing minor tenting along the perimeter flashings.

I recommend repairing holes and monitoring perimeters which may eventually need to be relaxed. I recommend continued inspections and maintenance.

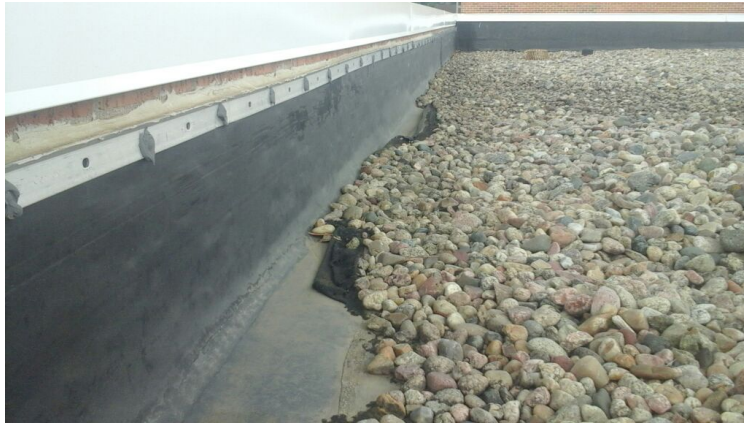
Photo showing where metal does not cover term bar.

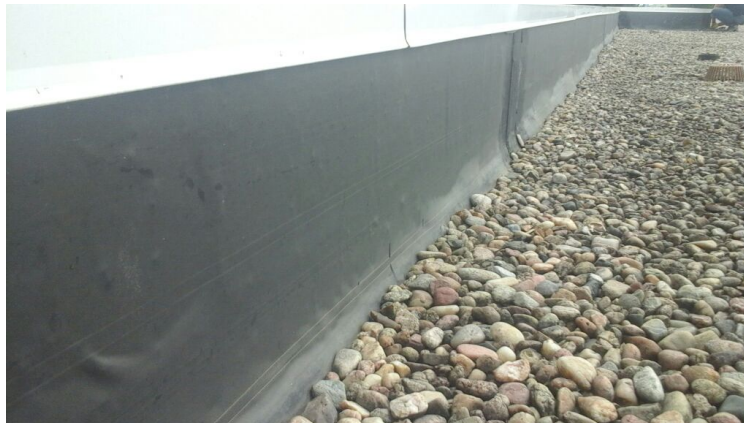
Photo showing additional tenting along the perimeter flashings.

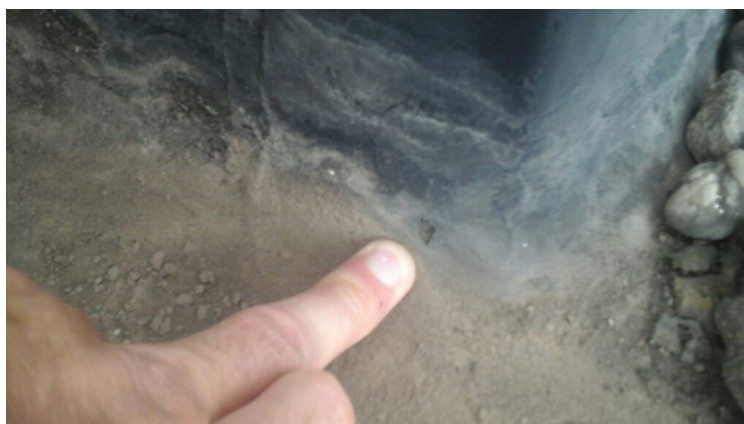
Photo showing a hole in the perimeter flashing.

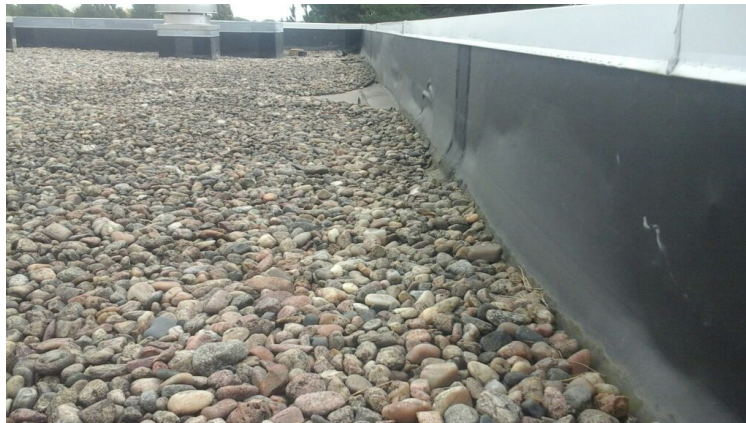
Photo showing tenting occurring along perimeter flashing and into corner.

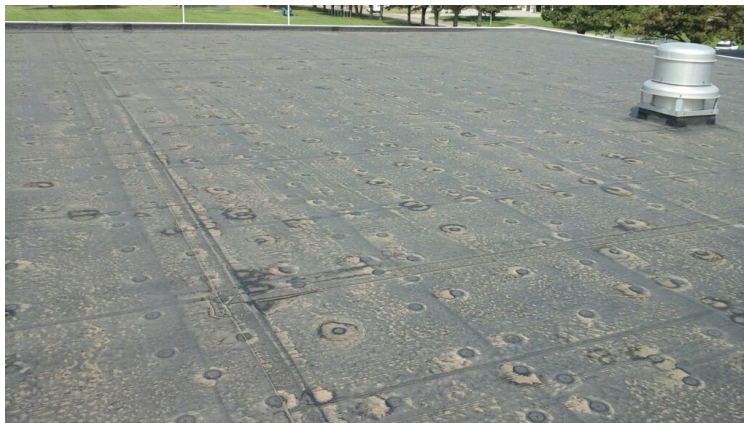
Photo showing additional overview of Area 01 Roof.

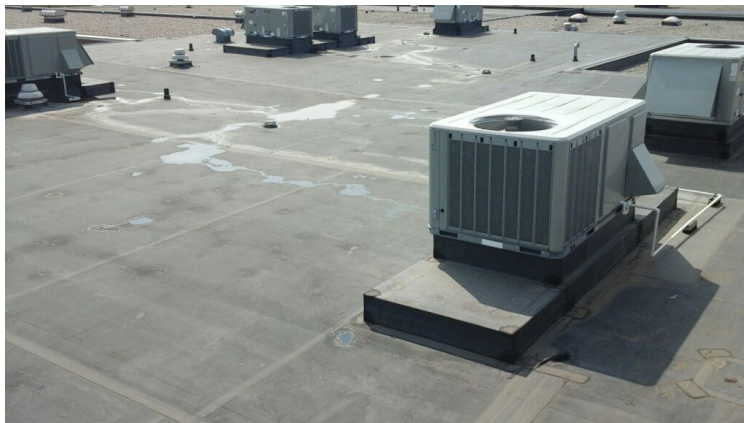
This roof is in good condition and appears to be performing well. There is a persistent leak on the corner of the skylight that is likely caused by excess caulking under the counter flashing.

Photo showing additional overview of Area 02 Roof.

I recommend continued inspections and maintenance. I also recommend removing excess caulking to read evaluate skylight leak.

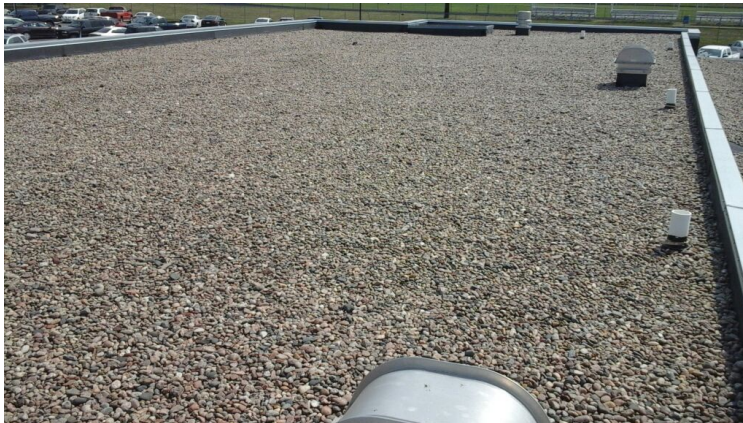
Photo showing additional overview of Area 04 Roof.

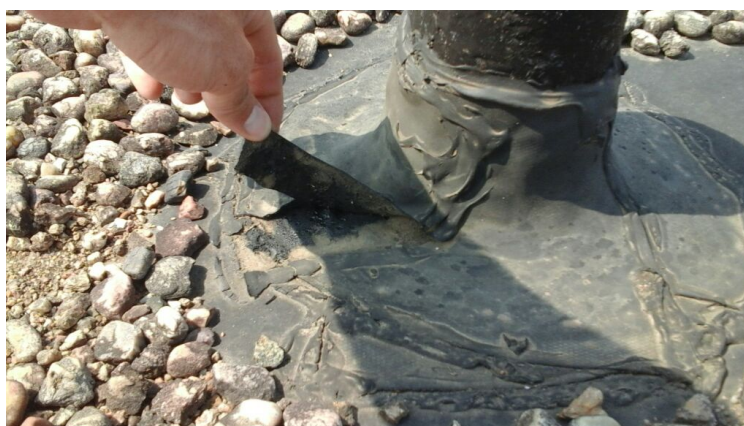
Photo showing flashing around soil stack beginning to pull loose.

This roof is in fair condition but has several areas where blowout patches are beginning to pull loose. There was also a hole found in the perimeter flashing that was open down to deckin.

I recommend restoring the problem areas in the flashings and continued inspections and maintenance to extend the life of this roof. The estimated budget number for restoring this roof is \$30,000.

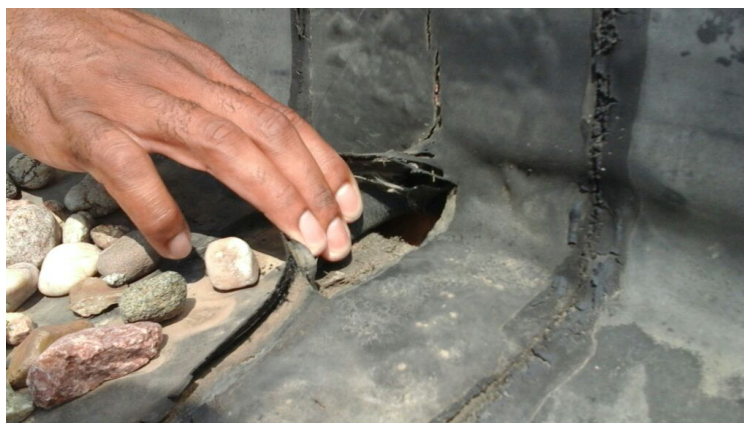
Photo showing a hole in the perimeter flashing. The decking is exposed and this is almost certainly a leak.

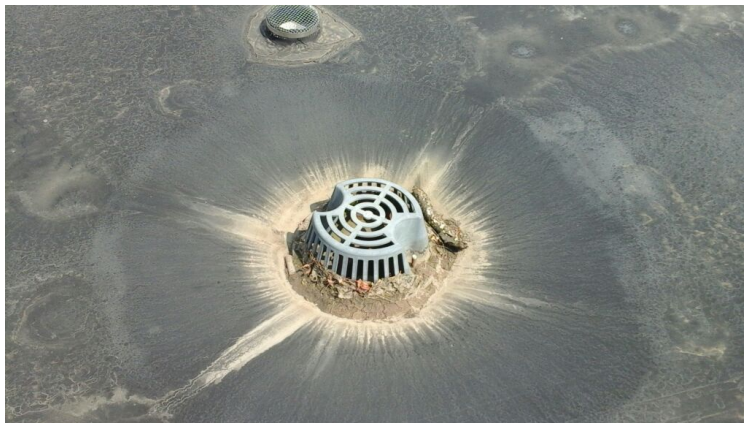
Photo showing additional clogged drain.

I recommend continued inspections and maintenance which would include clearing drains.

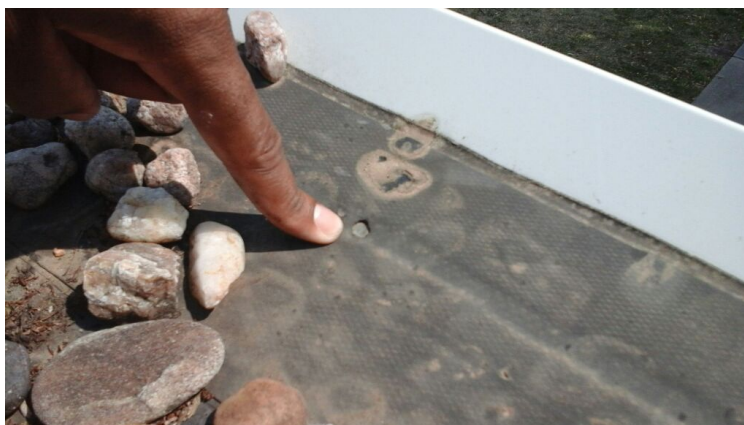
This roof is in poor condition. There are numerous holes in the projection flashings that need attention.

Photo showing an additional hole in the form flashings.

I recommend scheduling a restoration on the problem areas of this roof as budgets allow. I also recommend continued inspections and maintenance. The estimated budget number for restoring this roof is \$50,000.

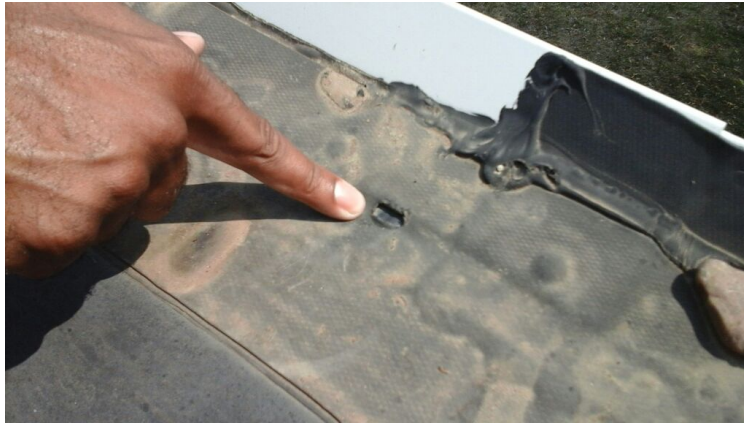
Photo showing a hole in the form flashings.

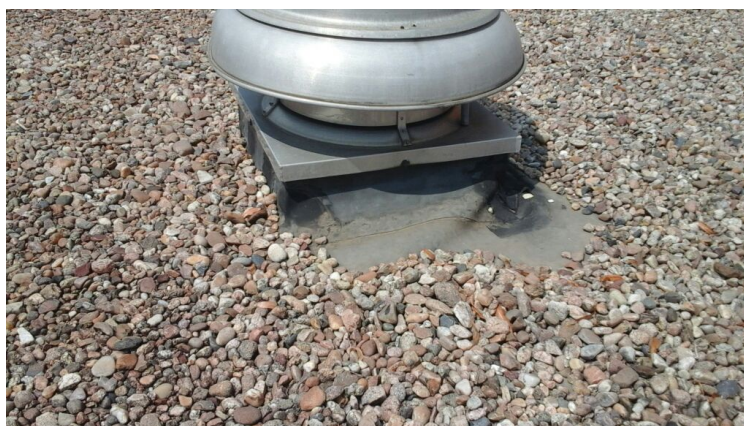
Photo showing tenting along the projection flashings.

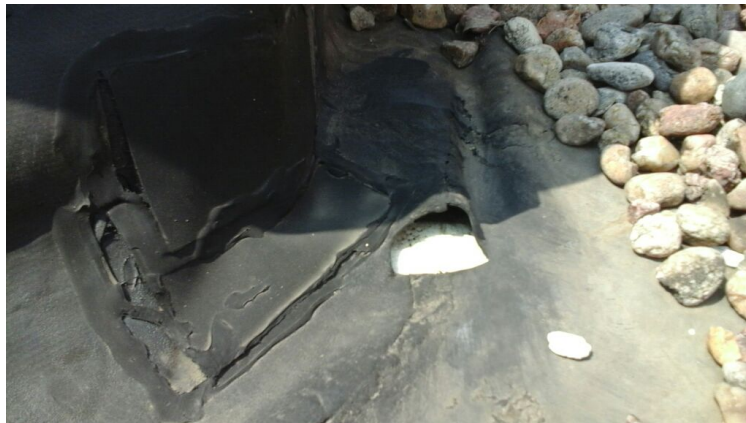
Photo showing a hole in the tenting projection flashings where EPS is exposed.

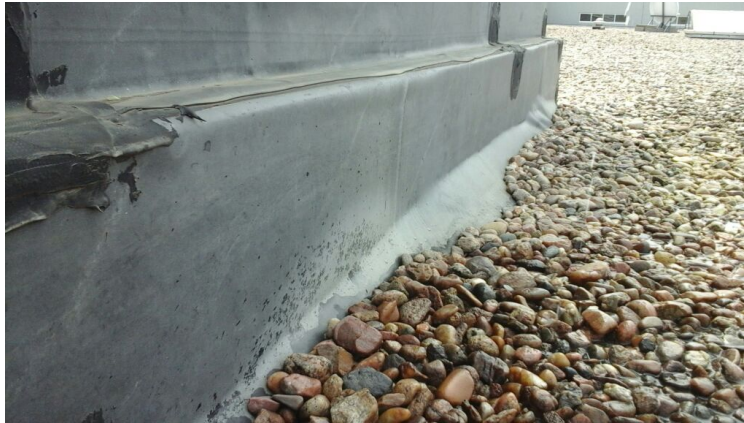
Photo showing tenting along the projection flashings.

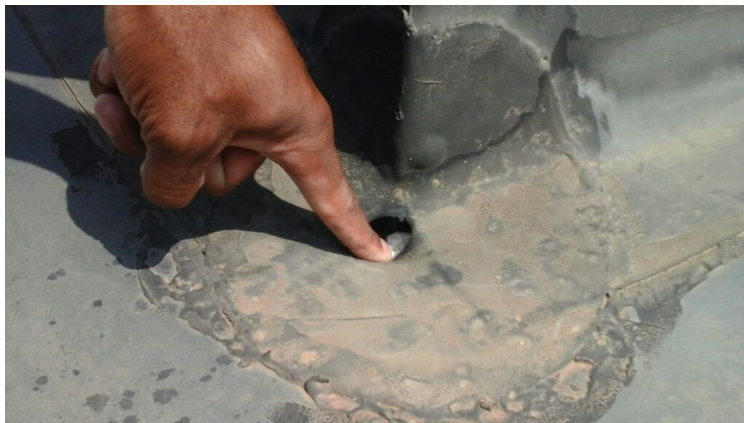
Photo showing a hole in the projection flashing where EPS is exposed.

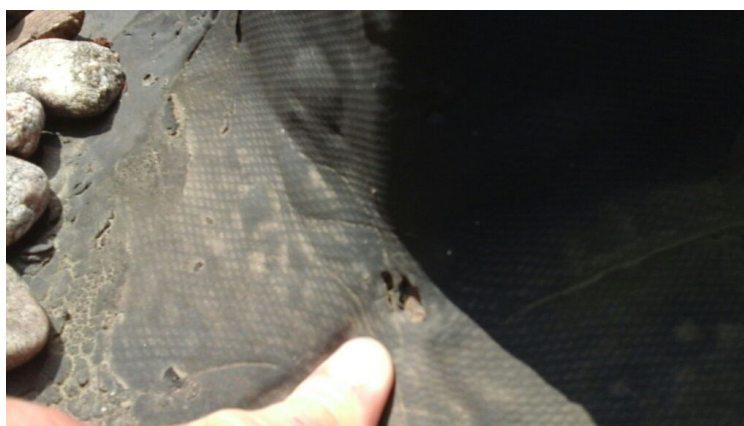
Photo showing a hole in the projection flashing.

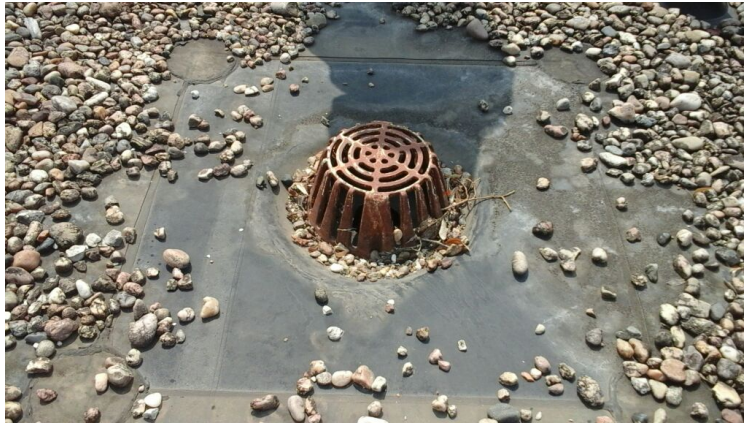
Photo showing a slightly clogged drain.

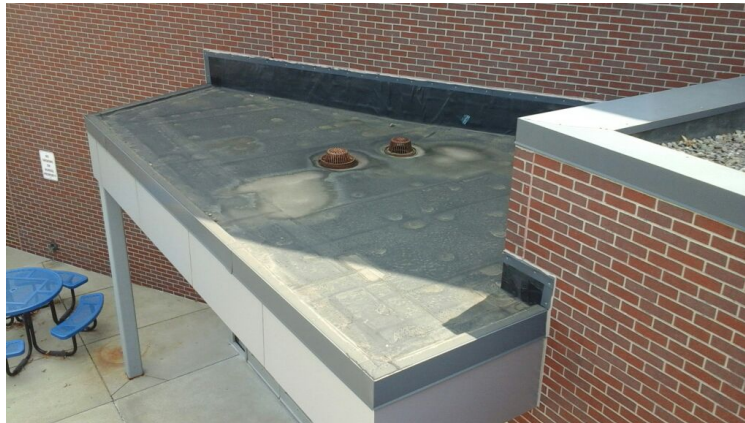
Photo showing overview of small Fully-adhered EPDM area adjacent to Area 11 Roof.

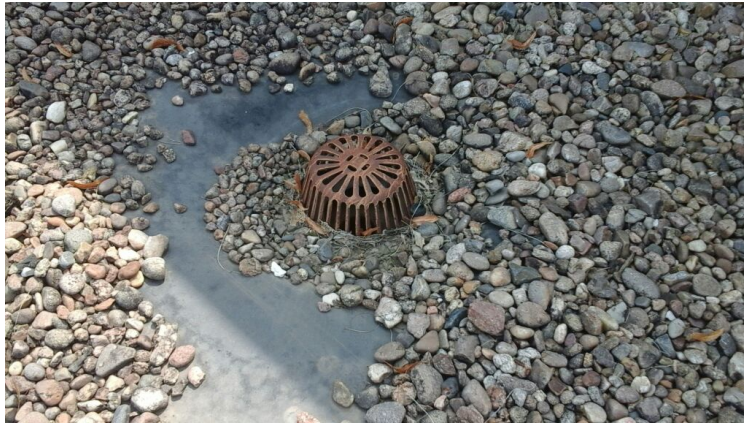
Photo showing clogged drain.

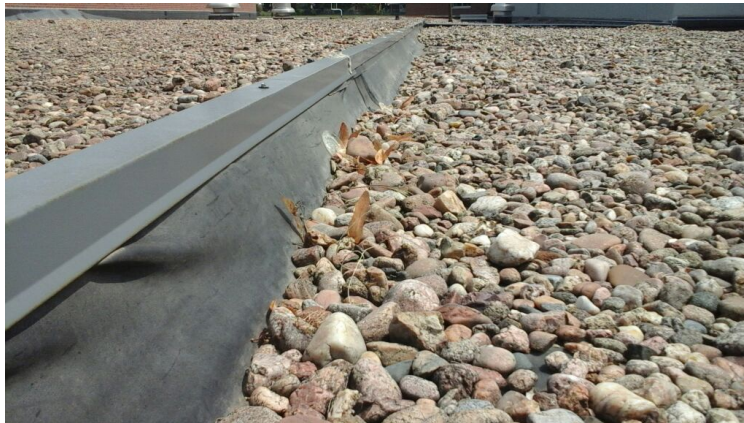
Photo showing minor tenting along the interior perimeter flashings.

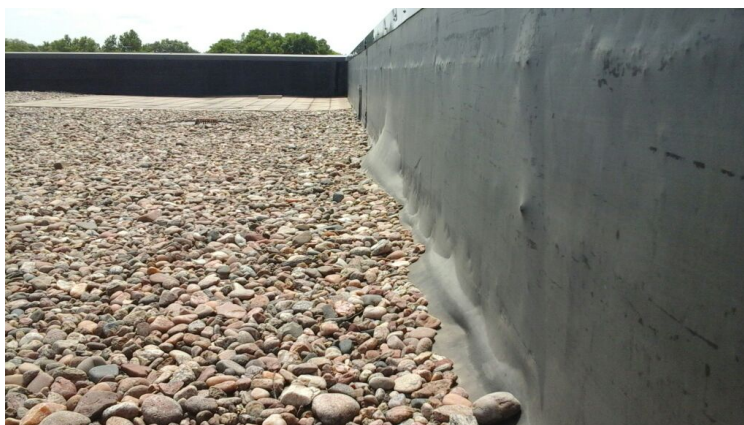
Photo showing minor tenting along the perimeter flashings.

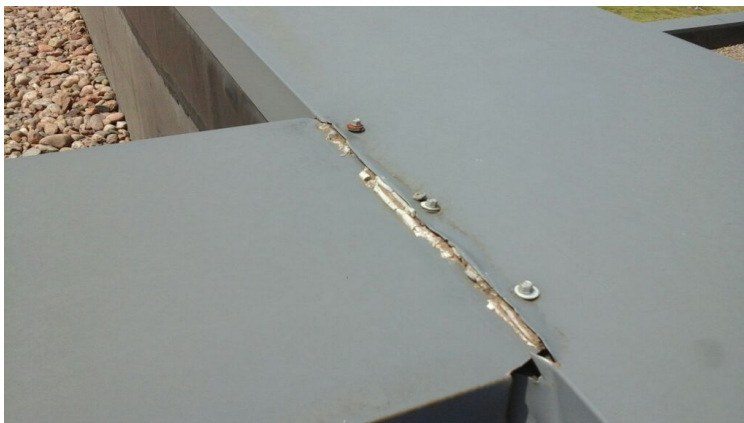
Photo showing caulking beginning to deteriorate on metal.

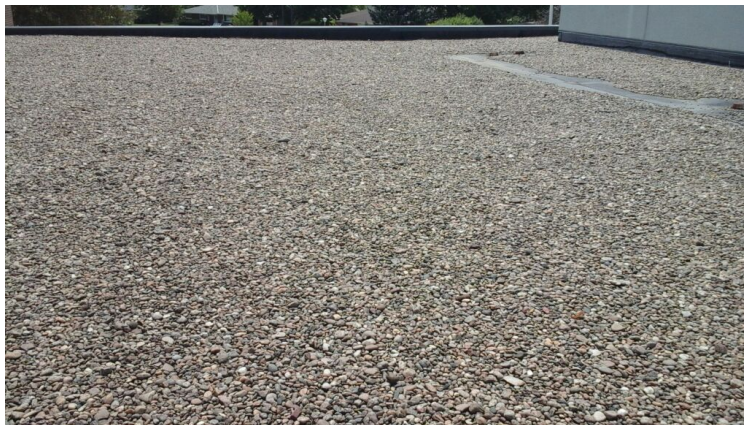
Photo showing additional overview of Area 17 Roof.

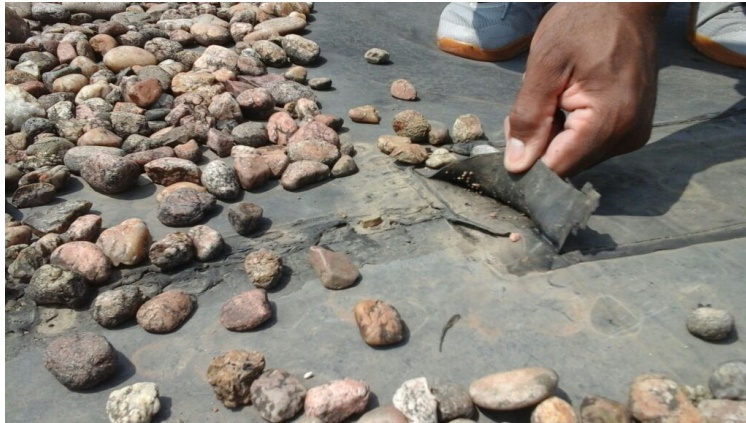
Photo showing patch pulling up along the seam.

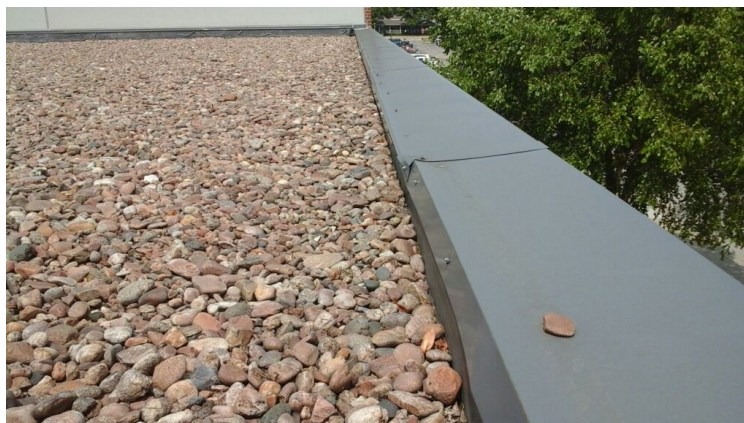
Photo showing mismatched metal sizes.

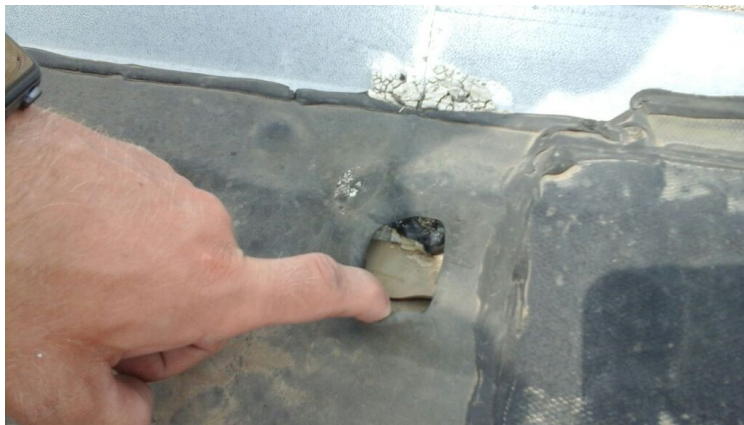
Photo showing a hole in the form flashings exposing interior.

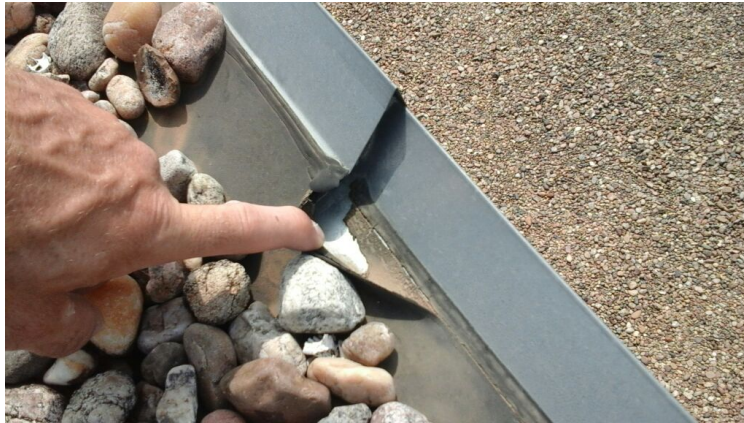
Photo showing form flashings opening up due to metal displacement.
